# ENGINE EXAMINATION REPORT

| AIRCRAFT MAKE & MODEL | Beechcraft 58 Baron |
| FILE NUMBER | 18-383 |

| EXAMINATION | | ACCIDENT DATA | |
|---|---|---|---|
| <b>DATE</b> | 10-8-2019 | <b>NTSB ACCIDENT #</b> | CEN19FA124 |

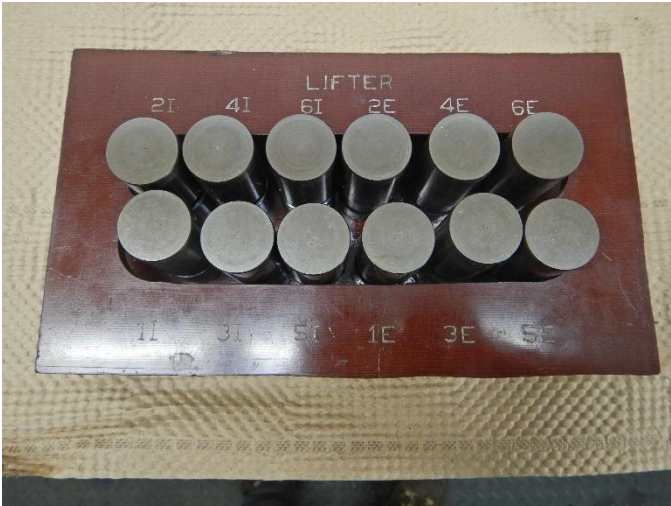
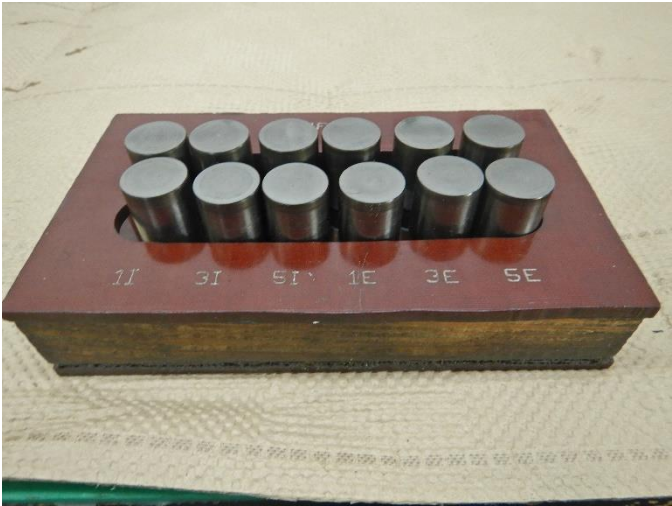
| LIFTERS | #1 | #3 | #5 | #2 | #4 | #6 |

| LIFTERS | #1 | #3 | #5 | #2 | #4 | #6 |
|---|---|---|---|---|---|---|
| Condition: | All lifters exhibited normal operating signatures. | | | | | |

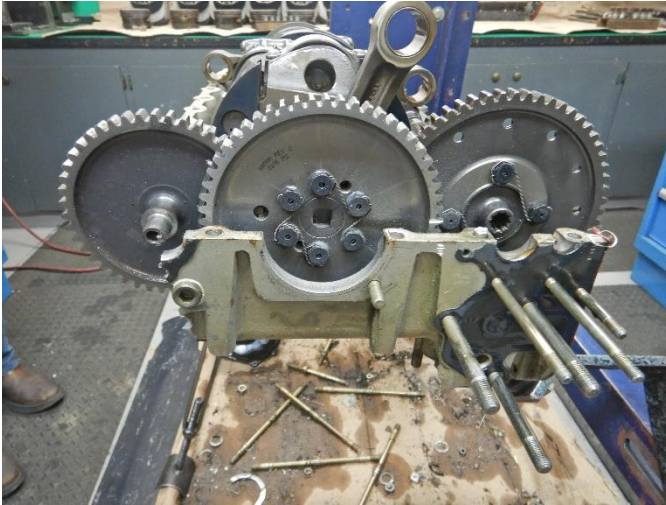
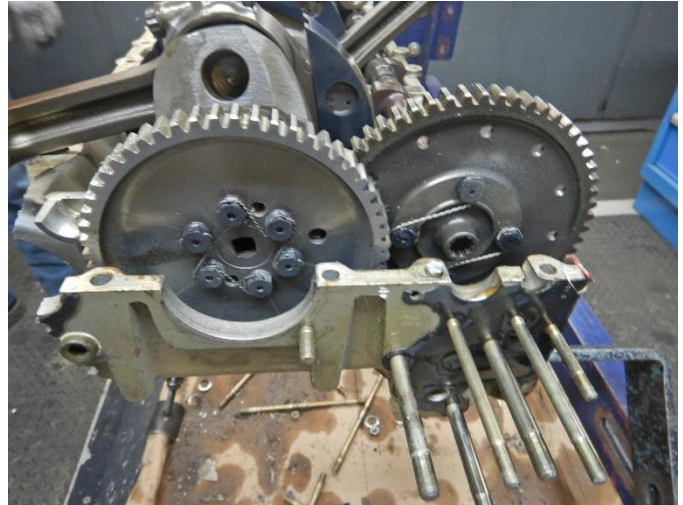
All gears exhibited normal operating signatures. Assembly bolts were correctly secured.

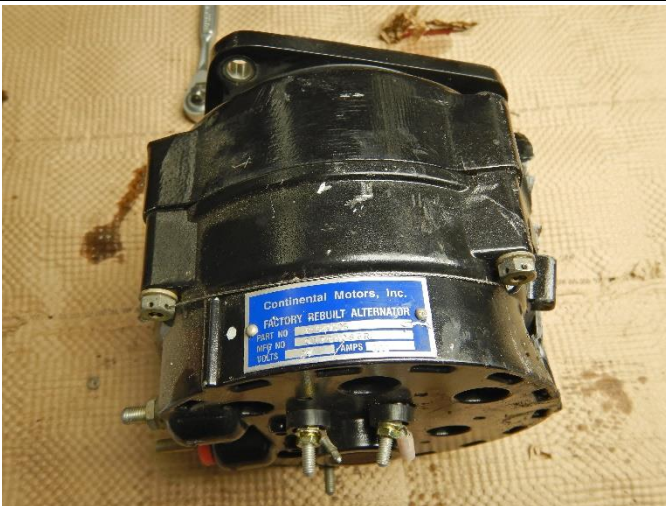
| <b>ALTERNATOR</b> | Manufacturer: Continental | P/N: R649805 | S/N: 017CA068R |

| Condition: | The alternator rotated smoothly. The lower case exhibited impact damage. The drive coupling was intact and secured properly. | | |

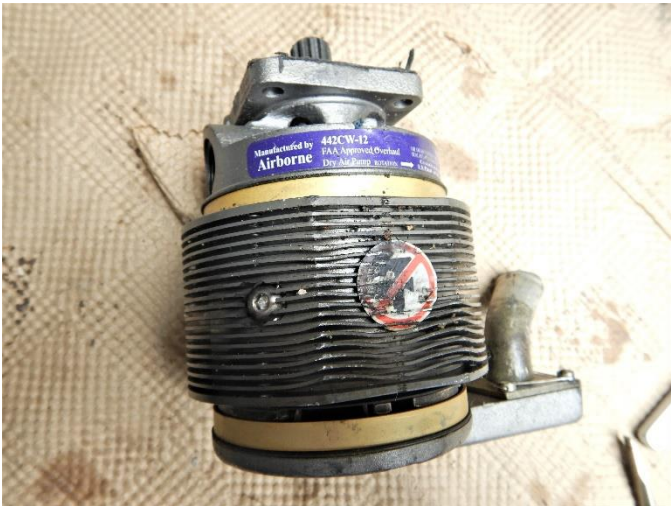
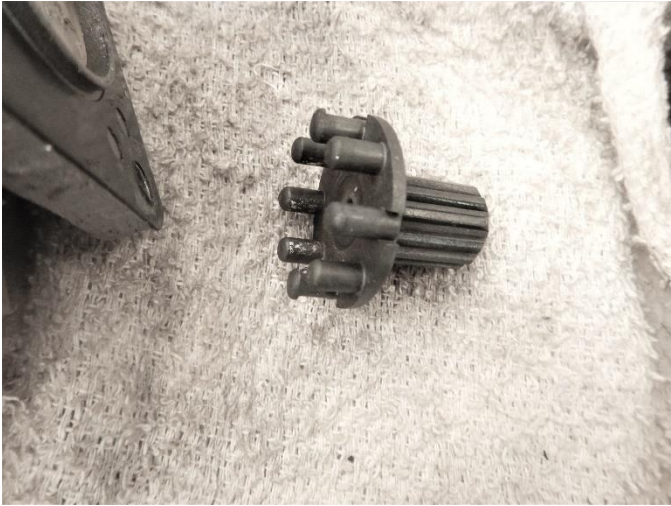
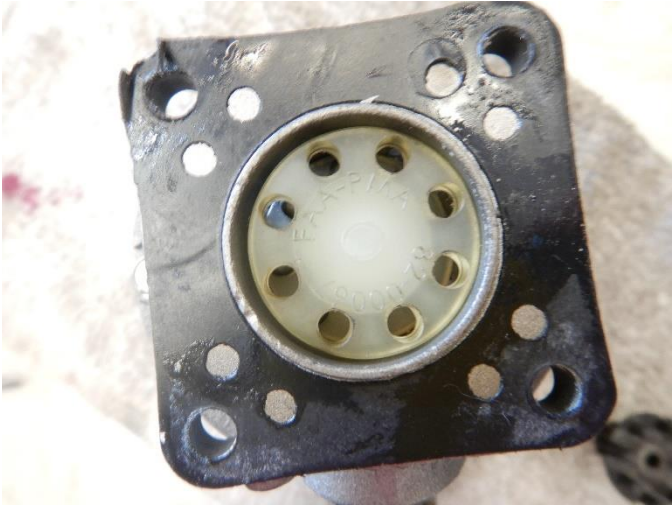
| VACUUM PUMP | Manufacturer: Airborne | P/N: 442CW-12 | S/N: 0AGF06 |

| Condition: | The external case exhibited impact damage. The drive couplings were intact. The pump turned smoothly when manually rotated. The carbon rotor and vanes were intact. | | |
