## ENGINE EXAMINATION REPORT

| ENGINE MODEL | TSIO-360-FB |
| AIRCRAFT REGISTRATION | N2890T |
| FILE NUMBER | 19-095 |

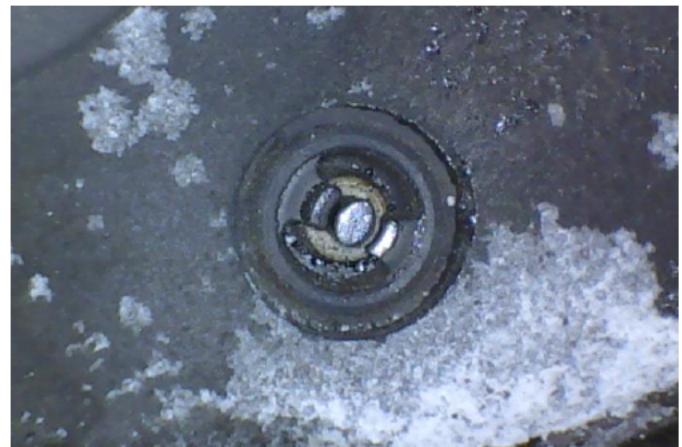
#1 Bottom Spark Plug

The spark plugs remained installed in their cylinders and were undamaged. The top spark plugs were removed for examination and the bottom spark plug electrodes were examined using a lighted borescope. The electrodes displayed normal operating and all of the spark plugs were in a normal worn-out condition.

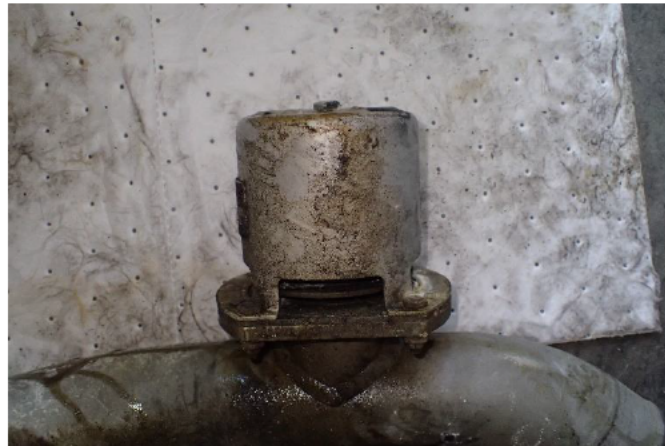
The overboost valve remained attached to its installation point and was undamaged. There were no anomalies observed.

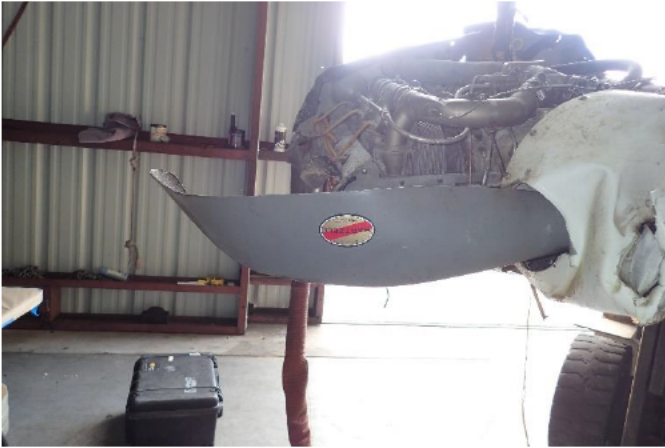
Propeller Blade "B"

The two-blade, constant speed propeller remained attached to the crankshaft and both propeller blades remained within the propeller hub. Both propeller blades displayed impact damage signatures. One of the propeller blades (blade "A") displayed minor aft bending deformation and minor chordwise scratches at the trailing edge of the blade. The other propeller blade (blade "B") displayed aft bending deformation, minor twisting deformation, and minor chordwise scratches at the leading edge of the blade.
