# National Transportation Safety Board

CEN23LA232

## **MATERIALS LABORATORY**

Factual Report 24-022

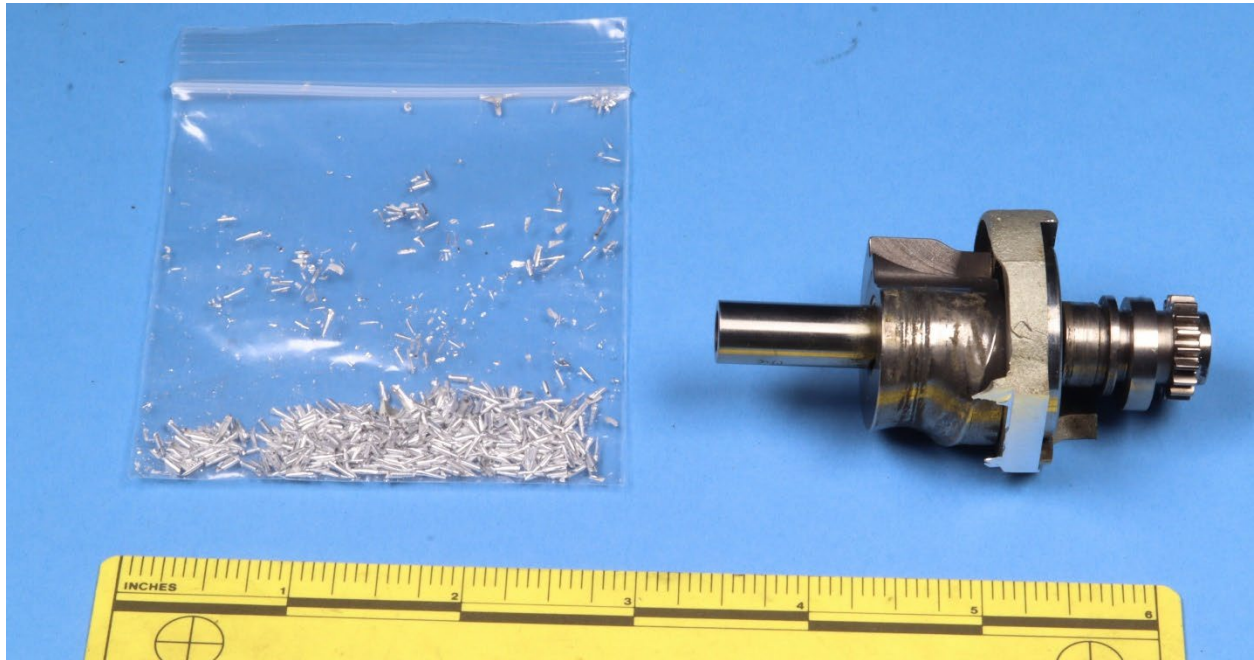
**Figure 1.** The camgear/camshaft assembly and a bag of metallic debris, as received.

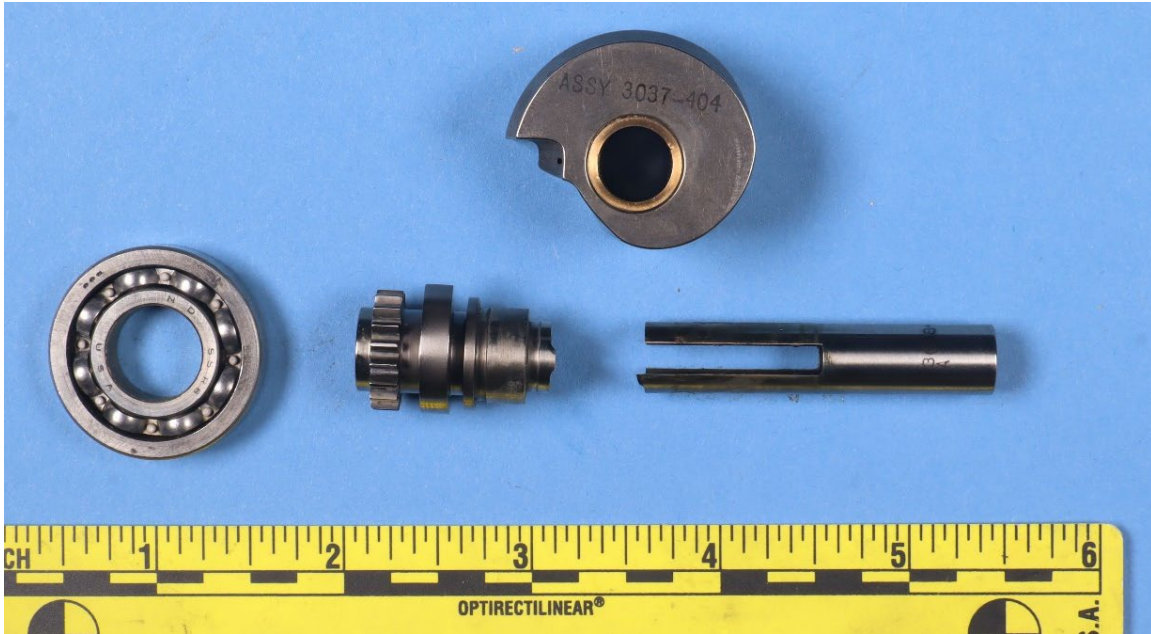
**Figure 17.** View of the camshaft, camgear, and bearing after sectioning and disassembly.

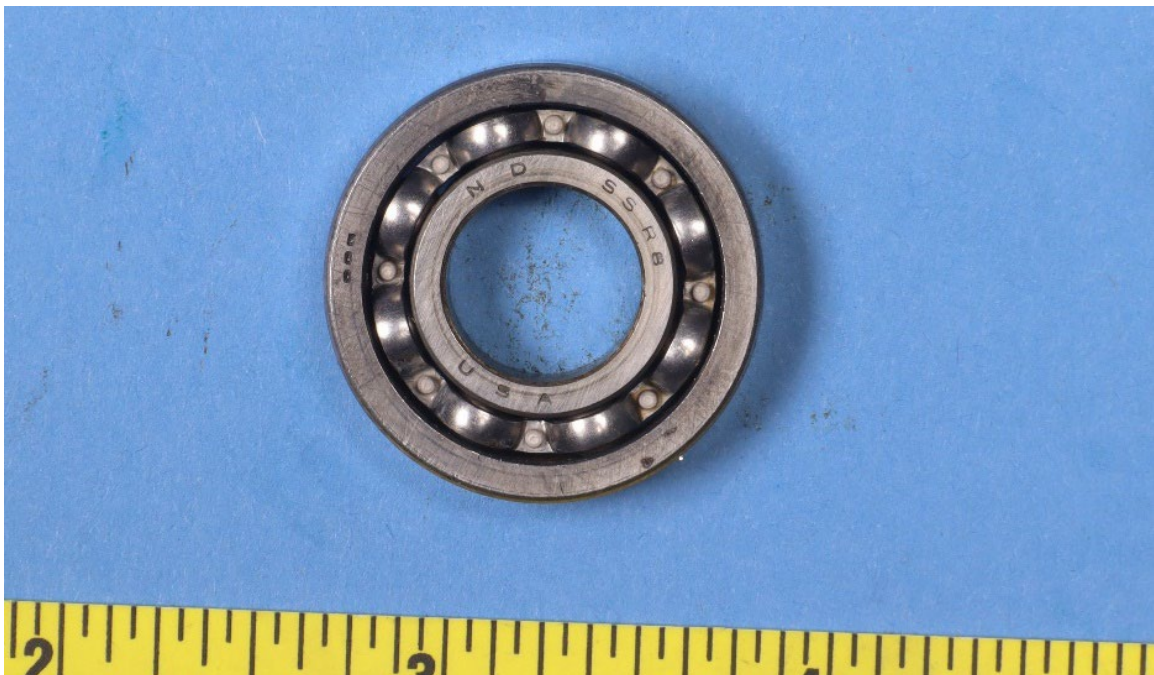
The bearing removed from the camshaft is shown in Figure 63. The face of the inner bearing race bore the following markings: "ND SS R8 USA." There were no severe

**Figure 63.** View of the bearing after removal from the camshaft assembly.
