# BACKGROUND

On April 17th, 2018 SWA 1380 experienced a fan blade out (FBO) event at FL 320. The FBO event resulted in portions of the inlet and fan cowl departing the aircraft, specifically the inlet d-duct, inlet outer barrel, forward sections of the inlet inner barrel and large sections of the fan cowl. In support of the NTSB, Collins Aerospace (Collins) documented the condition of the inlet and fan cowl components that remained on the aircraft as well as the recovered hardware that departed the A/C. The recovered hardware and the remaining portions of the inlet and fan cowl were removed from the aircraft and were shipped to the Collins facility in Chula Vista, California.

# Fan Blade Fragment Trajectories and Inlet Damage

# COLLINS INLET FAN FRAGMENT DAMAGE ASSESSMENT

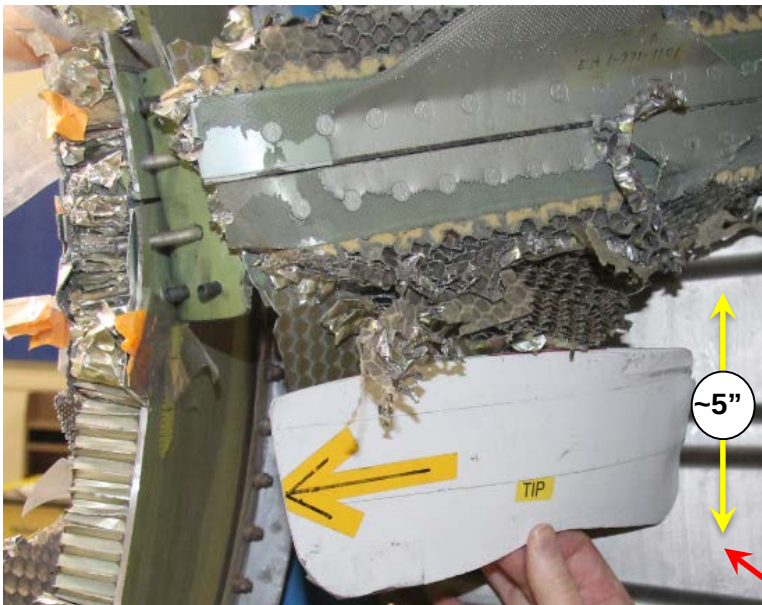
TIP FRAGMENT COLLAPSES ACOUSTIC CORE AND IS ARRESTED AT 9:00 BEAM

~14 cells (~5") of acoustic core was in-plane collapsed into 9:00 beam

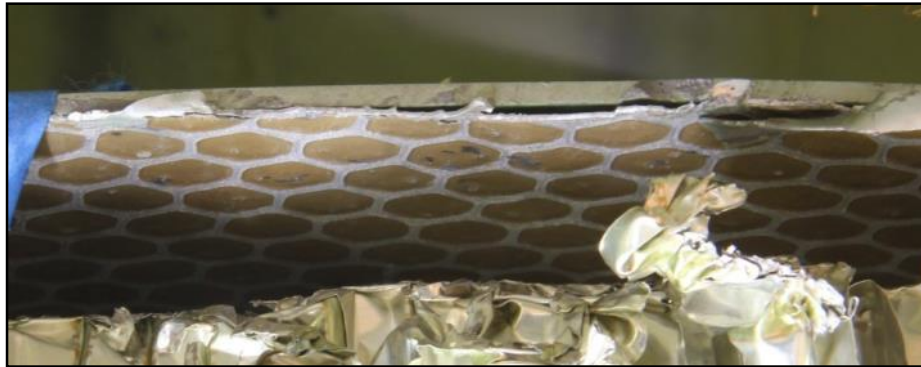
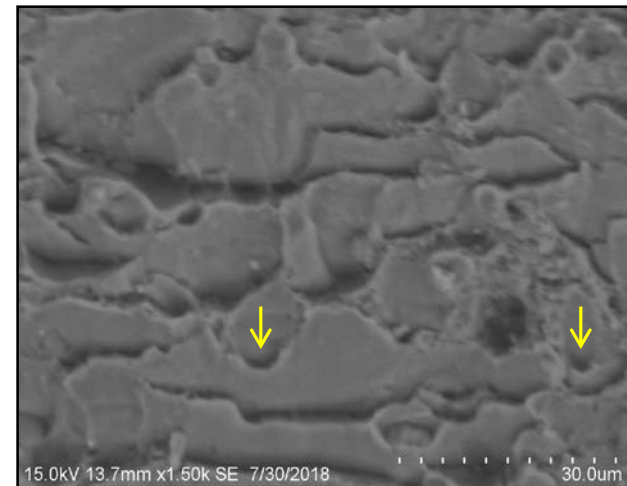
## AREA 11: BACK SKIN RADIAL OUTBOARD SHEAR

- 10:30 Back-Skin – Radial Outboard

↑ FWD Skin Shear

| Radial Outboard

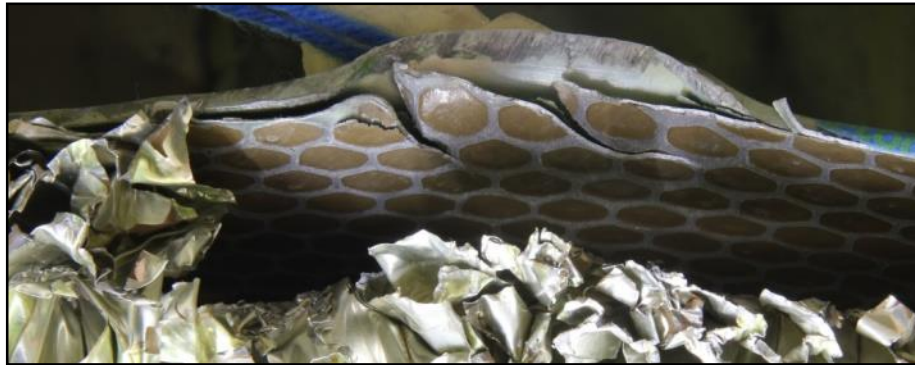
## AREA 12: BACK SKIN RADIAL OUTBOARD SHEAR

- 11:00 Back Skin Radial Outboard

↑ FWD Skin Shear  
Radial Outboard

AFT (Back Skin) Microvoid Coalescence

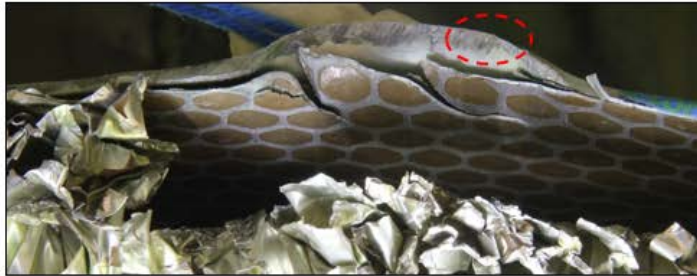
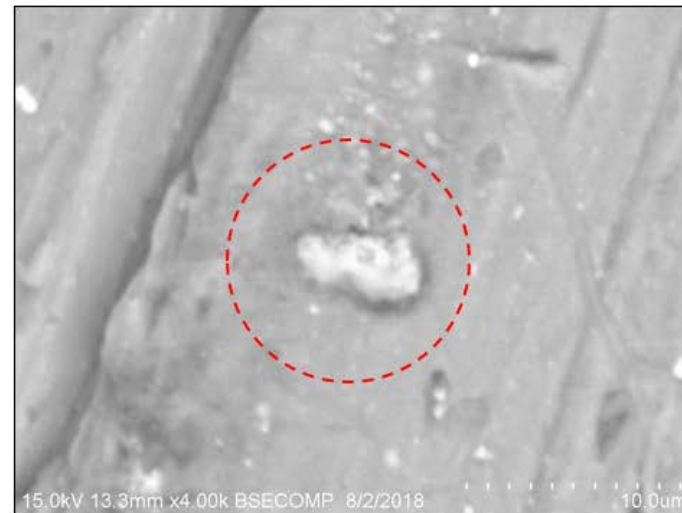
## AREA 12: TITANIUM ON CONTAINMENT SHIELD

- 11:00 Containment Shield – Titanium Particle

Titanium Alloy  
Particles Imbedded

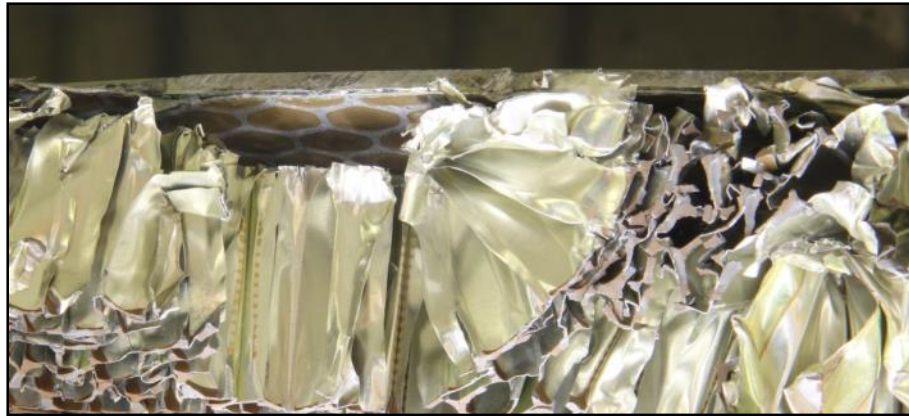
## AREA 13: BACK SKIN TANGENTIAL CLOCKWISE RADIAL INBOARD SHEAR

- 11:30 Back Skin Tangential CW Radial Inboard

FWD Skin Shear  
↙ Tangential CW  
Radial Inboard

AFT (Back Skin) Microvoid Coalescence

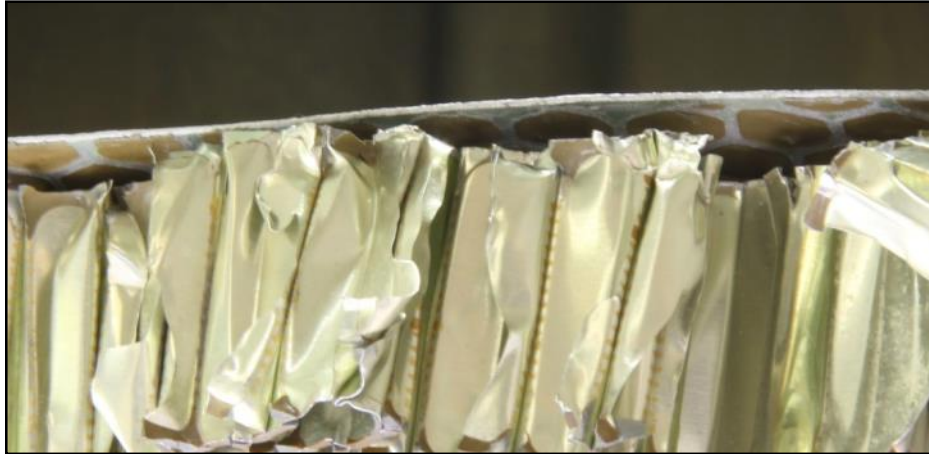
## AREA 14: BACK SKIN RADIAL OUTBOARD SHEAR

- 12:00 Back Skin - Radial Outboard

↑ FWD Skin Shear  
Radial Outboard

AFT (Back Skin) Microvoid Coalescence

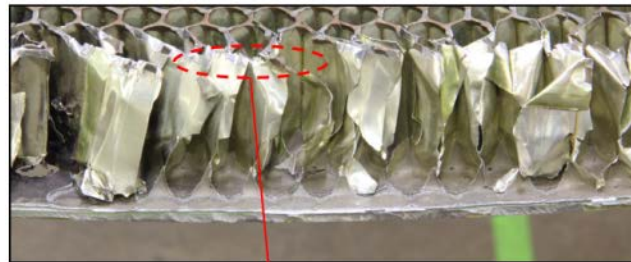
## AREA 2: TITANIUM ON FOLDED CORE

- 6:00 Folded Core – Ti-6Al-4V Particles

Titanium Alloy  
Particles Impacted  
and Imbedded

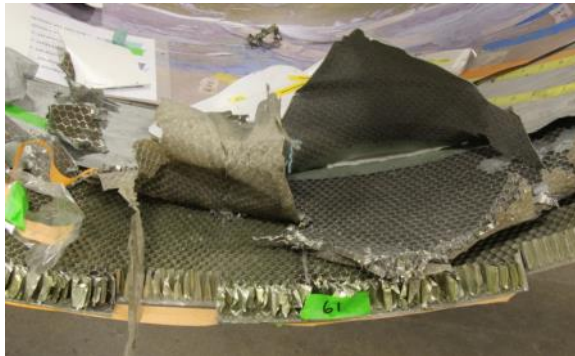
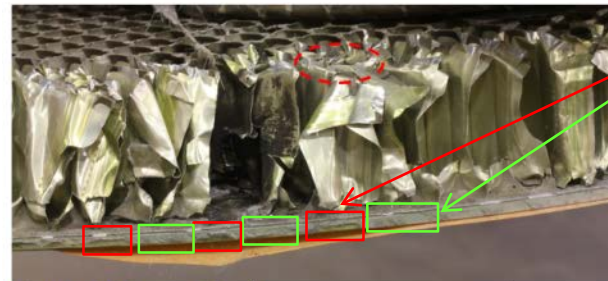
## AREA 61: TITANIUM ON FOLDED CORE, BACK SKIN ALTERNATING SHEAR

- 6:30 Folded Core – Ti-6Al-4V Particles

Back Skin Alt Shear

Titanium Alloy  
Particles Impacted  
and Imbedded

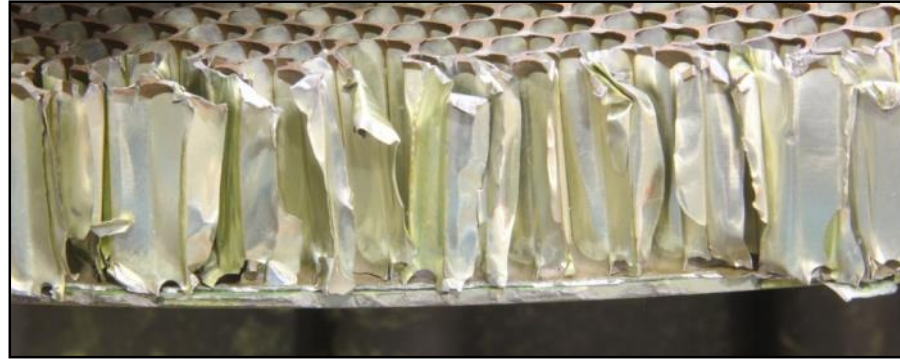
## AREA 3: AXIAL TENSILE OVERLOAD

- 7:00 Back-Skin – Tensile

FWD Skin  
Directionality  
Axial Tensile  
Overload

AFT (Back Skin) Microvoid Coalescence

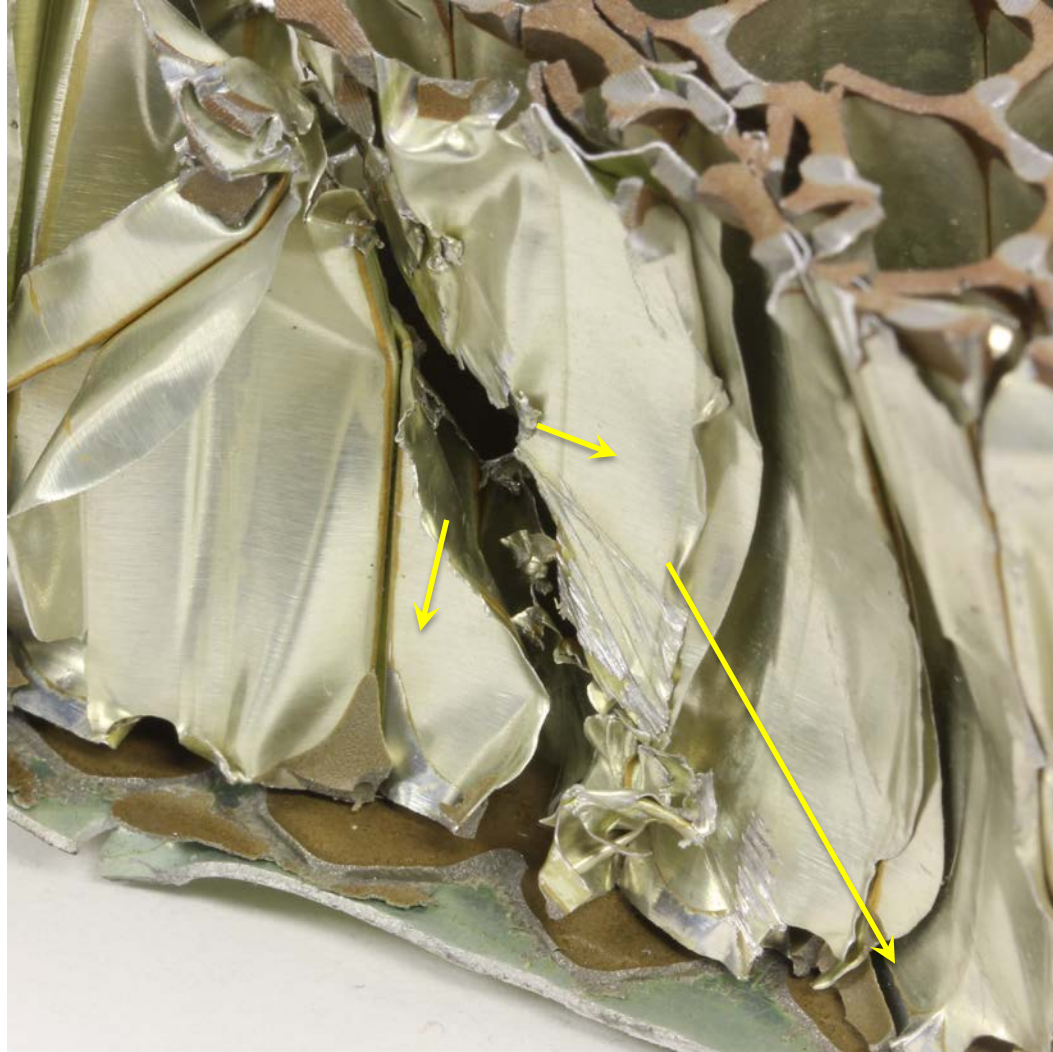
## AREA 56: TITANIUM ON FOLDED CORE

- 7:30 Core Slice

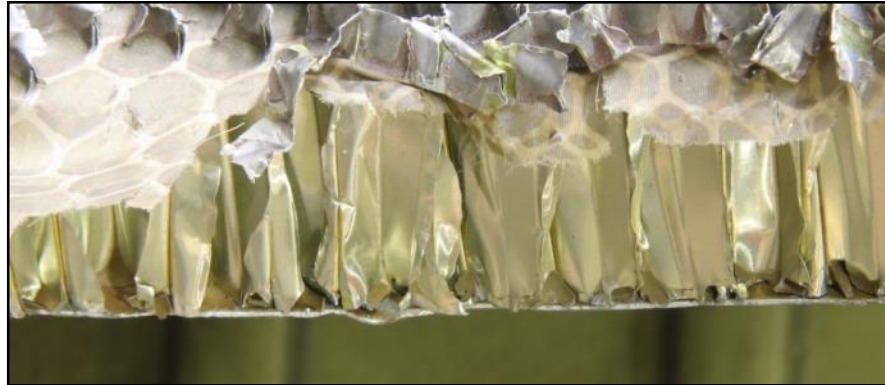
## AREA 5: BACK SKIN RADIAL OUTBOARD SHEAR

- 8:00 Back-Skin – Radial Outboard

↓ FWD Skin Shear  
↓ Radial Outboard

AFT (Back Skin) Microvoid Coalescence

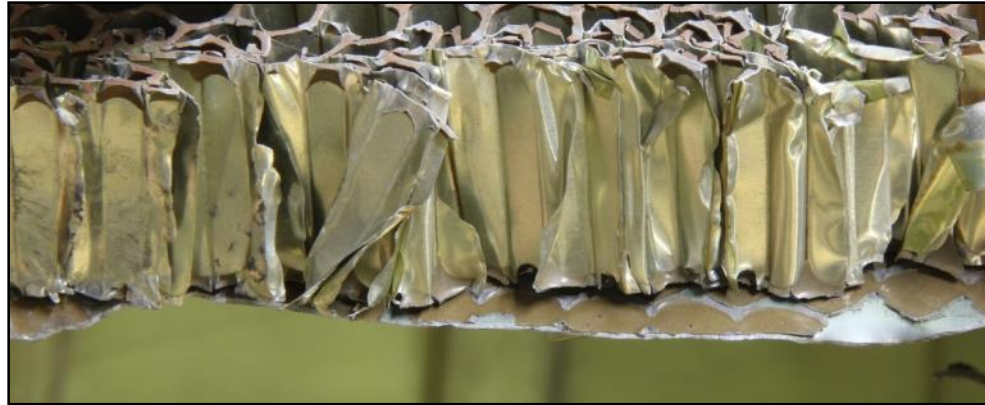
## AREA 6: BACK SKIN RADIAL OUTBOARD SHEAR

- 8:30 Back-Skin – Radial Outboard

FWD Skin Shear  
Radial Outboard

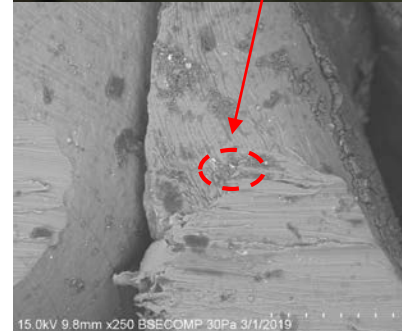
Area 8 (Core) – Position: 9:30

## ZINC PARTICLES FOUND IN 9:00 BEAM AND ACOUSTIC CORE

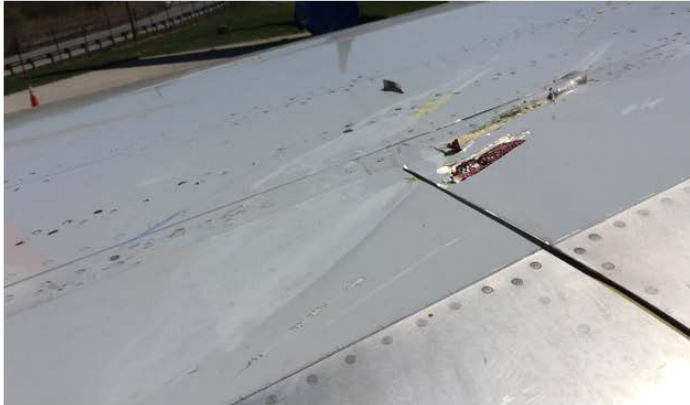
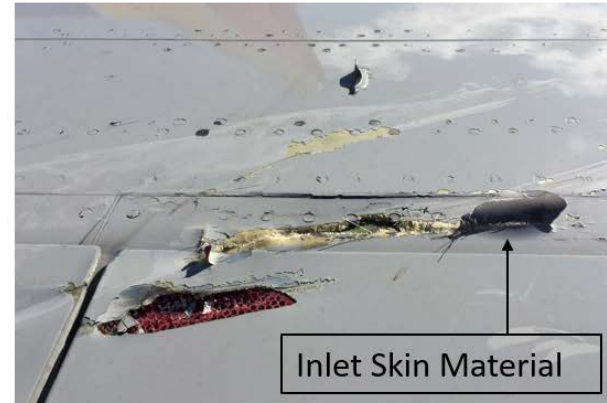
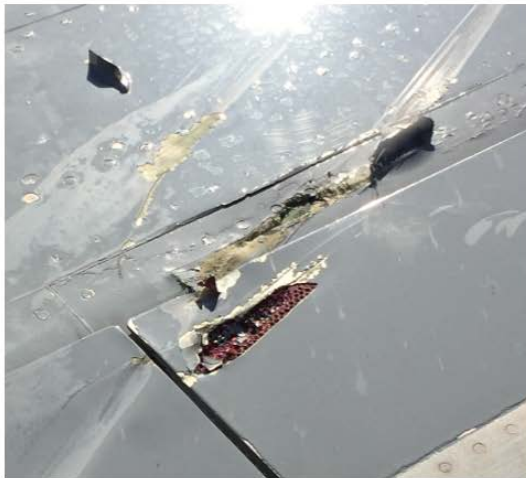
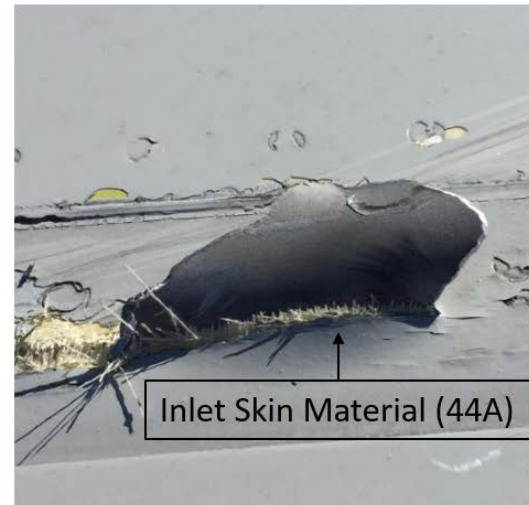
- D-Duct – Inlet Skin Embedded in Wing Top Surface

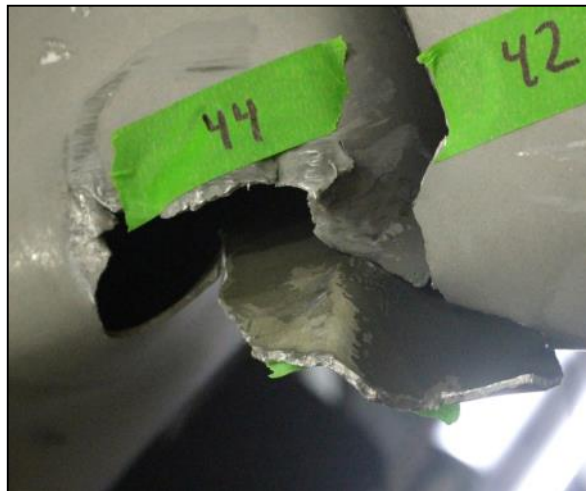
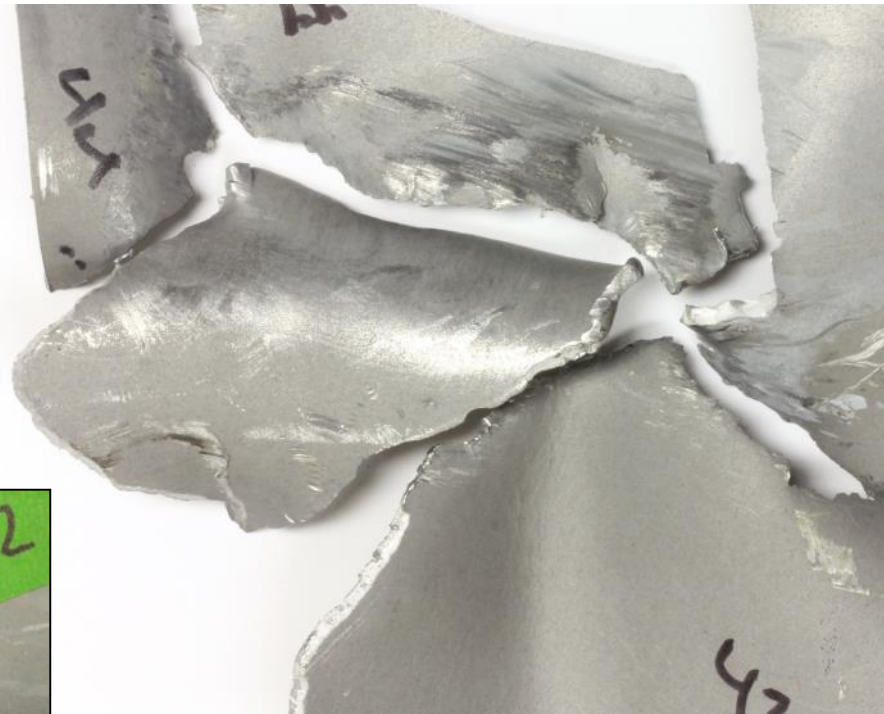
- D-Duct – Inlet Skin (Flow Surface)

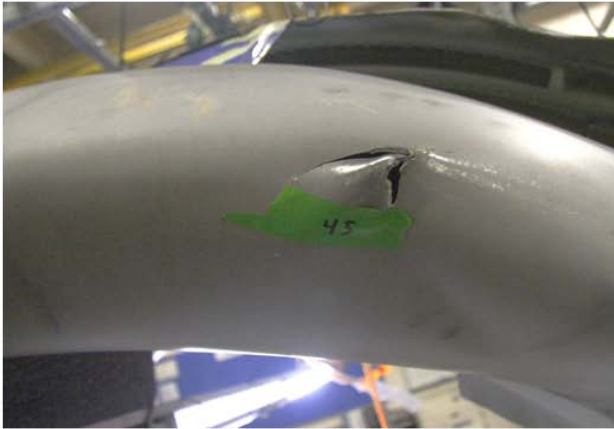
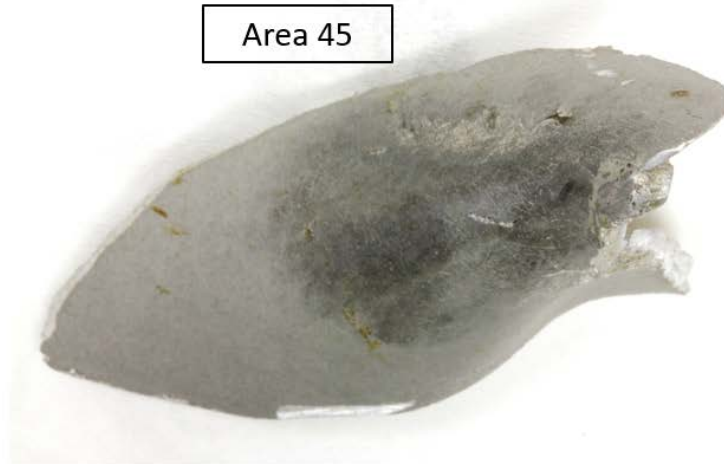
Area 45

- D-Duct – Inlet Skin Flow Surface 11:00

Inlet Skin

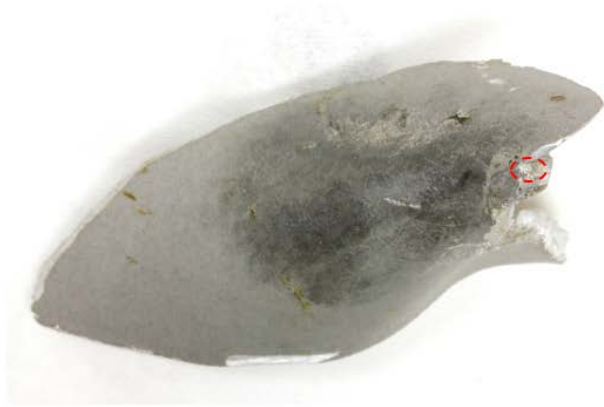
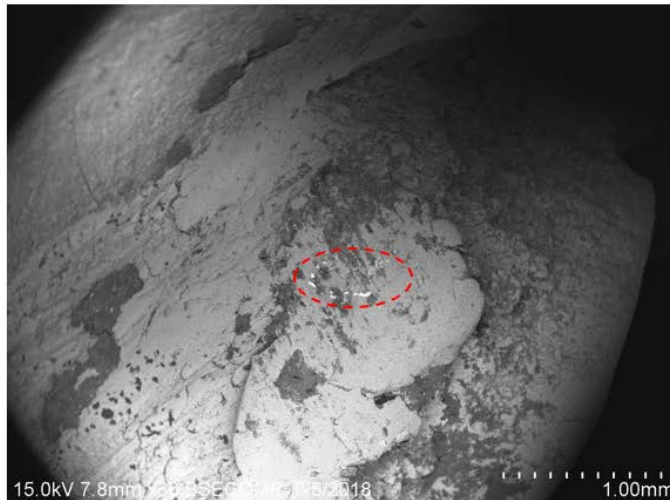
- D-Duct – Inlet Skin Flow Surface – (Piccolo Tube (Cp Ti))

CP Titanium Particles  
Impacted and Imbedded

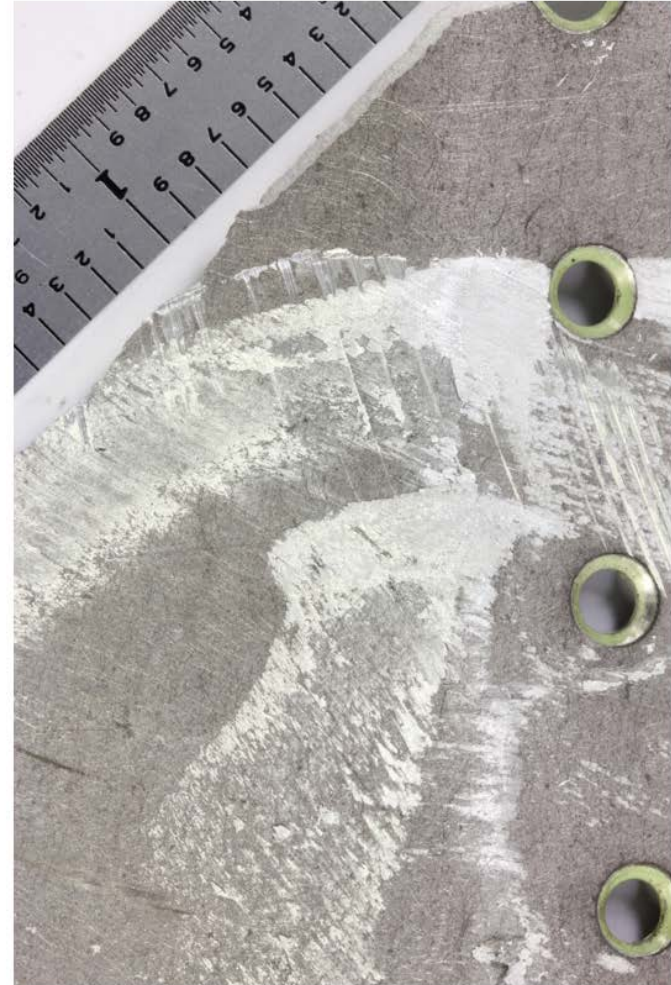
- D-Duct – Inlet Skin 3:30 (9 O'clock Splice Plate Contact)

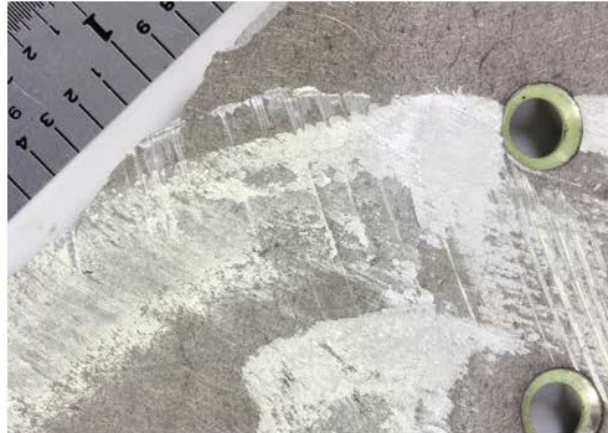
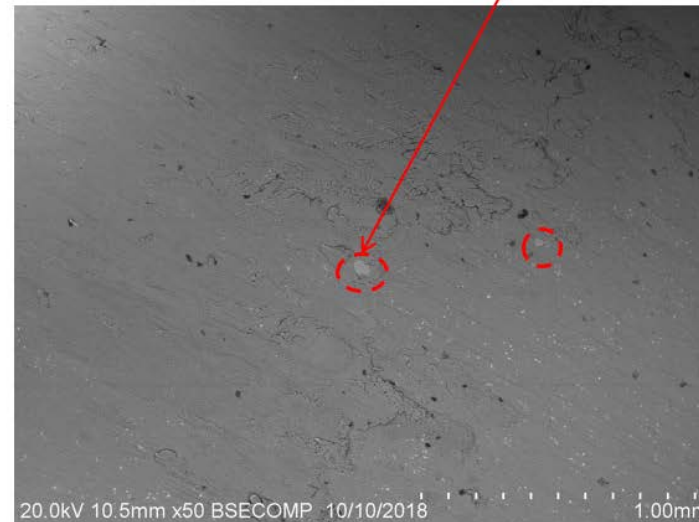
- D-Duct – Inlet Skin 3:30 (9 O'clock Splice Plate)

Titanium Alloy Particles  
Impacted and Imbedded

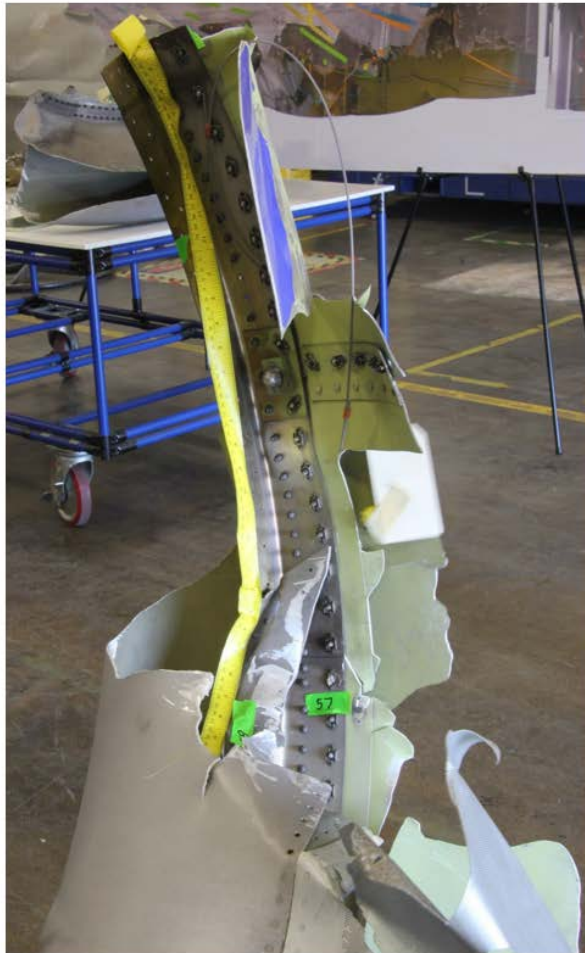
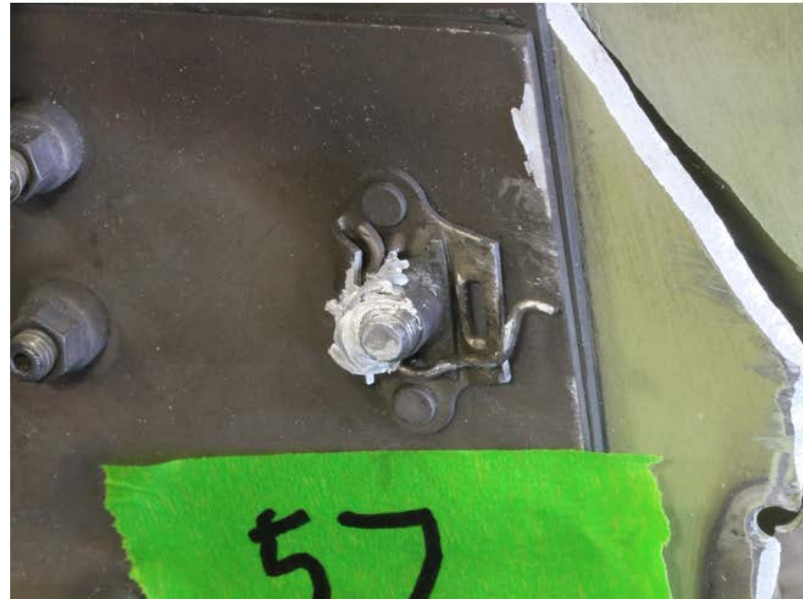
- D-Duct – Inlet Skin 4:00 (Wing Slat Material)

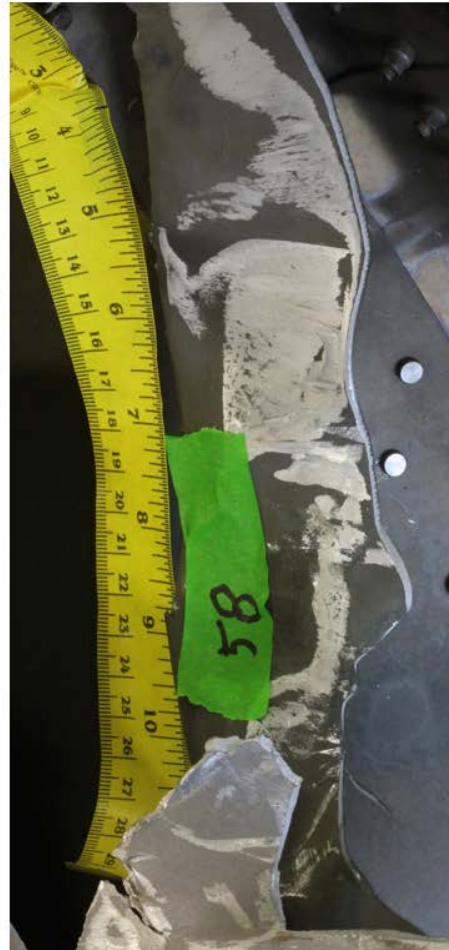
- D-Duct – Inlet Skin 4:00 (Wing Slat Material)

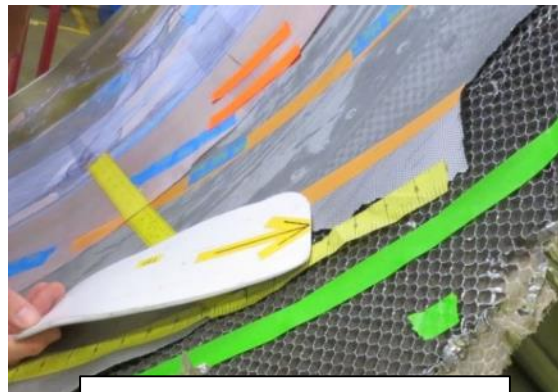
**10)** Tip slides at  $\sim 30^\circ$  helix delaminating perforate skin

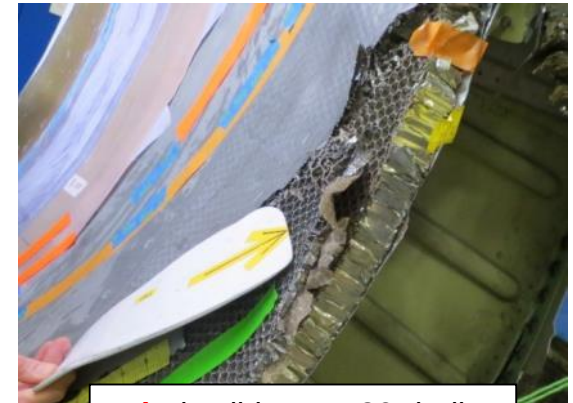
**11)** Tip slides at  $\sim 30^\circ$  helix delaminating perforate skin

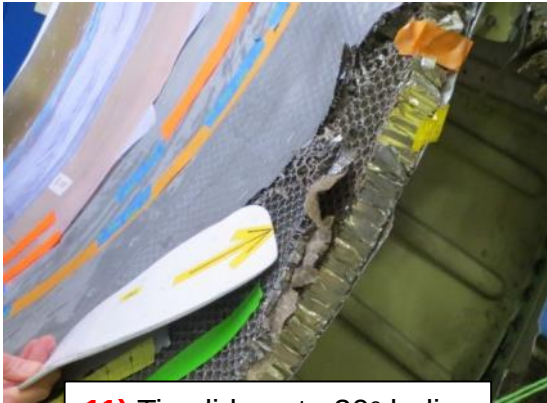
**11)** Tip slides at  $\sim 30^\circ$  helix delaminating perforate skin

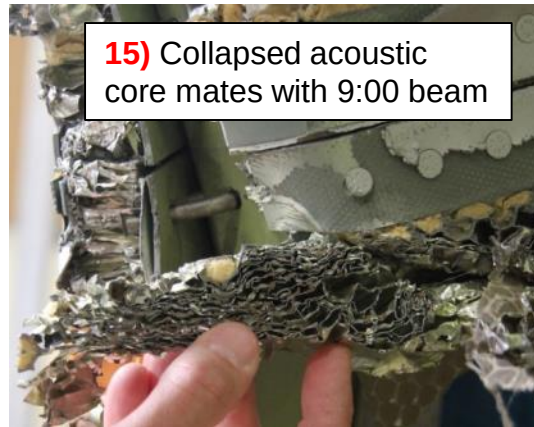
**15)** Collapsed acoustic core mates with 9:00 beam

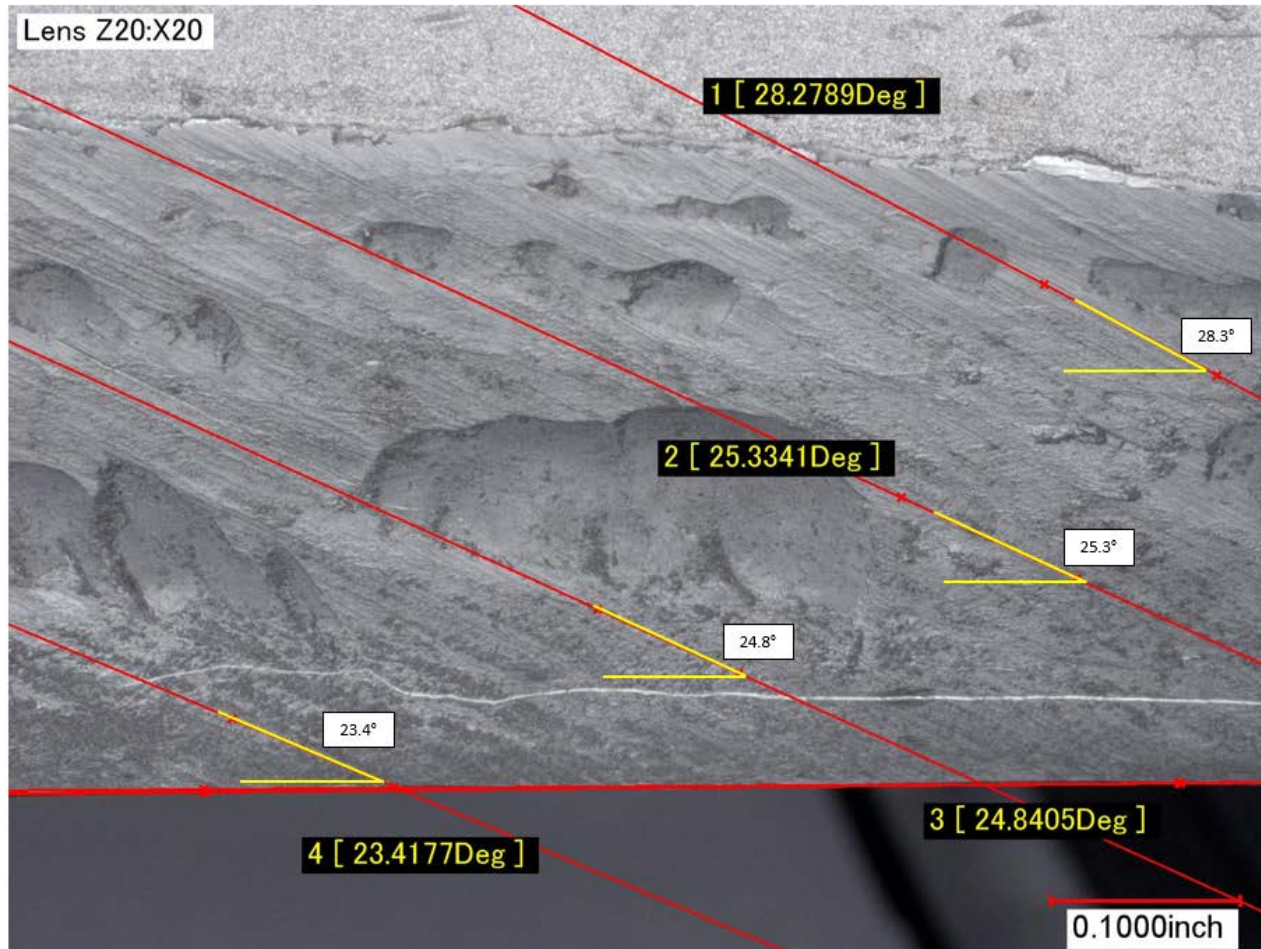
### Blade Tip Impact – Section D (Avg: 25.5°)

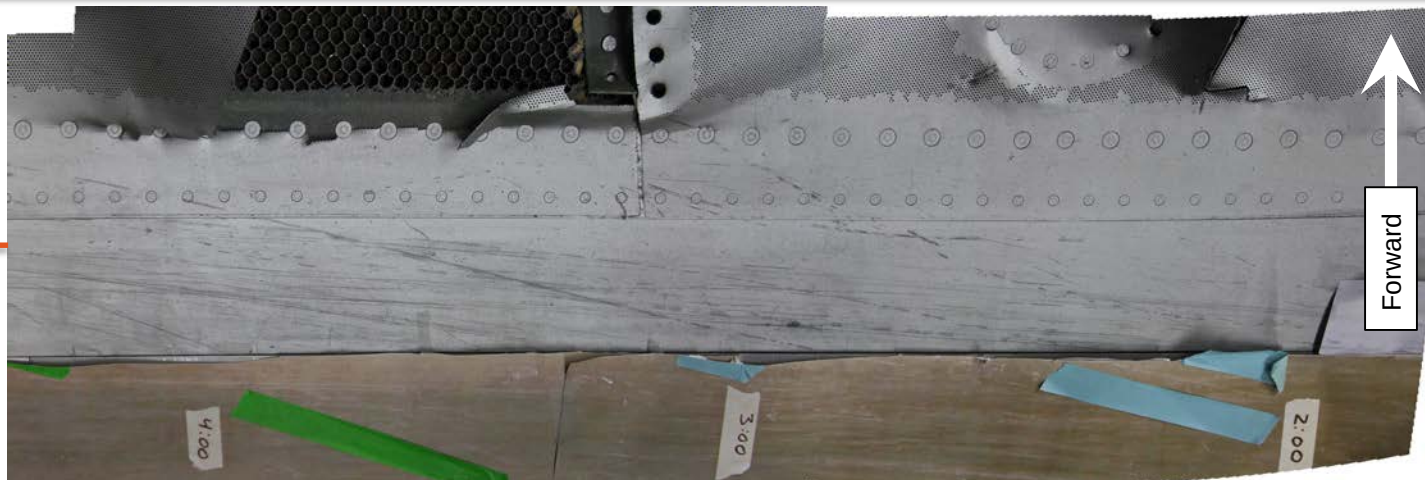
### Inner Barrel Scratch Marks 2:00-6:00
