NATIONAL TRANSPORTATION SAFETY BOARD  
OFFICE OF AVIATION SAFETY  
WASHINGTON, D.C. 20594

**POWERPLANTS GROUP CHAIRMAN'S FACTUAL REPORT**

NTSB ID No.: ENG17IA026

Location: G344 airway northeast of CUTE intersection  
Date: June 7, 2017  
Time: 0950 universal coordinated time  
Aircraft: Boeing 747-451, N668US, Delta Air Lines flight 276

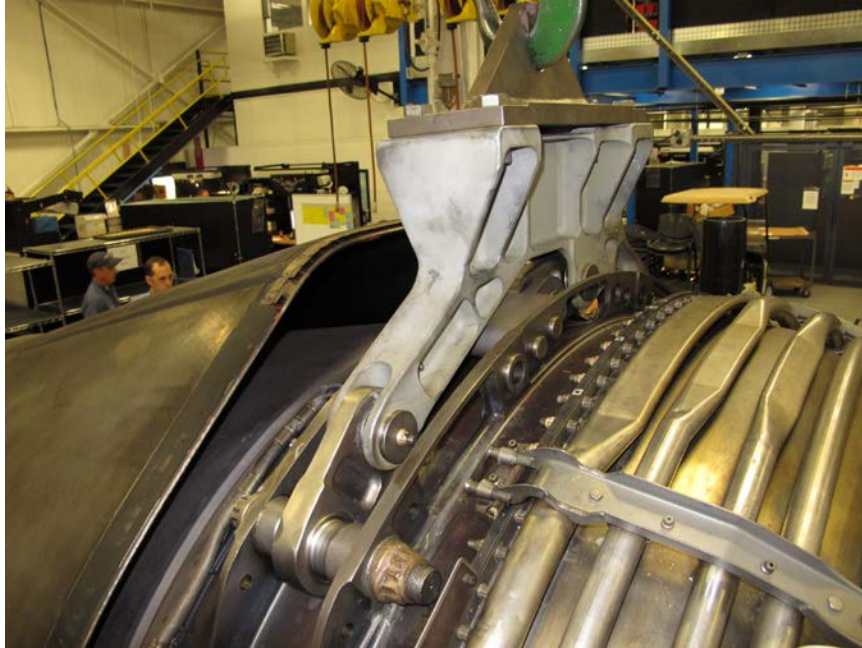
Photo No. 13: View of rear engine mount showing no apparent distress. (P&W)

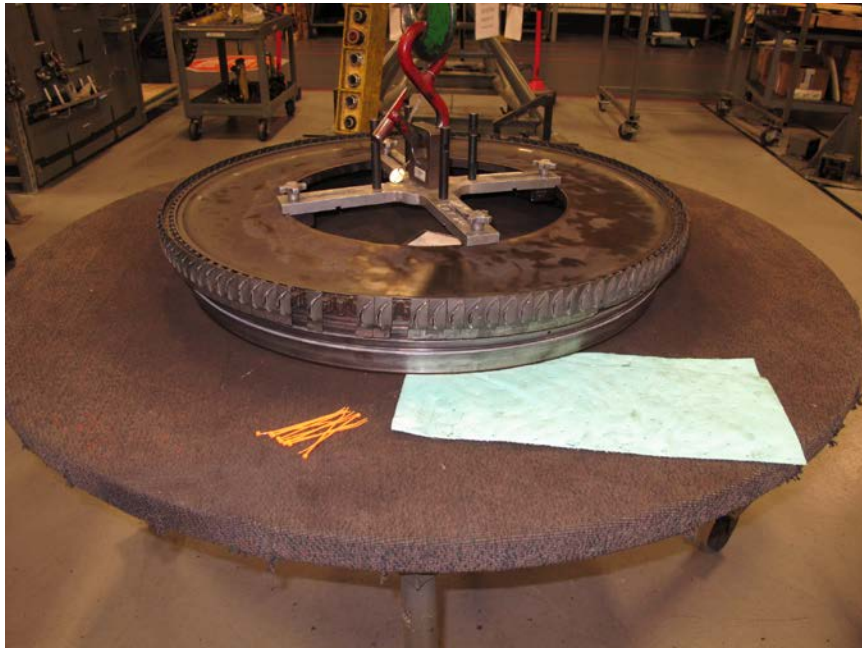
Photo No. 57: View of 6th stage turbine disk showing that it was intact. (P&W)
