| <p><b>AIRBUS</b><br/>HELICOPTERS</p> <p>QUALITY MATERIALS &amp; PROCESSES<br/>LABORATORY</p> | | <p align="center"><b>SYNTHESIS REPORT</b></p> <p align="center"><b>2020-3223 indB</b></p> <p align="center"><i>(Cancels and replaces the version without index)</i></p> <p align="center">Airbus Helicopters - LMP - Aéroport International<br/>Marseille Provence - 13725 Marignane</p> | |
| Affair designation | Hydraulic pump drive bearing seizure POST MOD 07-9568 | | |

| Helicopter N° : | AS 350 B3 | Part number: | 350A35013201 (Post Mod 07-9568) |
| Customer/user: | MACNEIL AVIATION LLC | Part Designation: | Hydraulic pump drive assy |

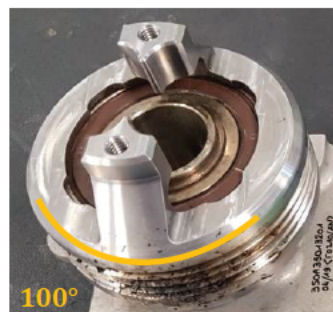
In the thread, on approximately 100°, black residues are observed. It is most likely belt residues.

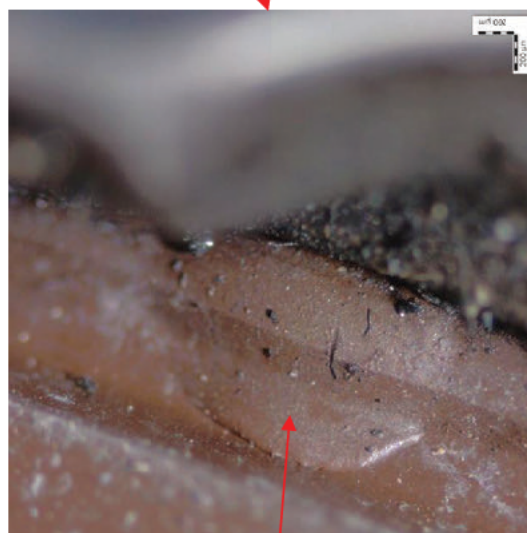
The flange has one over more material (beading) on different areas.

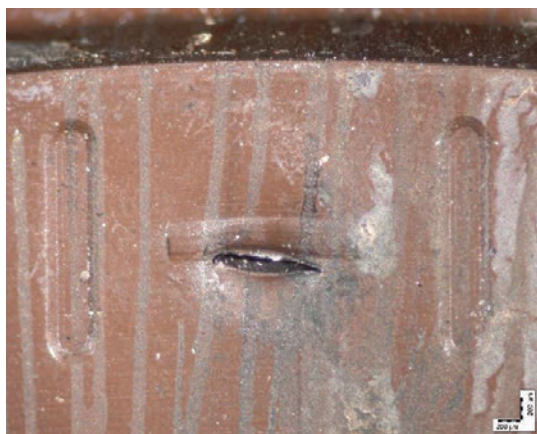
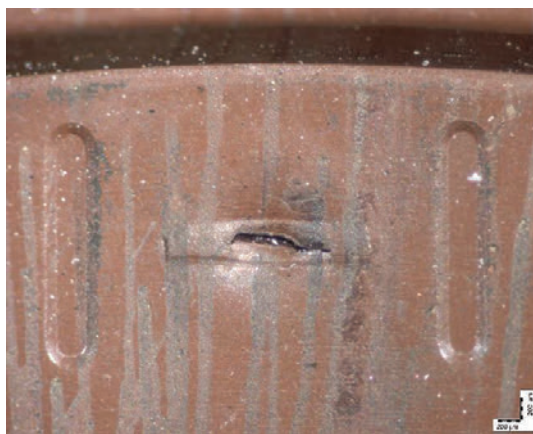
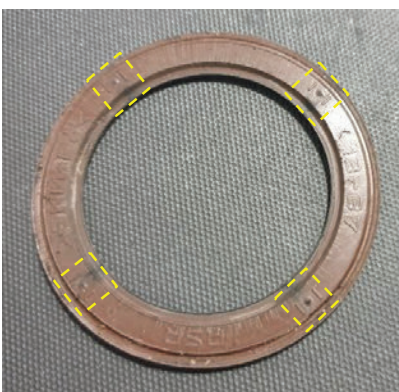
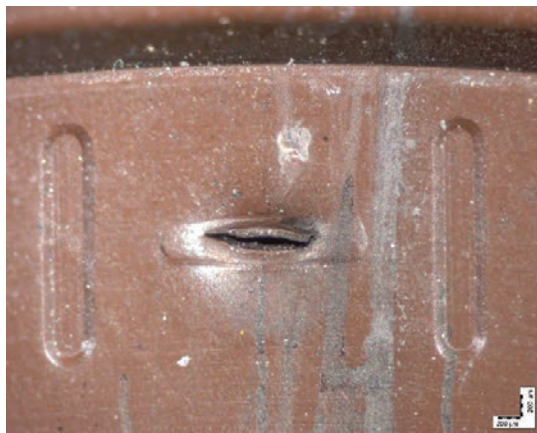
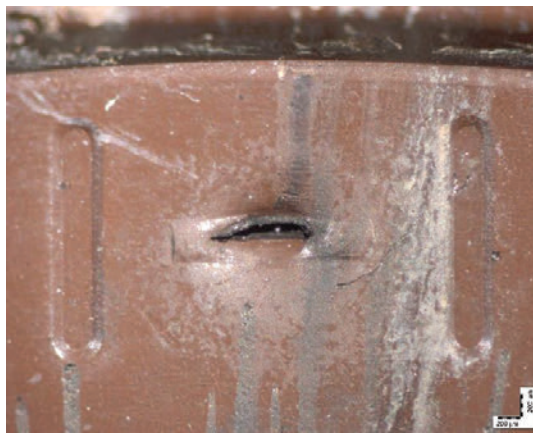
Observation of the flange lids, pump side :

The bearing lids, pump side, are pre-drilled.

As detailed previously, the tests of lids drilling showed that it was not possible to determine, by observing the condition of the lids, if the bearing is regreased or not.

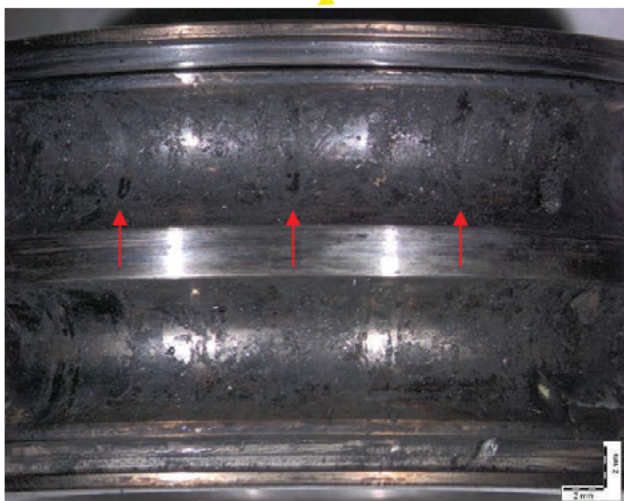
➤ Inner ring

Presence of coked grease delimiting balls locations, after jamming.

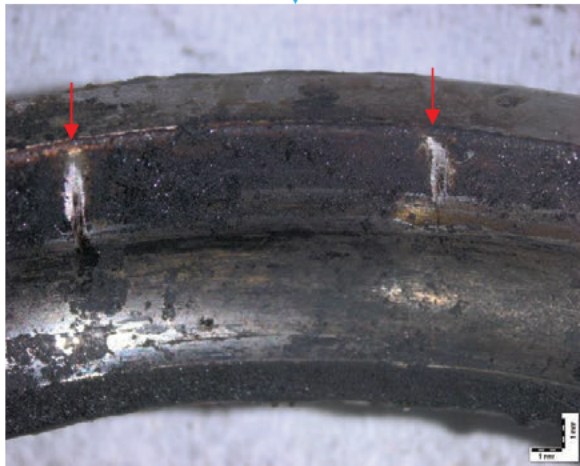
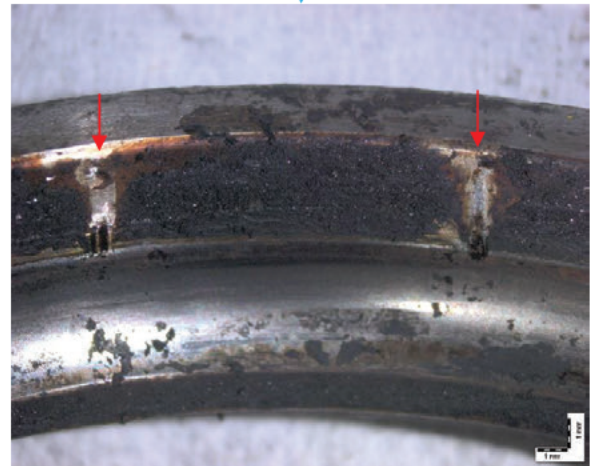
Pump side

Presence of coked grease showing the position of the cage, after jamming.

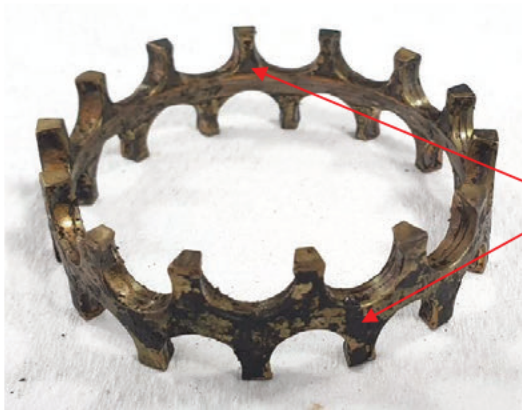
➤ Cage

Presence of coked grease all over the cage.

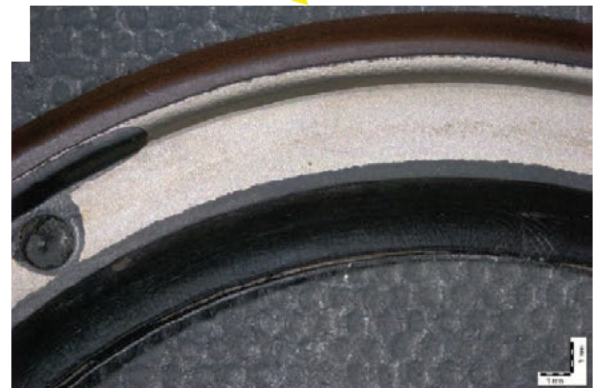
Inner side

There is no trace of rust on the 2 flanges.

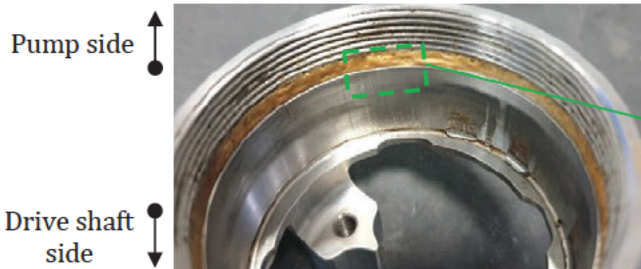
Longitudinal scratches (on 360°) are observed on the outer diameter of the outer ring, drive shaft side. In addition, material aggregates are present on the ends of the outer diameter. They are probably created when the bearing is fitted in the pulley, as shown in the picture below of the inner diameter of the pulley with scratches. It is possible that these aggregates are material transfers from the pulley to the outer ring.

Slight longitudinal scratches but no aggregate are observed on the outer diameter of the other ring, pump side.

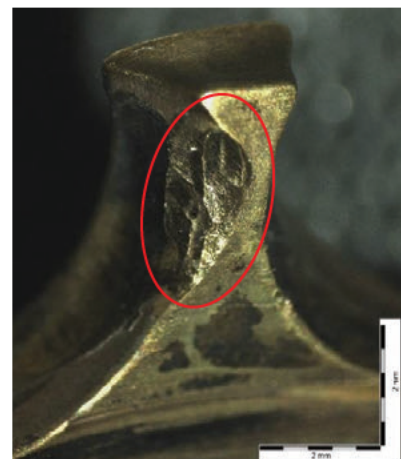
The pile up of material causes deformation of the cell and also material pick-up.
