## **POWERPLANT GROUP CHAIRMAN'S FACTUAL REPORT**

**ENG21LA013**

**GE's MAS Air Cargo ESN 695440 Failure Analysis Findings & Root  
Cause Summary Presentation**

4/1/2021

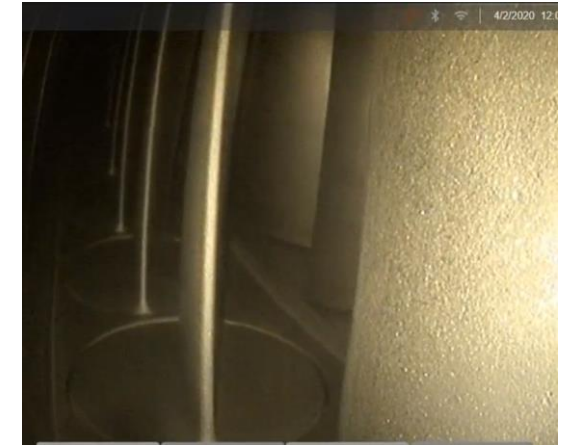
HPC Stage 5 Airfoil and Vanes

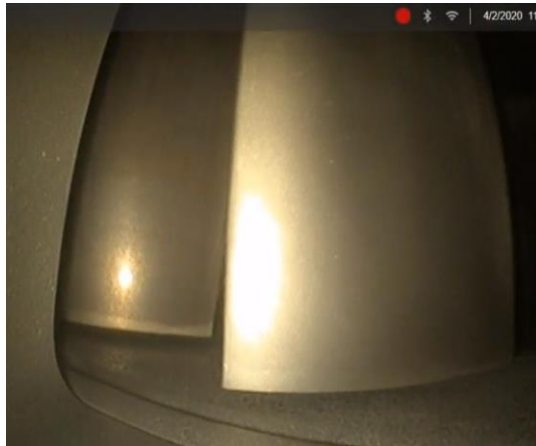
HPC Stage 7 Airfoil

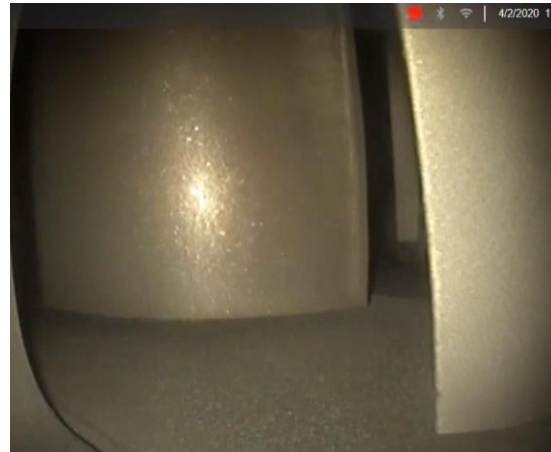
HPC Stage 10 Airfoil

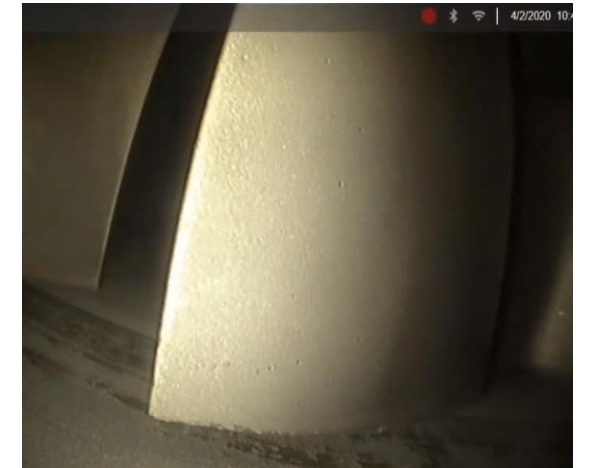
HPC Stage 14 Airfoil

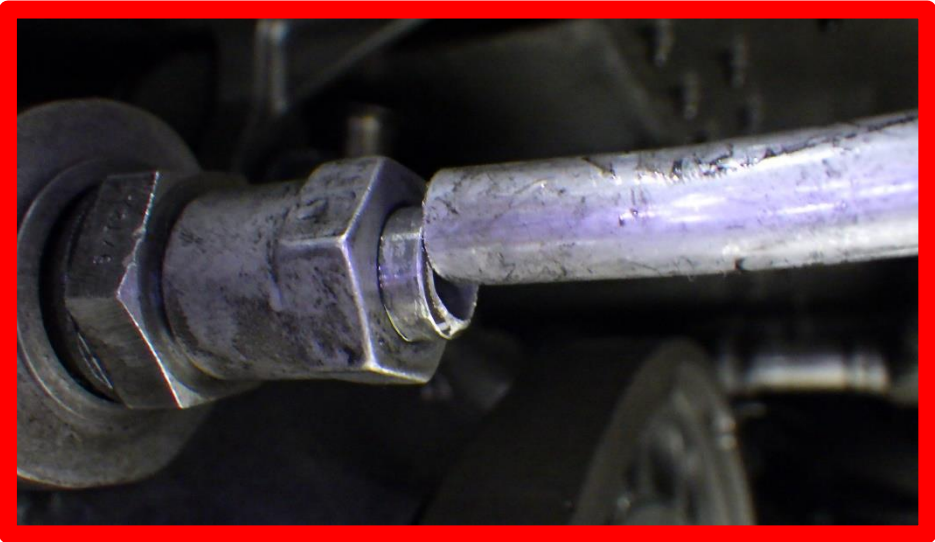
Oil tube separated on the AGB at the 7 o'clock position (ALF).

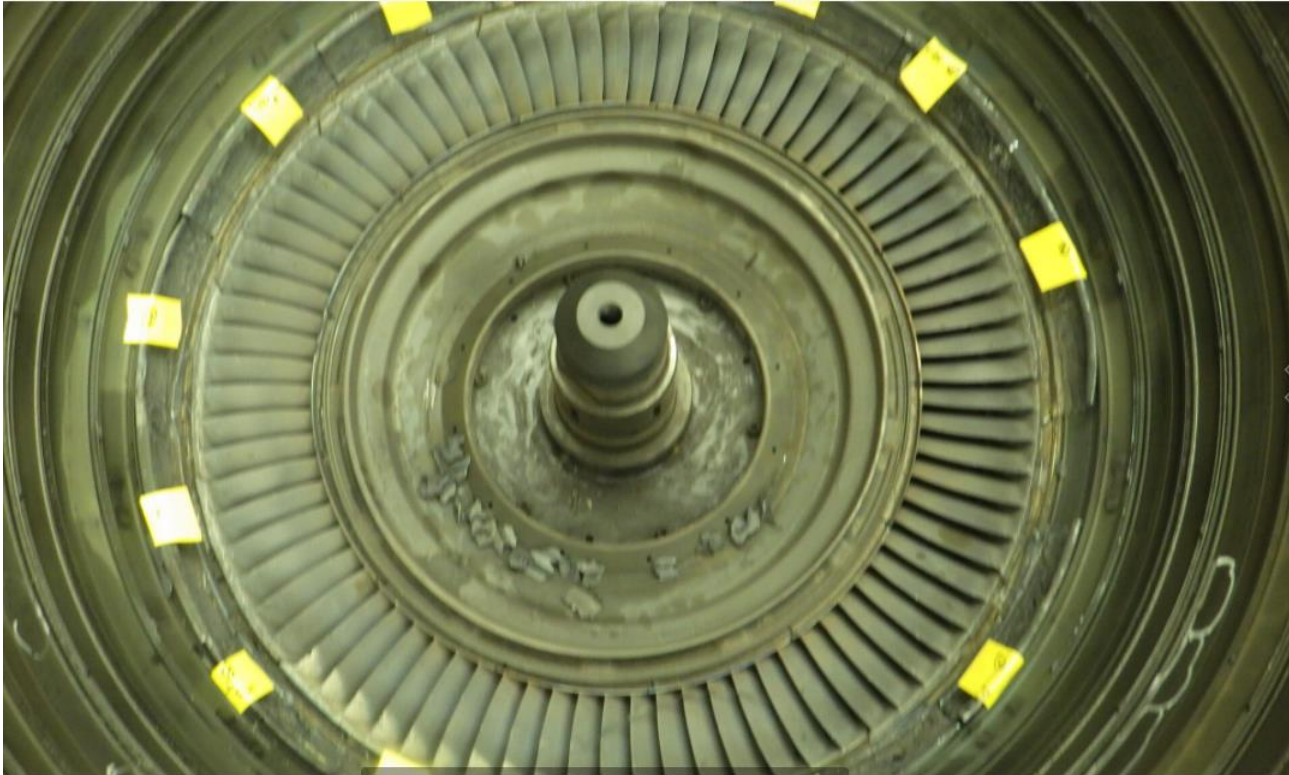
LPT Stage 1 Nozzles (Aft)

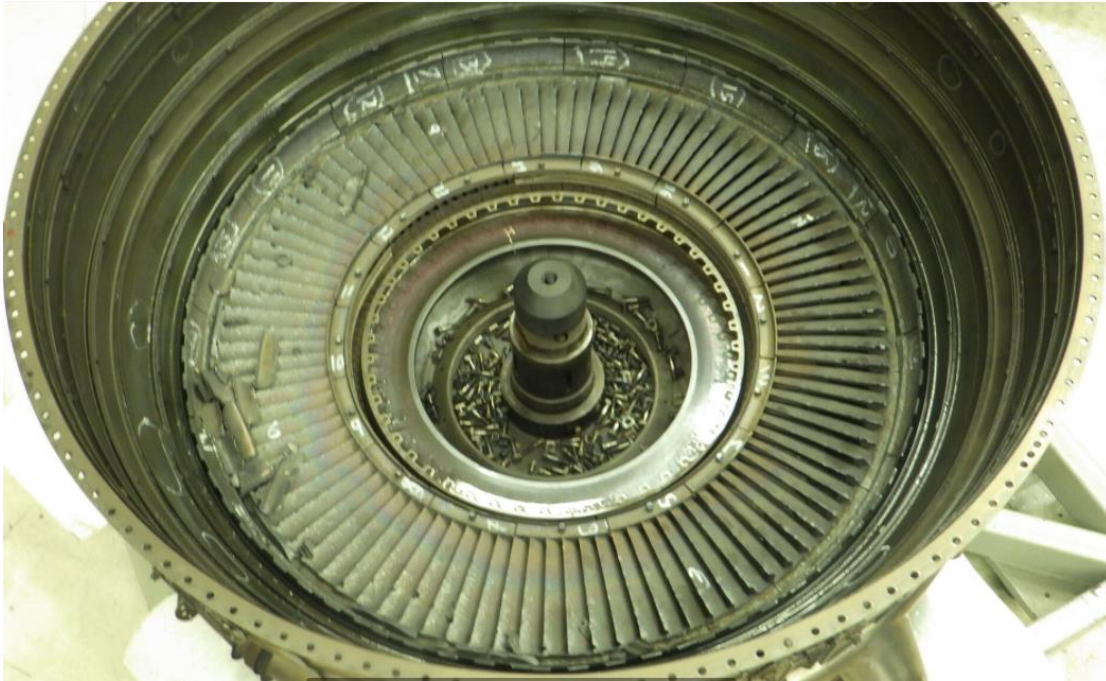
LPT Stage 2 Nozzles (Aft)

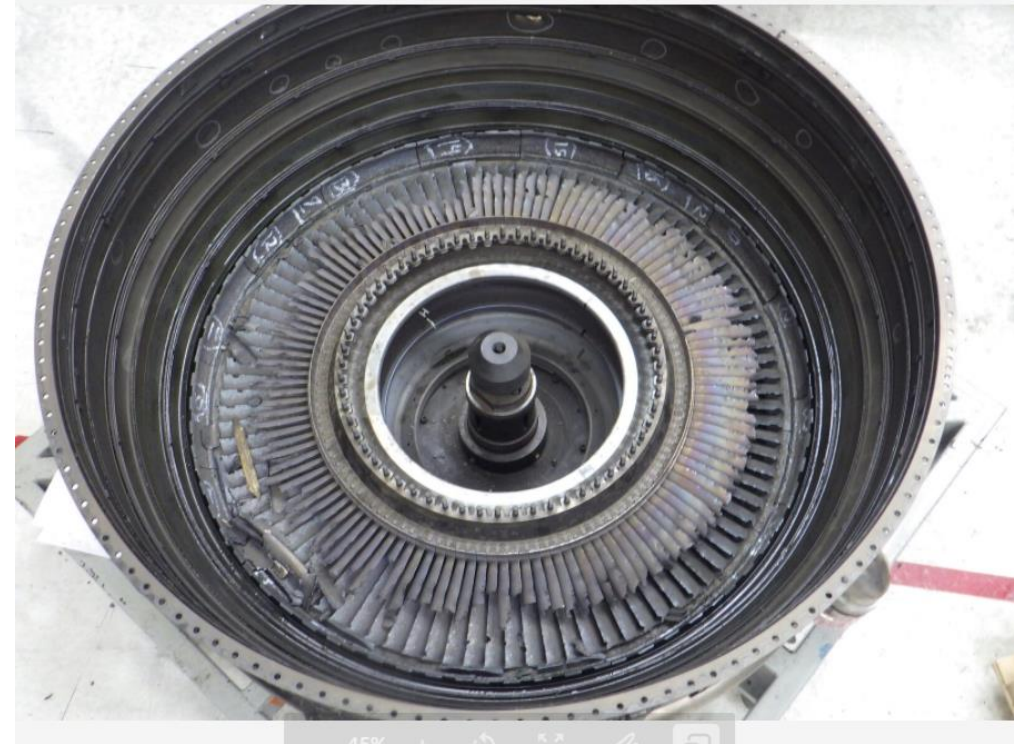
LPT Stage 2 Blades (Fwd)

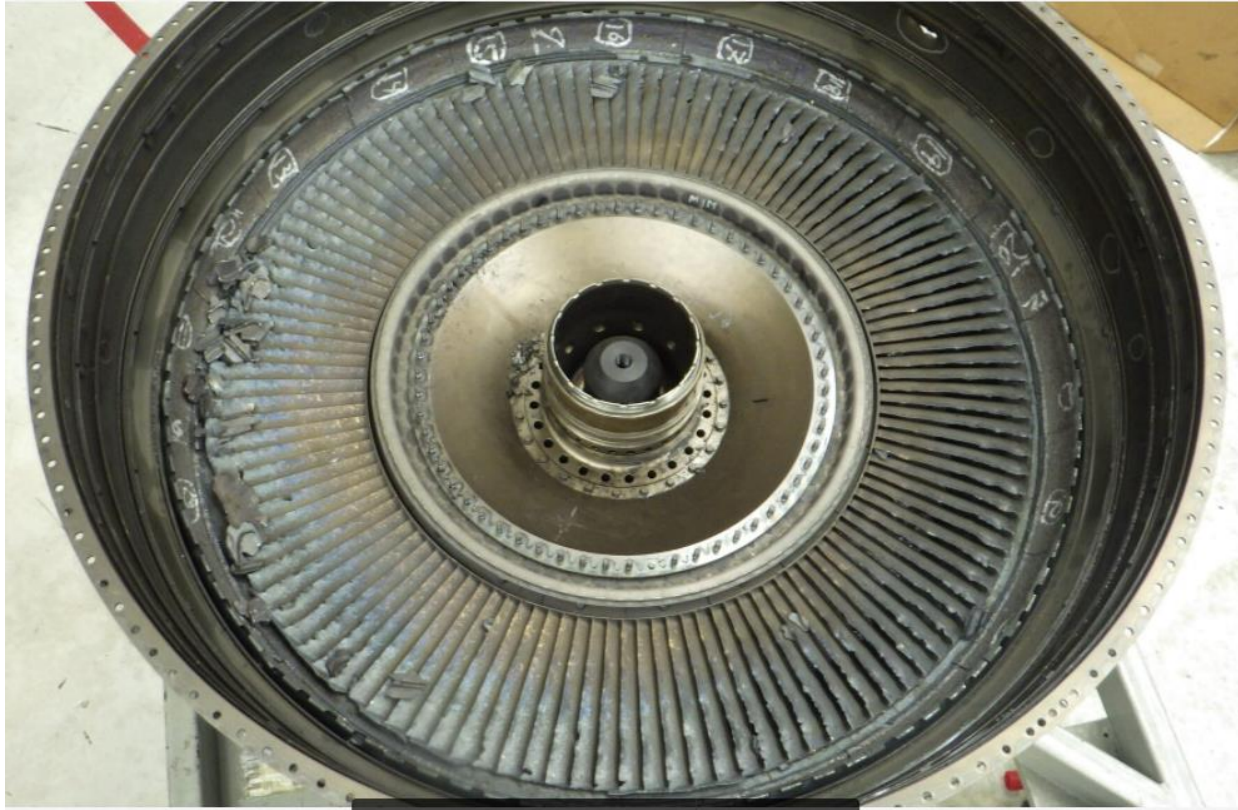
LPT Stage 3 Nozzles (Aft)

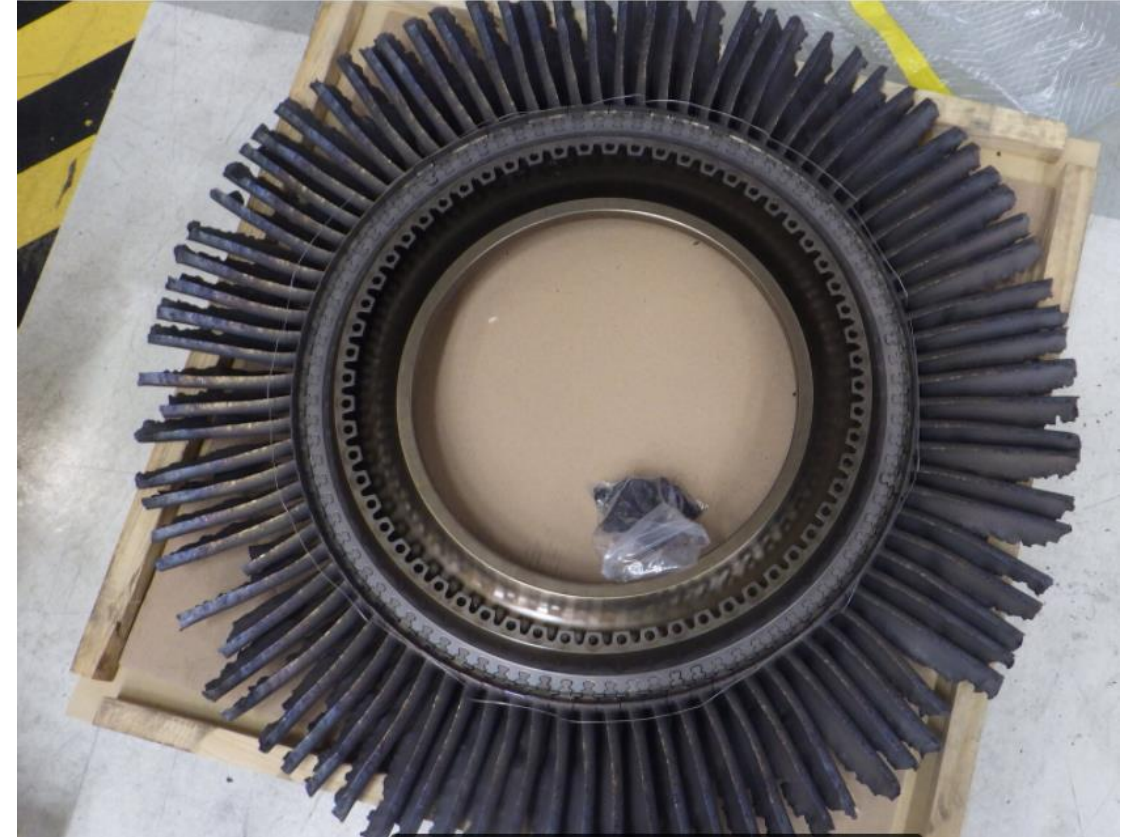
LPT Stage 3 Blades (Fwd)

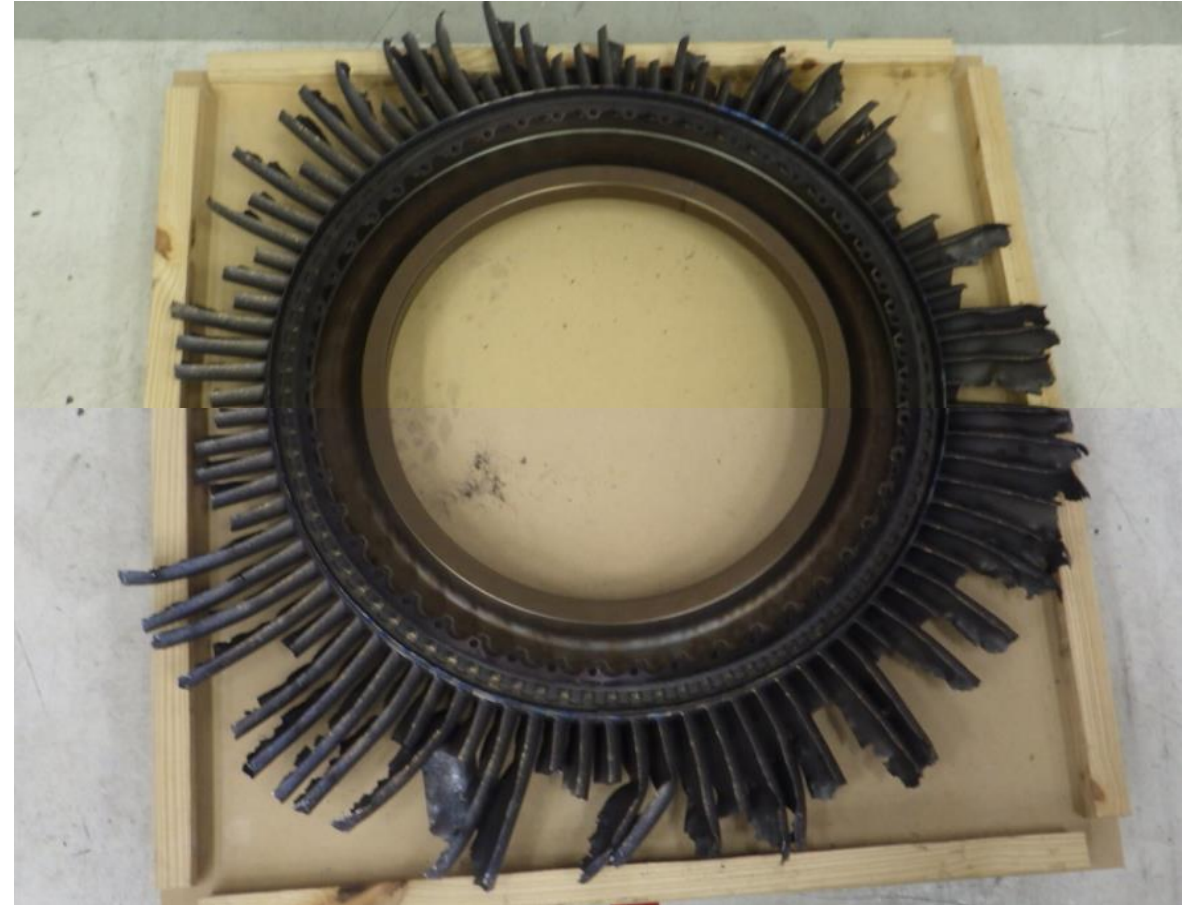
LPT Stage 4 Blades (Fwd)

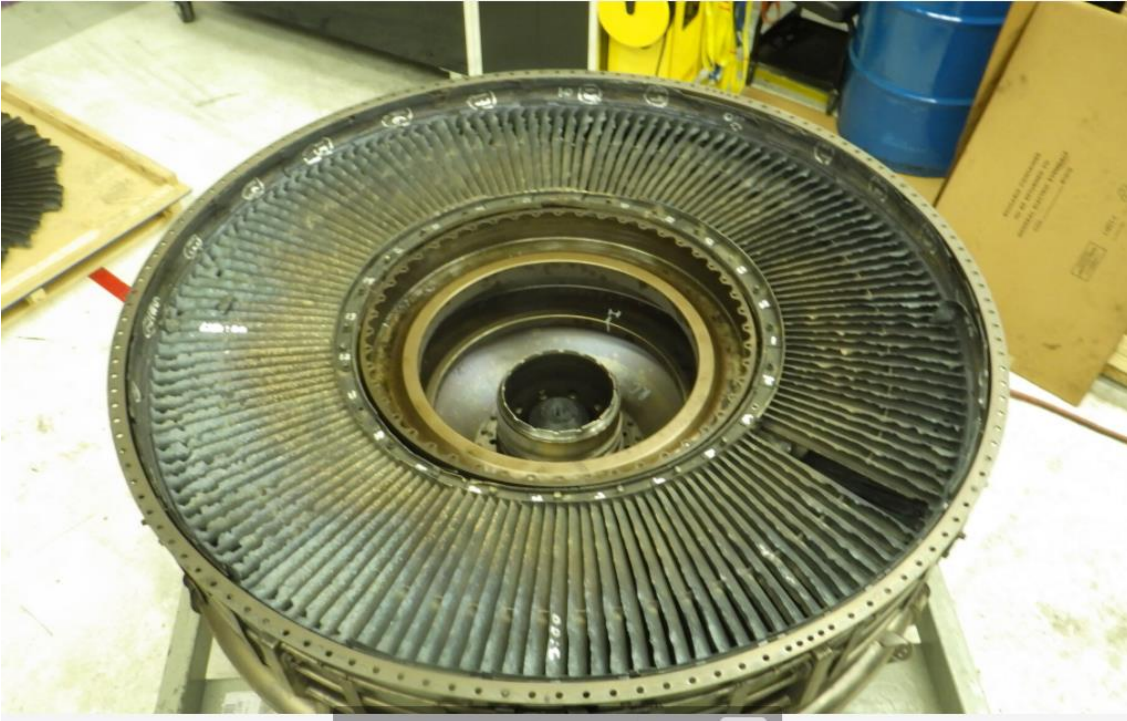
LPT Stage 5 Nozzles (Aft)

LPT S5N initiated failure led to secondary damage to LPT S4. Ultimately leading to 50.0+ CU rotor imbalance.

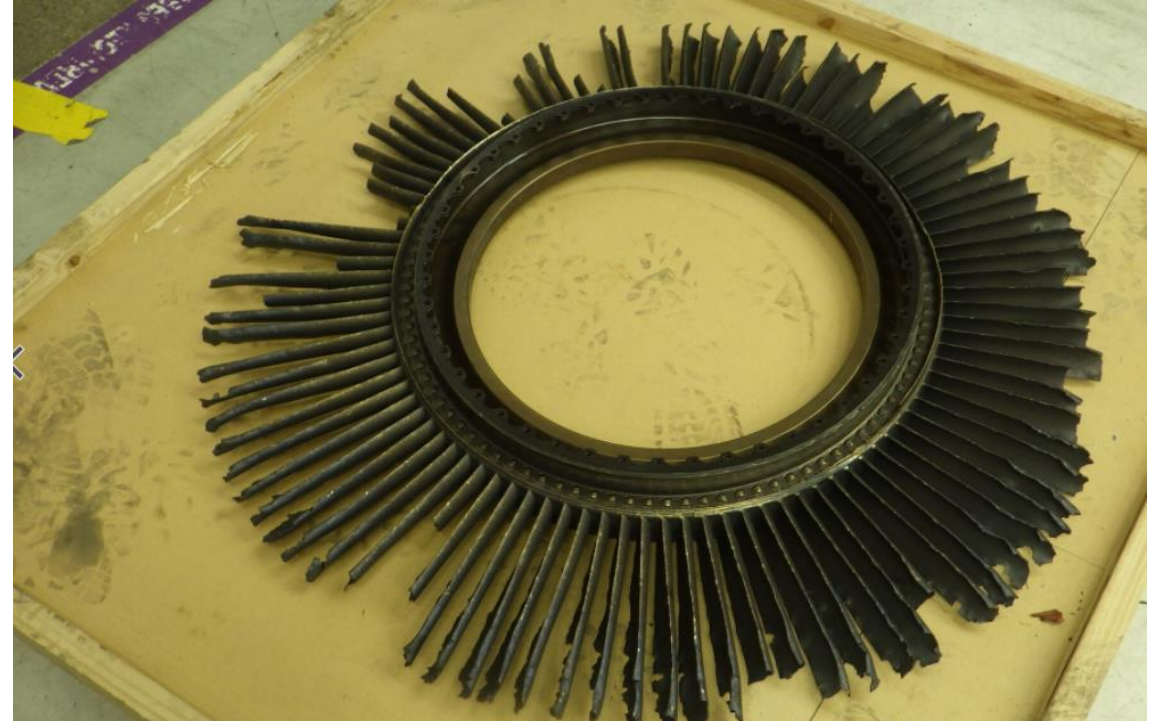
LPT Stage 5 Blades (Fwd)
