## Accident / Incident Summary Report

**Report No.: 14-081**

**Croom Aviation  
Gulfstream-Schweizer G-164B Reg. N425LS  
Bonifay, Florida  
25 July 2014  
PT6A-27 Engine  
S/N 40160**

**Date of Issue:** 5 October 2015

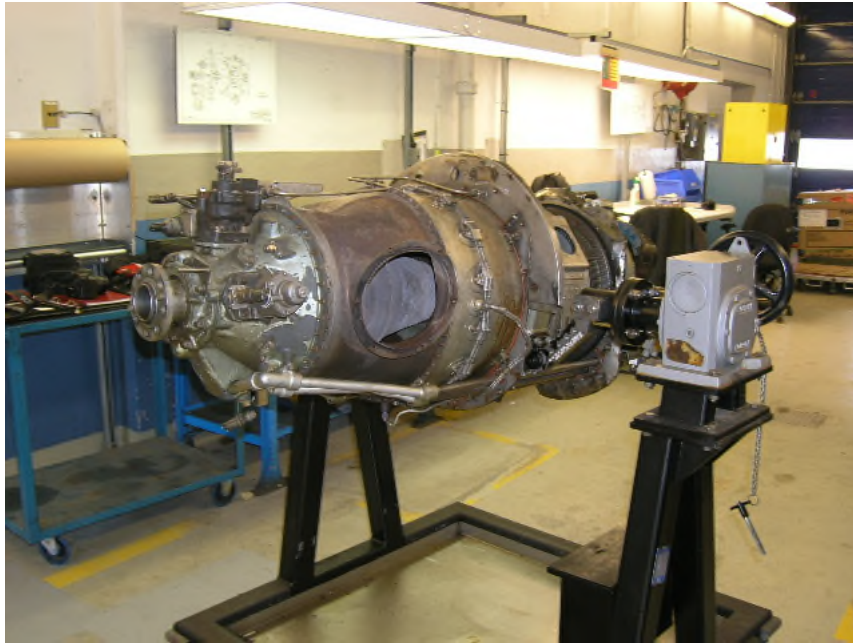
Photo No. 5  
Engine left hand forward view.

**Power Turbine Control (Py):** Intact and continuous from the propeller governor fitting to the fuel control unit fitting. All connections and lock wire were intact. Please refer to photos No. 5 and 9.

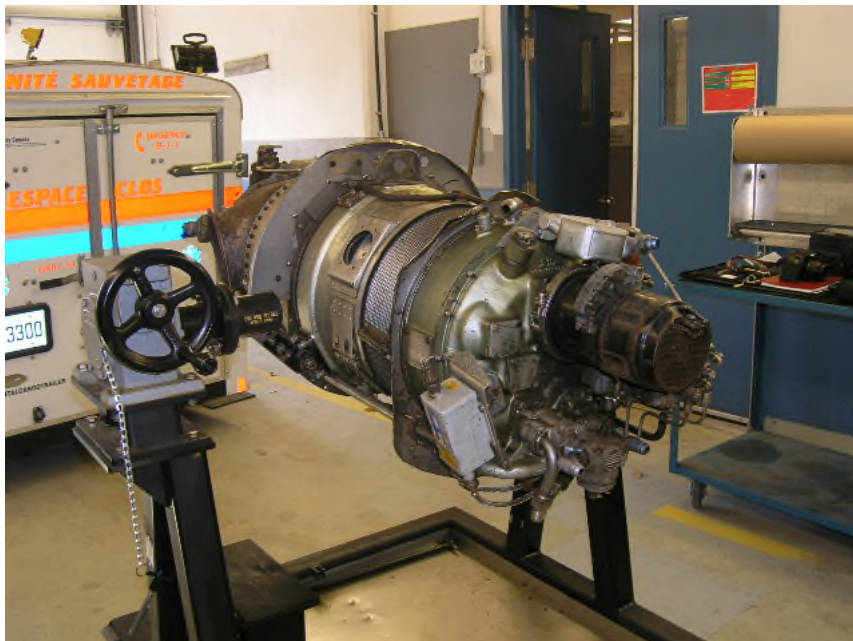
Photo No. 6  
Engine left hand aft view.

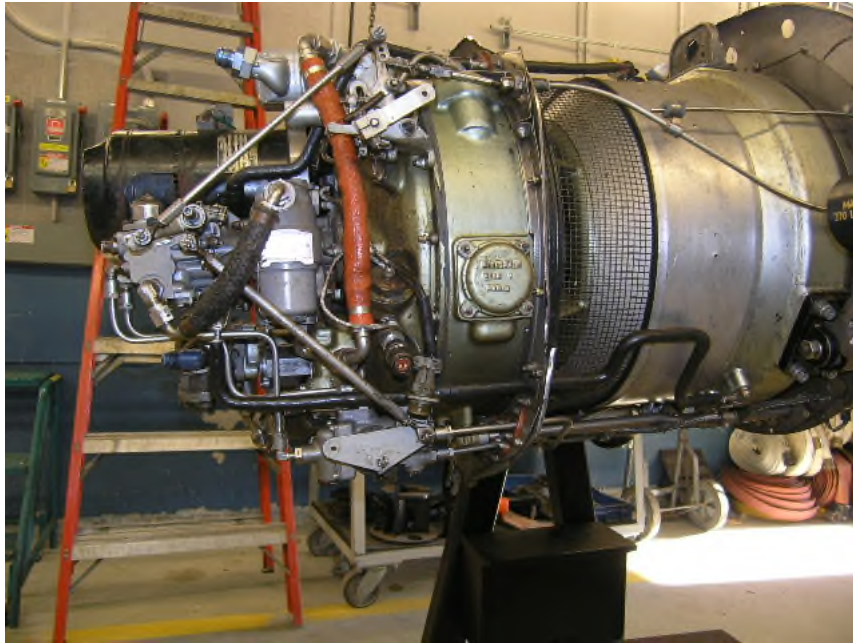
Photo No. 9

Engine aft gas generator case and accessory section.

The forward linkage was removed and not received. The linkage was otherwise continuous and intact to the controls cam box and fuel control unit. Please refer to photos No. 7, 8, and 9.

**Compressor Discharge Air (P3):** Intact and continuous from the gas generator case fitting to the fuel control fitting. All connections and lock wire were intact. No P3 filter system was fitted. Please refer to photo No. 9.

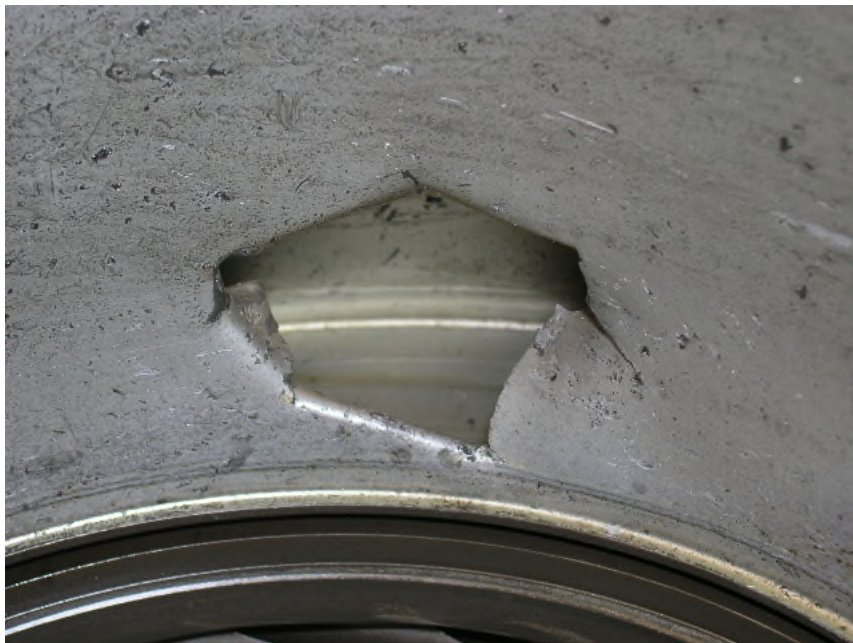
Photo No. 16

The gas generator case housing interior displayed an approximate 1 inch x 2 inch hole at the approximate 2:00 position, and an approximate 2 inch x 2-3/4 inch hole at the approximate 9:00 position. There were numerous outward dimples and pockmarks around the housing interior. Please refer to photos No. 15 through 17.

Gas generator case compressor housing interior, approximate 9:00 position.

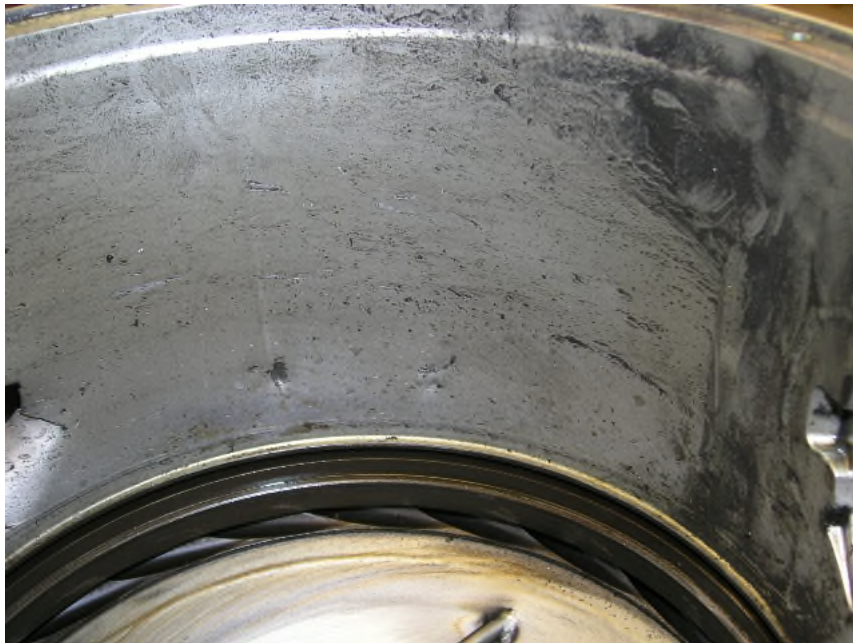
Photo No. 17

Gas generator case compressor housing interior, centered at the approximate 4:00 position.

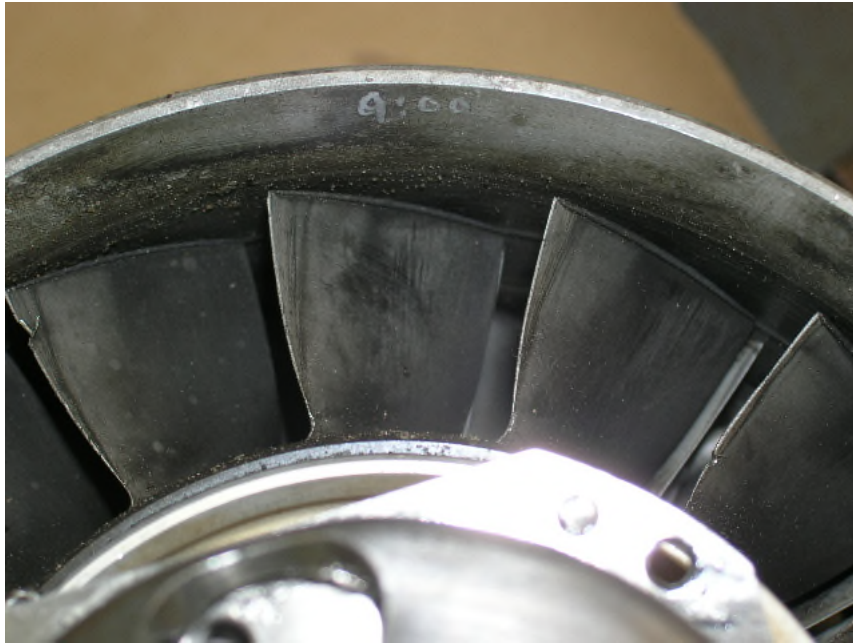
Photo No. 22

Compressor 1<sup>st</sup> stage blades and shroud, in-situ detail centered at the approximate 9:00 position.

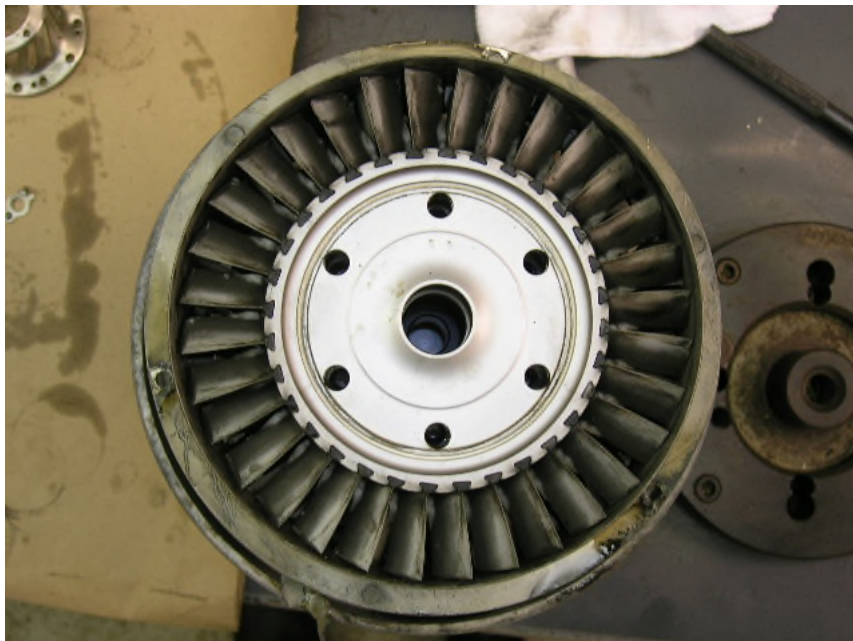
Photo No. 23

Compressor 2<sup>nd</sup> stage disc and blades upstream side, in-situ.

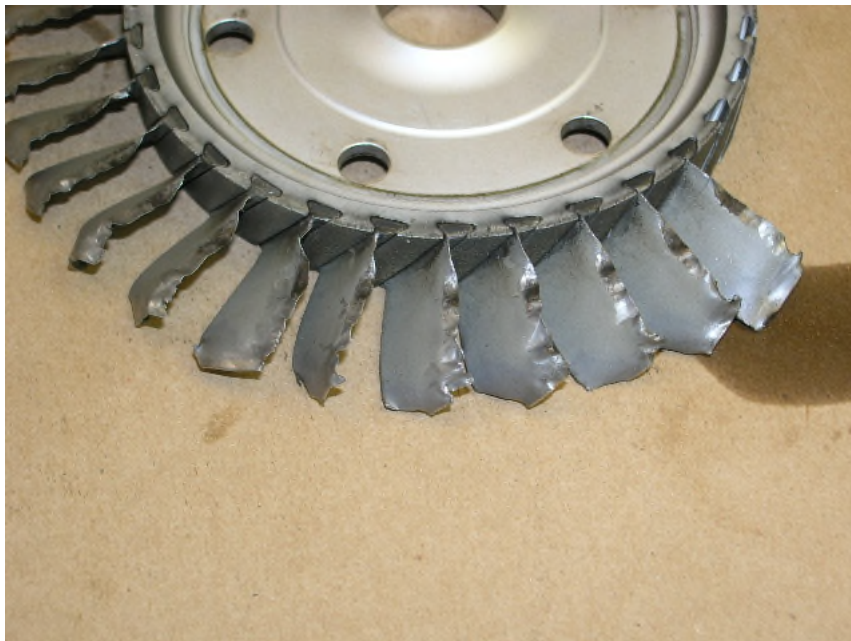
Photo No. 27  
Compressor 3<sup>rd</sup> stage disc and blades, downstream side.

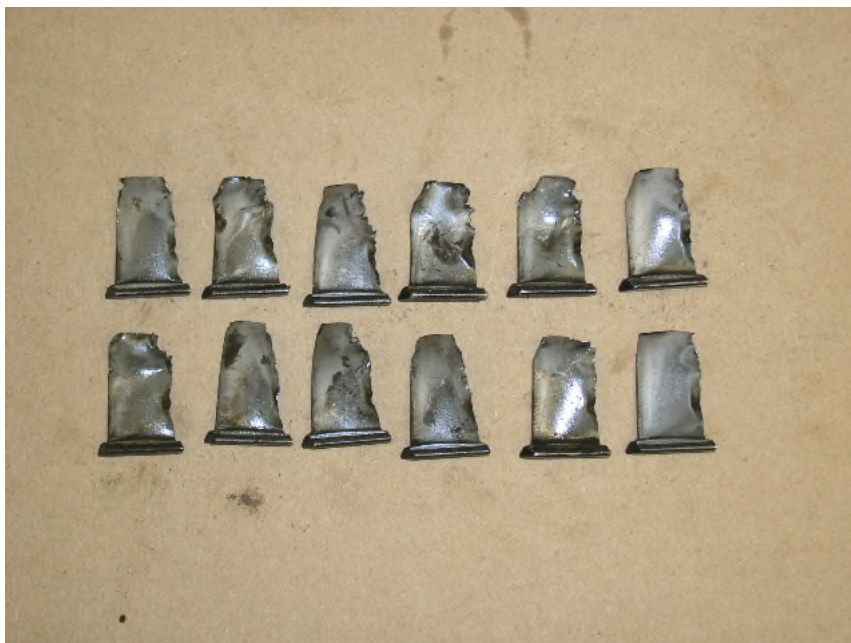
Photo No. 29  
Recovered 3<sup>rd</sup> stage blade airfoils, alternate view.

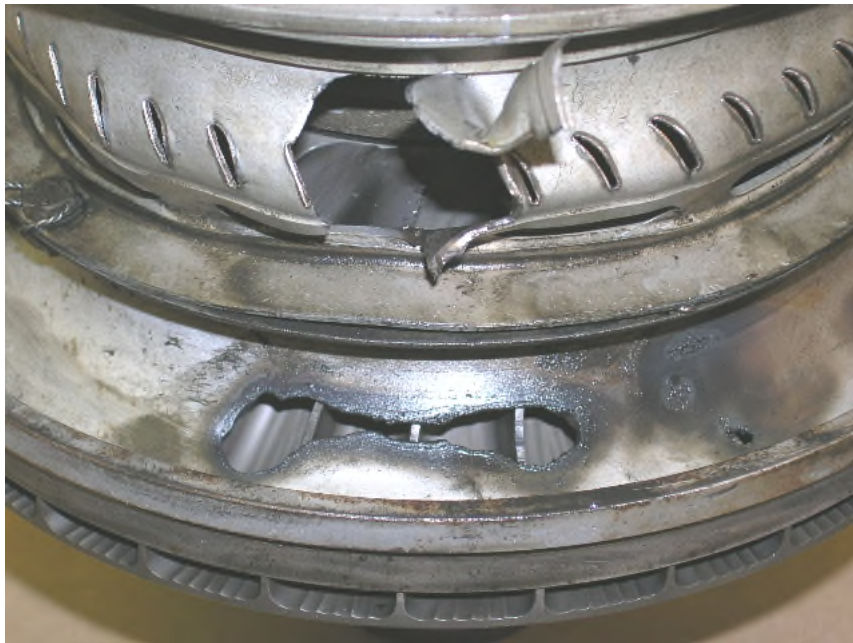
Photo No. 31

**Compressor 1<sup>st</sup>, 2<sup>nd</sup>, and 3<sup>rd</sup> Stage Stators and Shrouds:** The 3<sup>rd</sup> stage stator housing displayed an approximate 3-½ inch x ¾ inch outward rupture centred at the approximate 2:00 position and an approximate 1 inch x 1 inch outward rupture at the approximate 7:00 position. The 1<sup>st</sup> and 2<sup>nd</sup> stage stators and shrouds displayed heavy rubbing and deformation due to radial contact with the compressor rotor. The 3<sup>rd</sup> stage stator vanes were completely obliterated and the shroud rubbed completely though due to radial contact with compressor rotor. Only 7 identifiable fragments of the 3<sup>rd</sup> stage stator vane were recovered. Please refer to photos No. 18 and 19, and 30 through 38.

Compressor 3<sup>rd</sup> stage stator housing and impeller housing, centered at the approximate 7:00 position.

**Centrifugal Impeller Shroud:** The shroud face showed severe rubbing, with heavy frictional heat discoloration and material smearing, due to radial contact with the impeller. The shroud face was rubbed completely through at the approximate 7:00 and 11:00 positions. Please refer to photos No. 18 and 19, 31, 48, and 49.

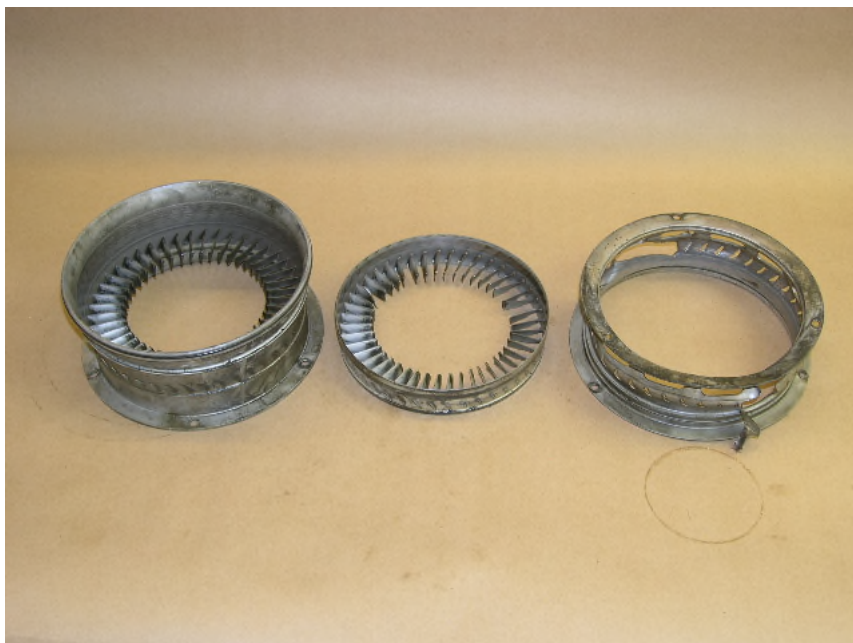
Photo No. 32

Compressor 1<sup>st</sup>, 2<sup>nd</sup>, and 3<sup>rd</sup> stage stator assemblies.

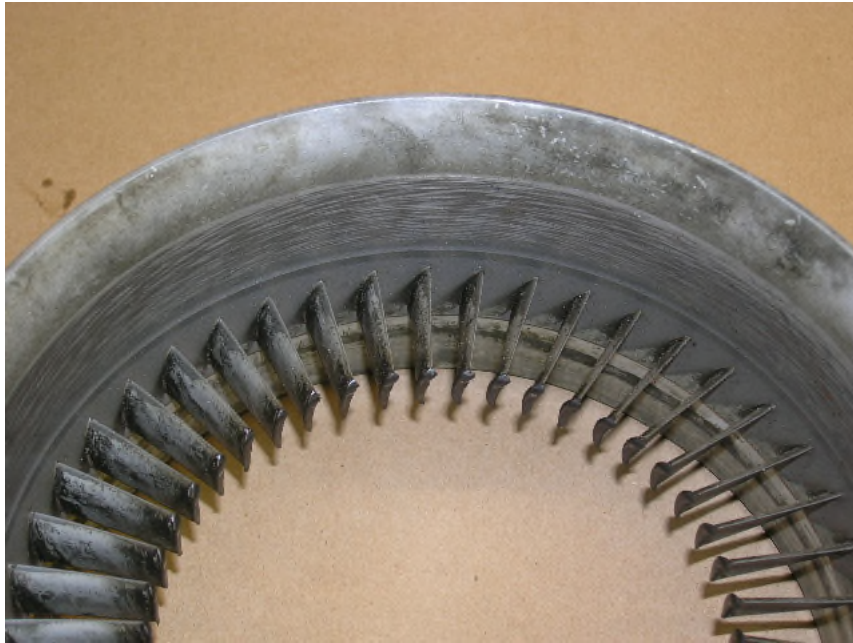
Photo No. 33

Compressor 1<sup>st</sup> stage stator and shroud upstream side, upper circumference.

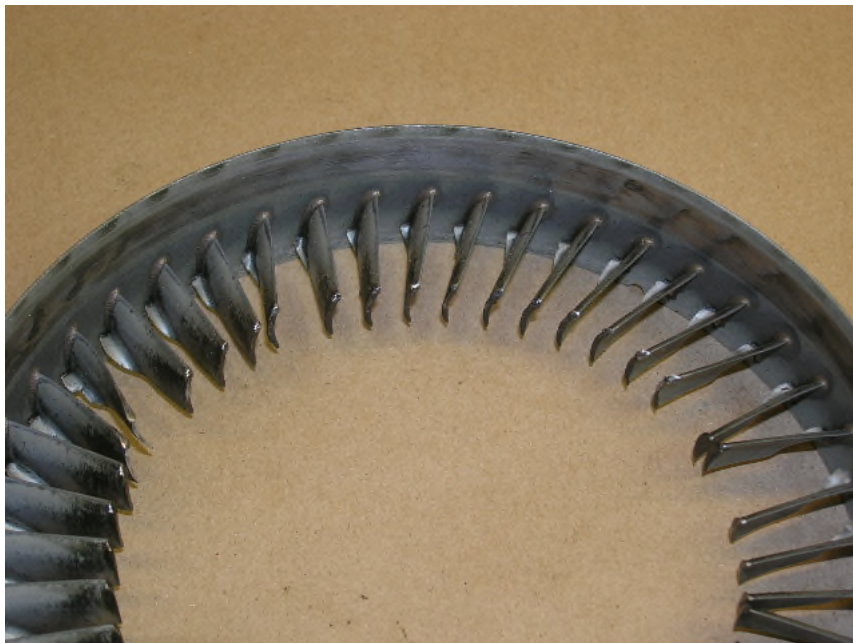
Photo No. 34

Compressor 2<sup>nd</sup> stage stator and shroud upstream side, upper circumference.

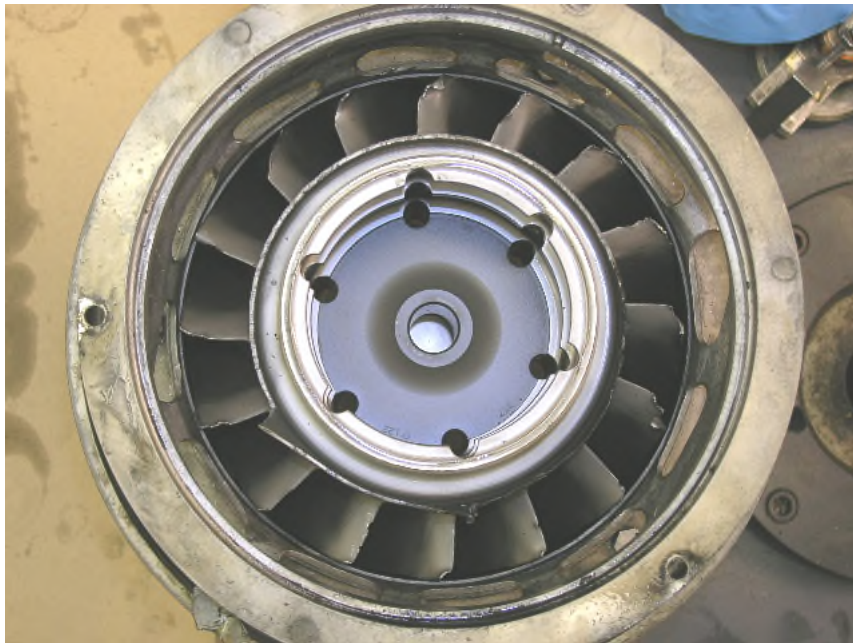
Photo No. 35

Compressor impeller, 3<sup>rd</sup> stage stator housing, and 3<sup>rd</sup> stage spacer in-situ.

**Compressor 1<sup>st</sup>, 2<sup>nd</sup>, and 3<sup>rd</sup> Stage Spacers:** For identification the spacer assembly was divided into quadrants “W, X, Y, and Z” with quadrant “X” centred at the “X” rotor balancing mark, clockwise viewed from aft looking forward. The 3<sup>rd</sup> stage spacer was completely rubbed obliterated across approximately  $\frac{3}{4}$ 's of its circumference to due rubbing and machining under radial contact with the 3<sup>rd</sup> stage stator vanes. The 1<sup>st</sup> and 2<sup>nd</sup> stage spacers displayed circumferential rubbing and machining completely through the spacer around the quadrant “Y” due to radial contact with their adjacent stator vanes. Please refer to photos No. 35 and 39 through 45.

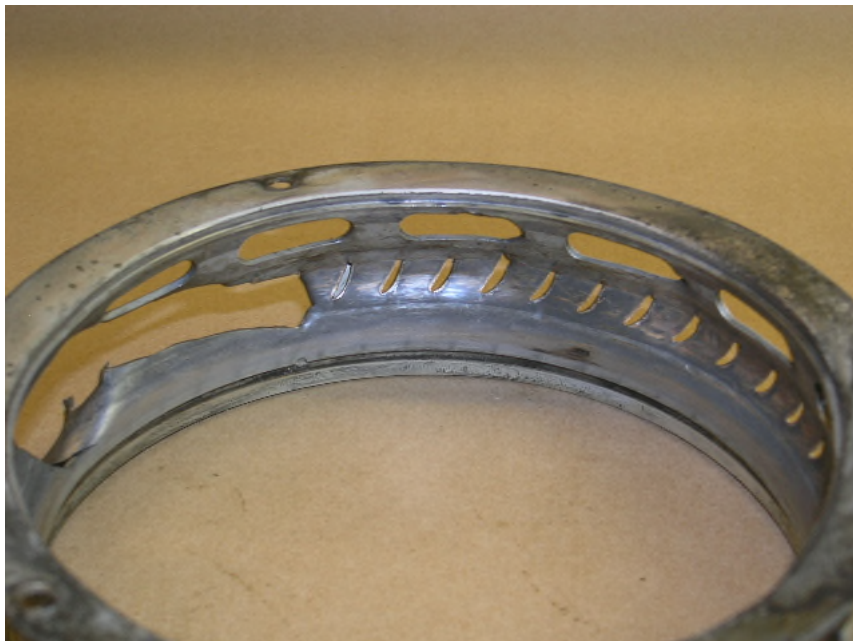
Photo No. 36

Compressor 3<sup>rd</sup> stage stator and shroud downstream side, upper circumference.

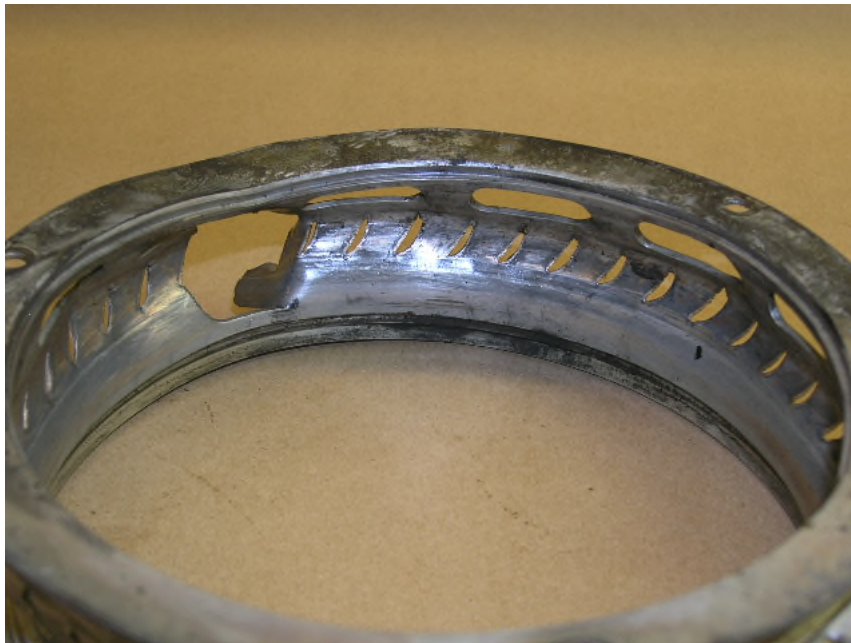
Photo No. 37

Compressor 3<sup>rd</sup> stage stator and shroud downstream side, lower circumference.

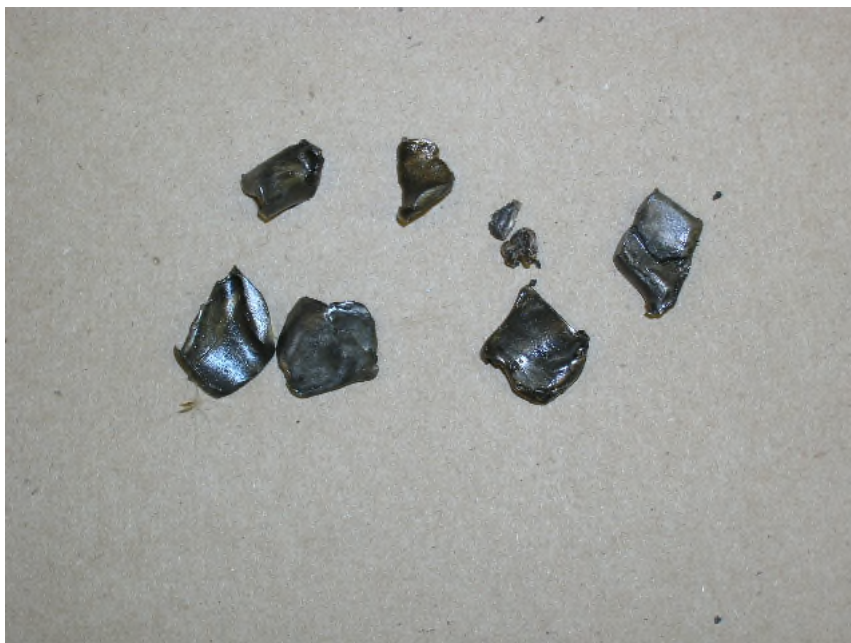
Photo No. 38

Recovered 3<sup>rd</sup> stage stator airfoil fragments.

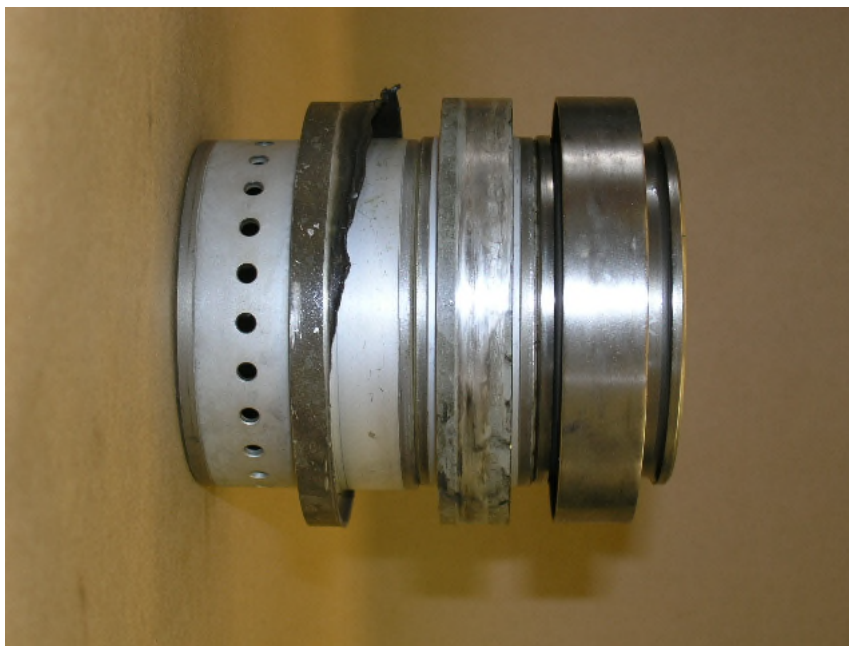
Photo No. 39

1<sup>st</sup>, 2<sup>nd</sup>, and 3<sup>rd</sup> stage compressor spacers quadrant “W”.

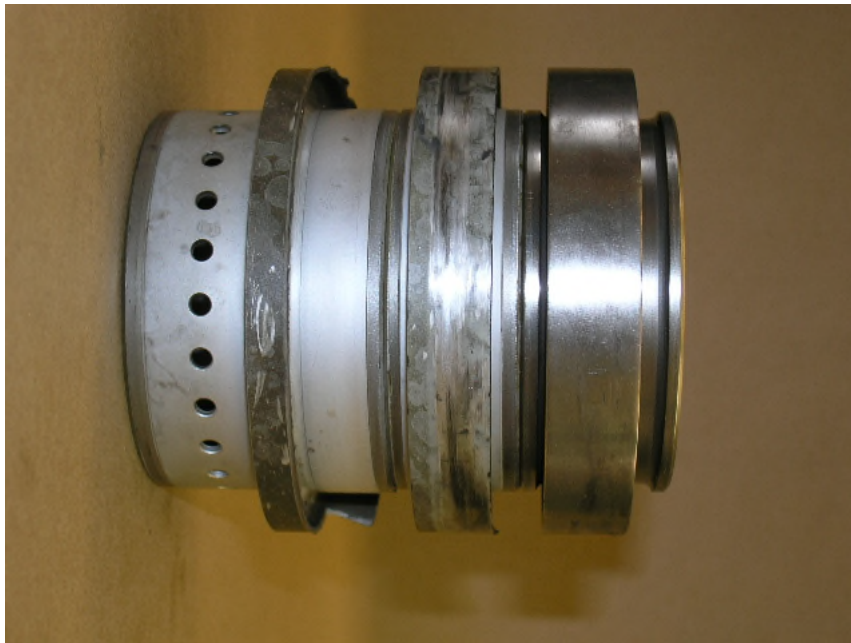
Photo No. 40

1<sup>st</sup>, 2<sup>nd</sup>, and 3<sup>rd</sup> stage compressor spacers quadrant "X"

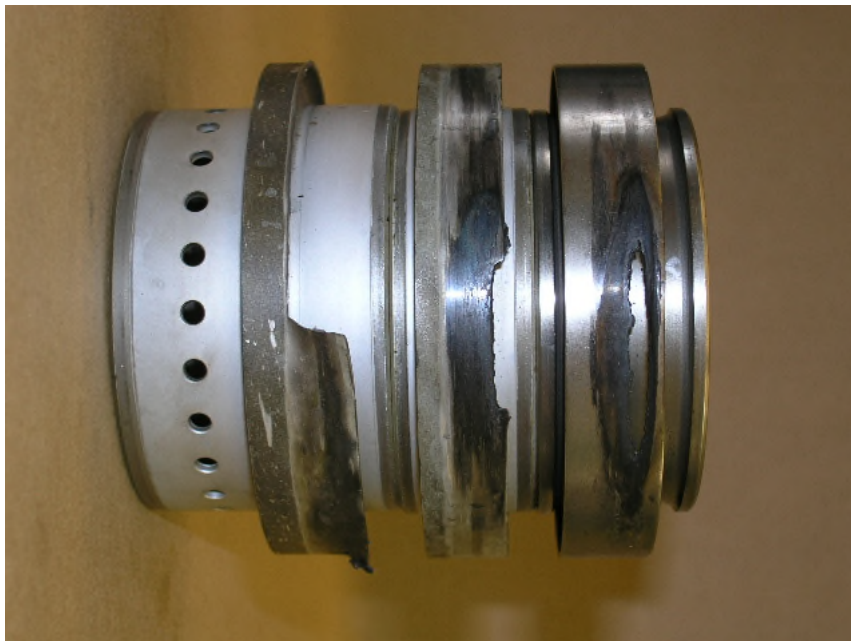
Photo No. 41

1<sup>st</sup>, 2<sup>nd</sup>, and 3<sup>rd</sup> stage compressor spacers quadrant "Y".

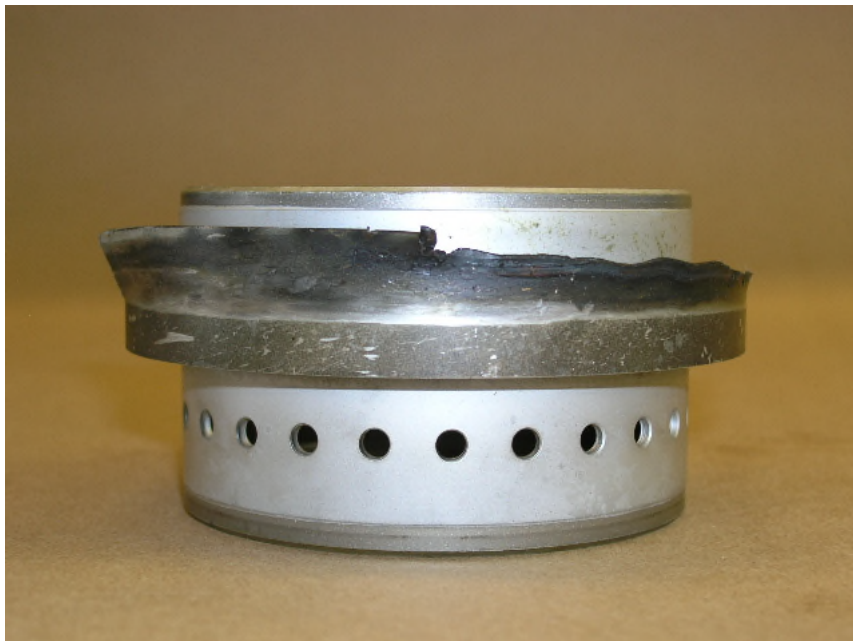
Photo No. 45  
Compressor 3<sup>rd</sup> stage spacer, centered at position “Z”

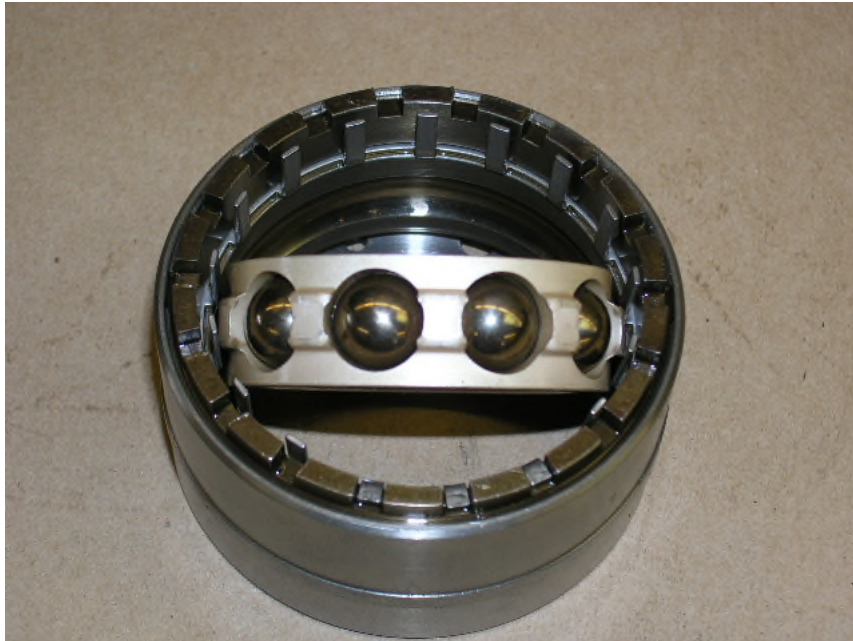
Photo No. 51

**No. 1 Bearing and Air Seals:** The No. 1 bearing displayed no indications of operational distress. The compressor bearing adapter housing forward face was displaced in clockwise torsion approximately 20 degrees in relation to the aft flange. Please refer to photos No. 50 through 52.

No. 1 bearing outer race, cage, and rolling elements.

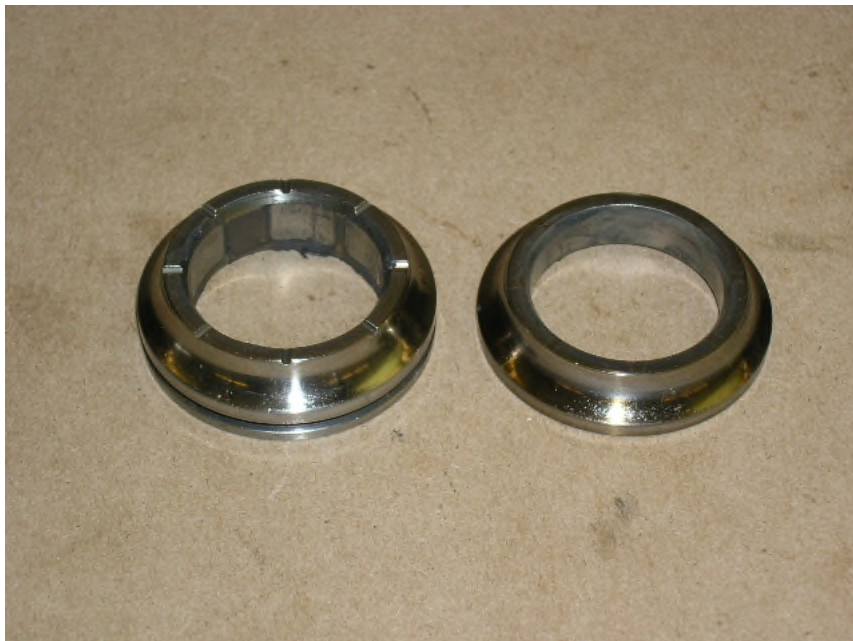
Photo No. 52

No. 1 bearing inner races.

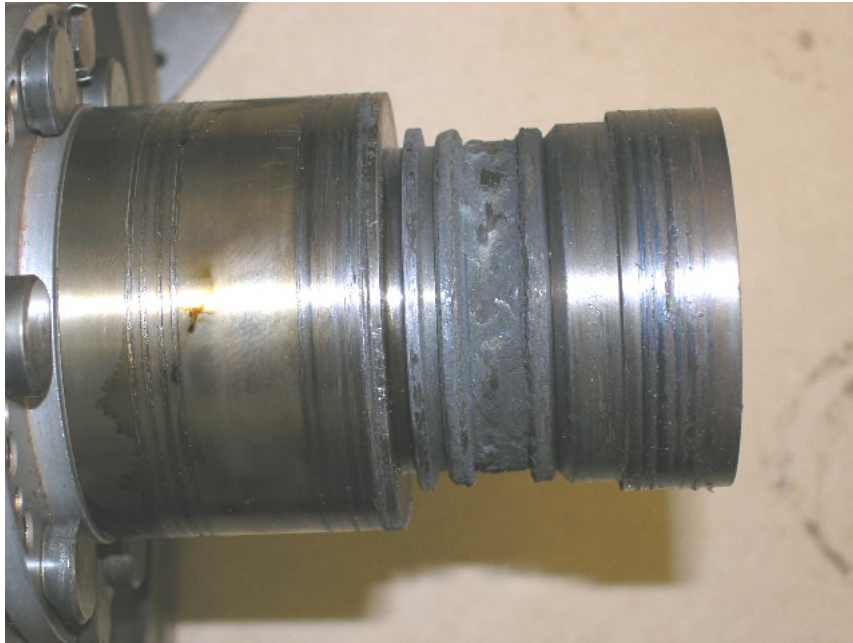
Photo No. 54

**No. 2 Bearing and Air Seals:** P/N 3006146, 3011426, S/N C757. The bearing rolling elements and cage were disintegrated. The compressor stub shaft could be moved radially by hand. The bearing air seal rotors displayed heavy circumferential scoring and machining due to radial contact with the air seal stator knife edges. 12 of the 16 rolling elements were recovered and displayed severe heat oxidation and mechanical damage. The cage was fractured into 5 sections and displayed severe heat oxidation, mechanical damage, and deformation. The bearing inner and outer races were coated with heat fused melted material. P&WC Materials Engineering analysis determined the material fused to the bearing races to show a significant amount of rolling element material under Scanning Electron Microscope - Energy Dispersive X-ray Spectroscopy (SEM-EDS) analysis. Trace amounts of Cadmium was observed on the inner race. The origin of this element could not be identified. Micro structural analysis and SEM-EDS chemical analysis of the bearing races and cage showed the material to be consistent with drawing requirements. The hardness of the inner race and the cage was consistent with drawing requirements. The hardness of the outer race appeared to be compromised by heat exposure. The material and hardness of the rolling elements could not be determined to meet drawing requirements due to their severe heat exposure. The primary mode of the bearing distress could not be determined due to the extent of mechanical and heat damage to all of the components.

No. 2 bearing inner race and air seal rotors, in-situ on compressor stub shaft.

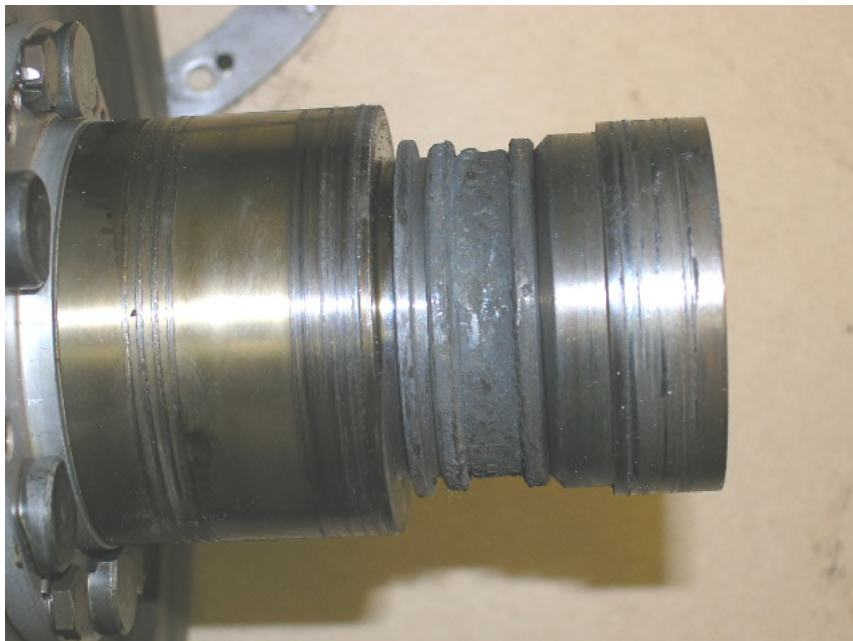
Photo No. 55

No. 2 bearing inner race and air seal rotors, in-situ on compressor stub shaft, opposite view.

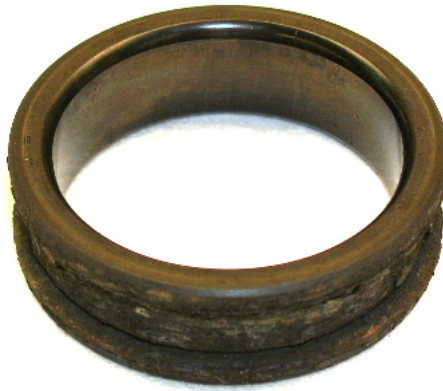
Photo No. 60  
No. 2 bearing inner race.

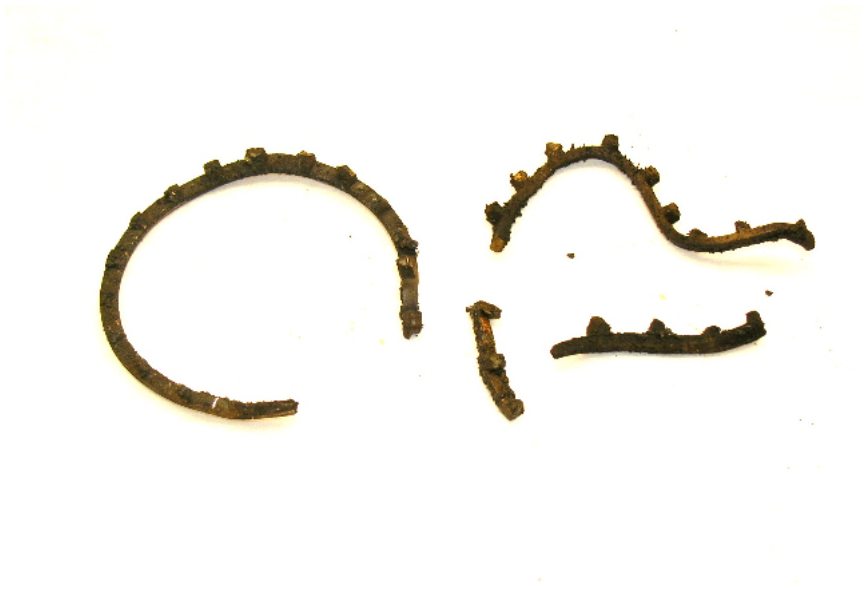
Photo No. 63

No. 2 bearing cage, as recovered.

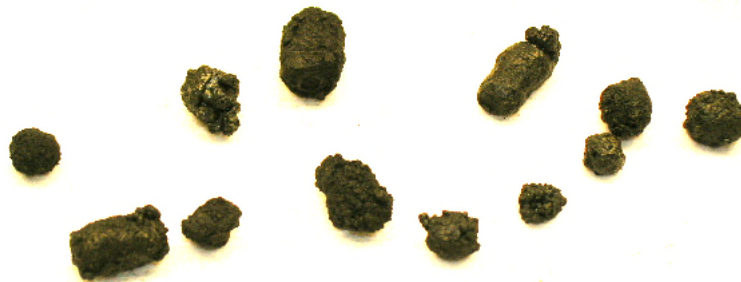
Photo No. 65

No. 2 bearing rollers, as recovered.

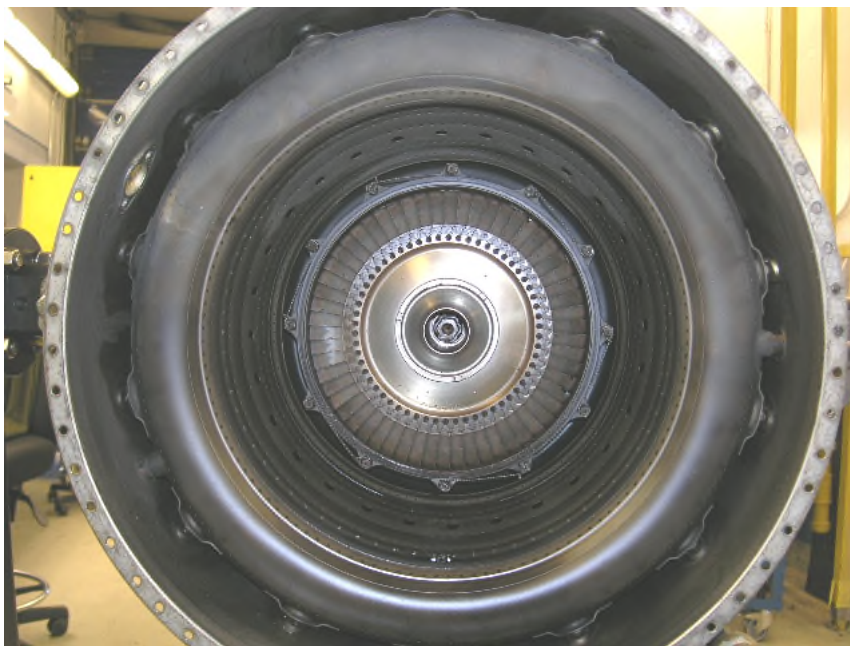
Photo No. 70

**Combustion Chamber Liner:** Displayed no indications of distress. Please refer to photo No. 70.

Gas generator case interior, combustion chamber liner and compressor turbine, in-situ.

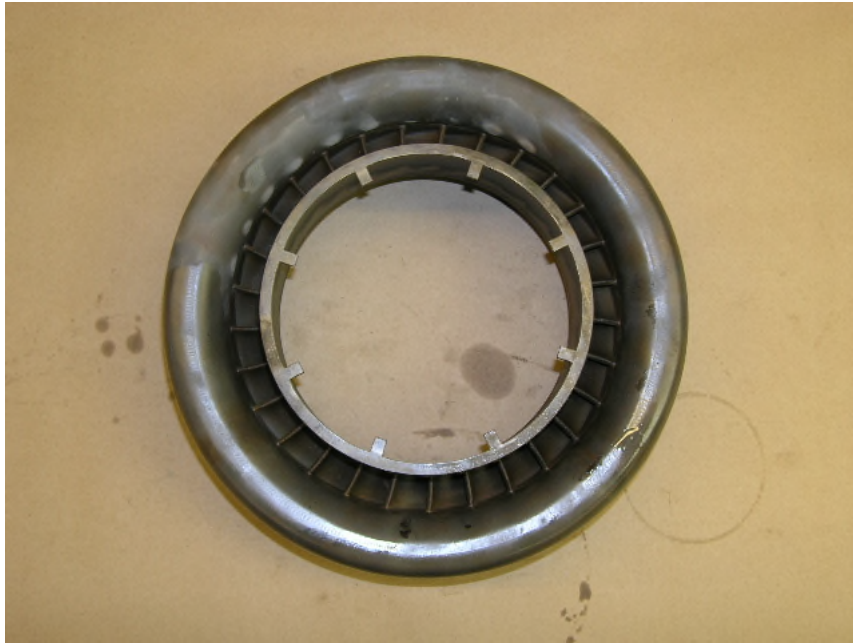
Photo No. 71

**Small Exit Duct:** Displayed no indications of distress. Please refer to photo No. 71.

**Compressor Turbine Guide Vane Ring:** The vane airfoil leading edges were intact. One vane airfoil at the approximate 8:00 position trailing was eroded, and the vane airfoil showed a bright silver metal deposit characteristic of melted compressor blade or vane material. Please refer to photos No. 71 through 73.

Compressor turbine guide vane ring and small exit duct, upstream side.

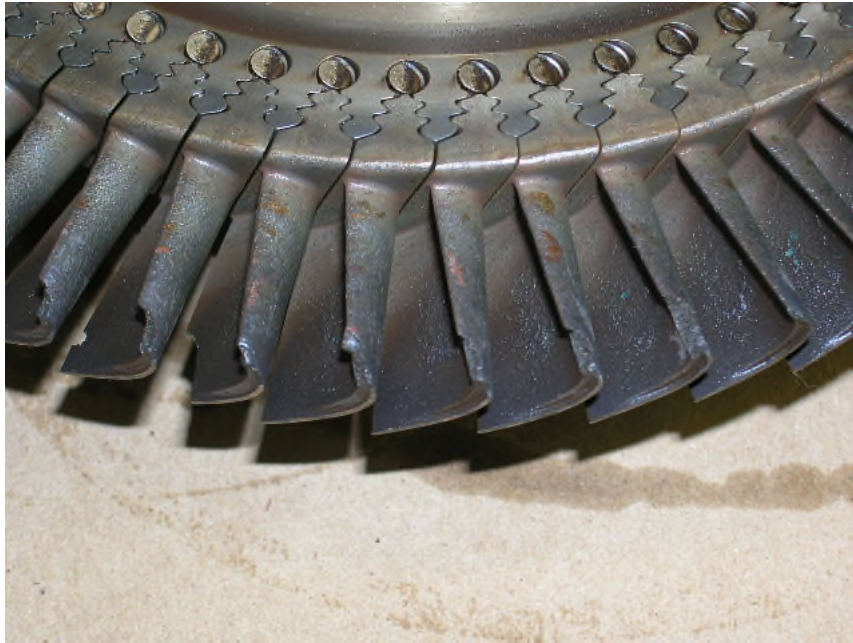
**Compressor Turbine:** The blade airfoils were lightly battered and gouged due to contact with upstream debris. The blade tips displayed circumferential rubbing due to contact with the shroud. Fine silver metal material was heat fused to the airfoil surfaces. The disc downstream side displayed circumferential rubbing due to contact with the power turbine guide vane ring. Please refer to photos No. 74 through 78.

Photo No. 76  
Compressor turbine upstream side, detail.

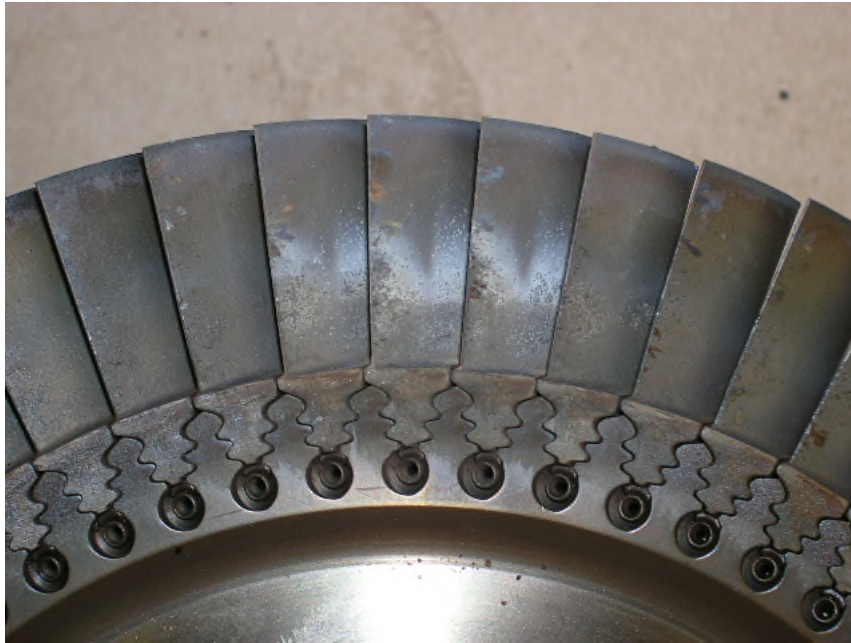
Photo No. 78

Compressor turbine downstream side, detail.

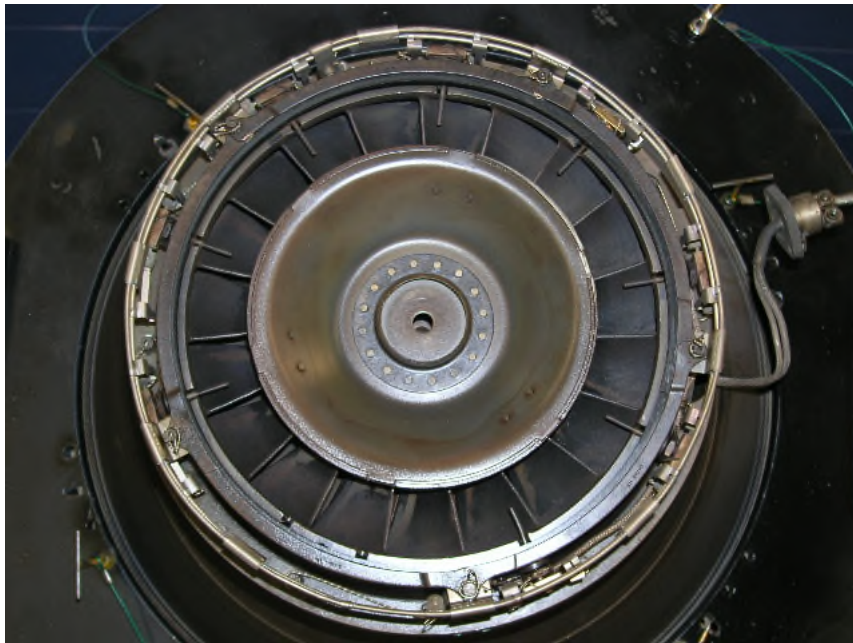
Photo No. 79

**ITT Probes, Bus bar, and Harness:** Displayed no distress. Please refer to photo No. 79.

**Power Turbine Housing:** Displayed no distress, please refer to photo No. 79.

**Power Turbine Guide Vane Ring and Interstage Baffle:** Observed in-situ, displayed no distress. Please refer to photo No. 79.

Power turbine guide vane ring and interstage baffle, in-situ.

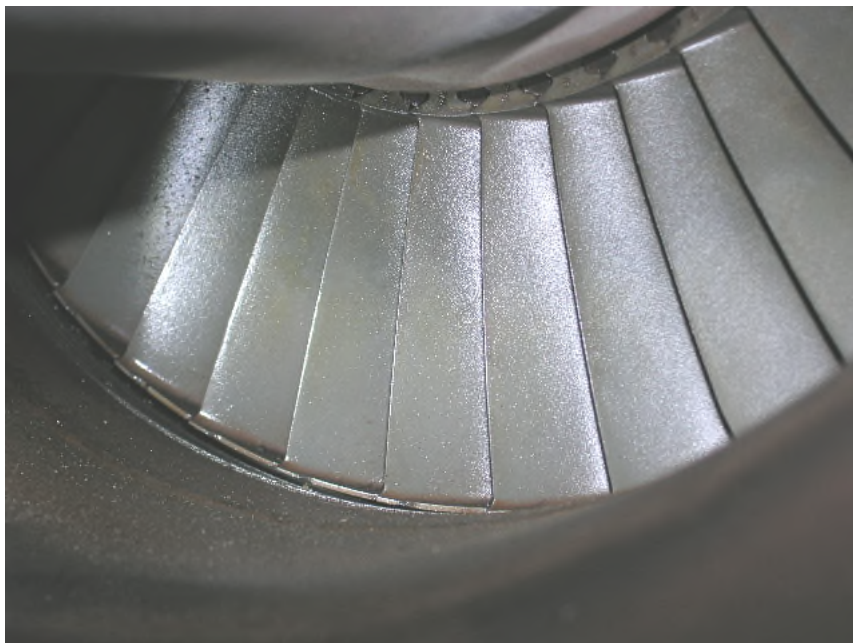
Photo No. 80

**Power Turbine Shroud:** Observed in-situ, displayed no distress. Please refer to photo No. 80.

**Power Turbine:** Observed in-situ, displayed no distress. Please refer to photo No. 80.

Power turbine downstream side, in-situ.
