## Robinson Helicopter Company Accident Report

| AIRCRAFT MODEL: | <u>R44 Raven II</u> |
| REGISTRATION: | <u>N544SC</u> |
| NTSB IDENTIFICATION: | <u>ERA22FA096</u> |

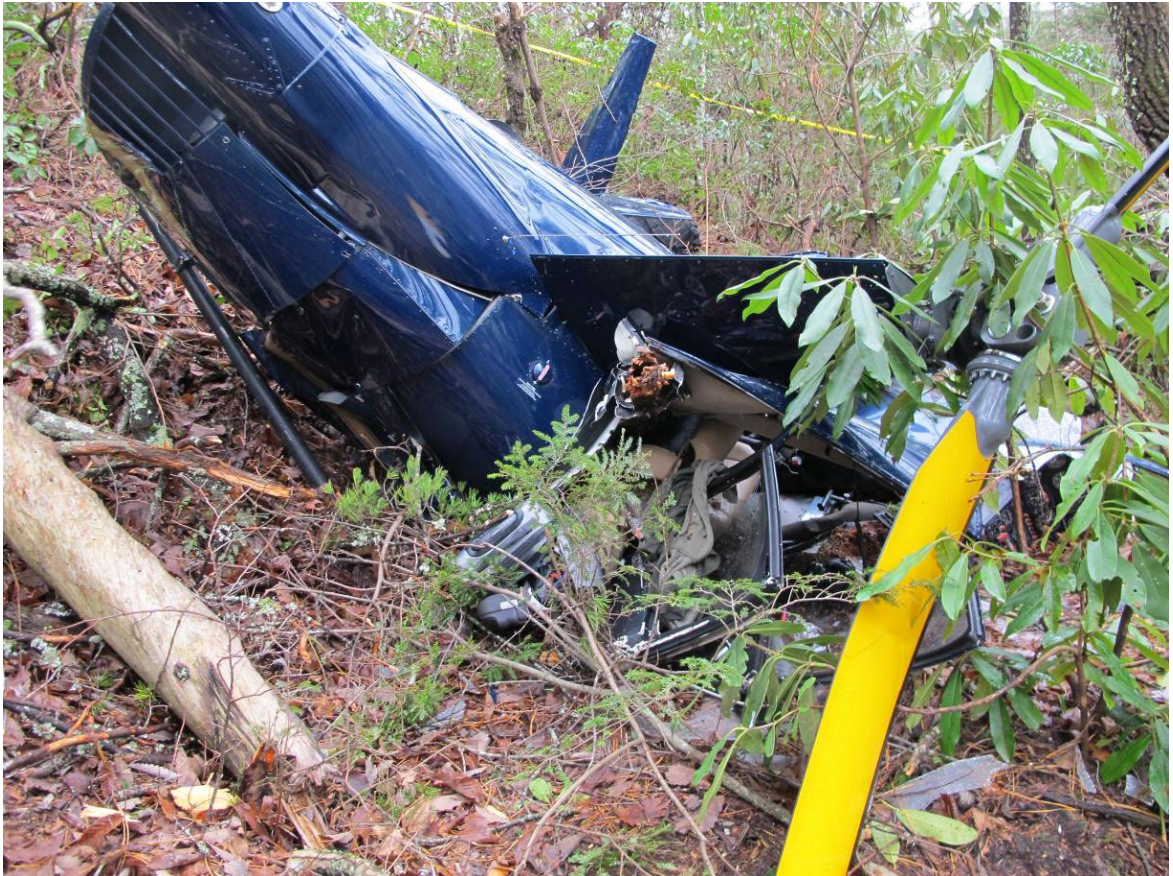
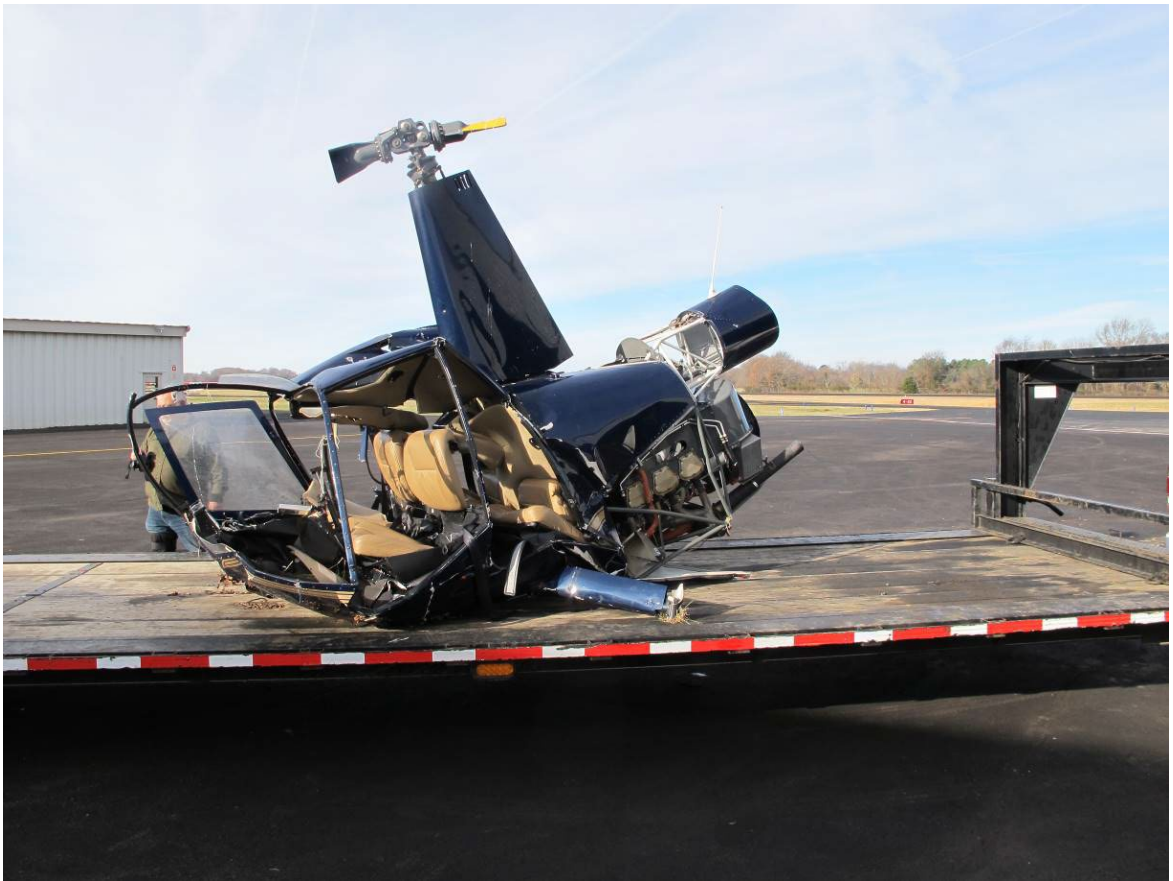
Above and below: Main wreckage after recovery.

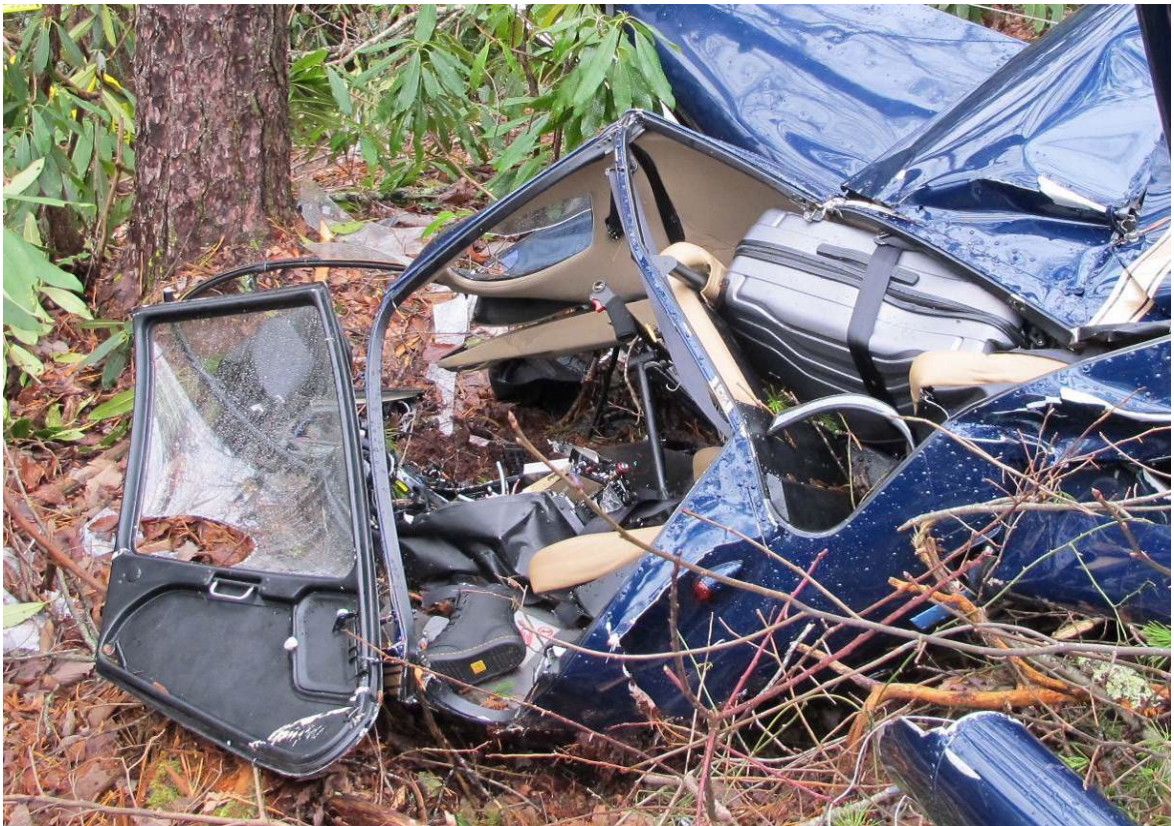
Left side of cabin prior to recovery.

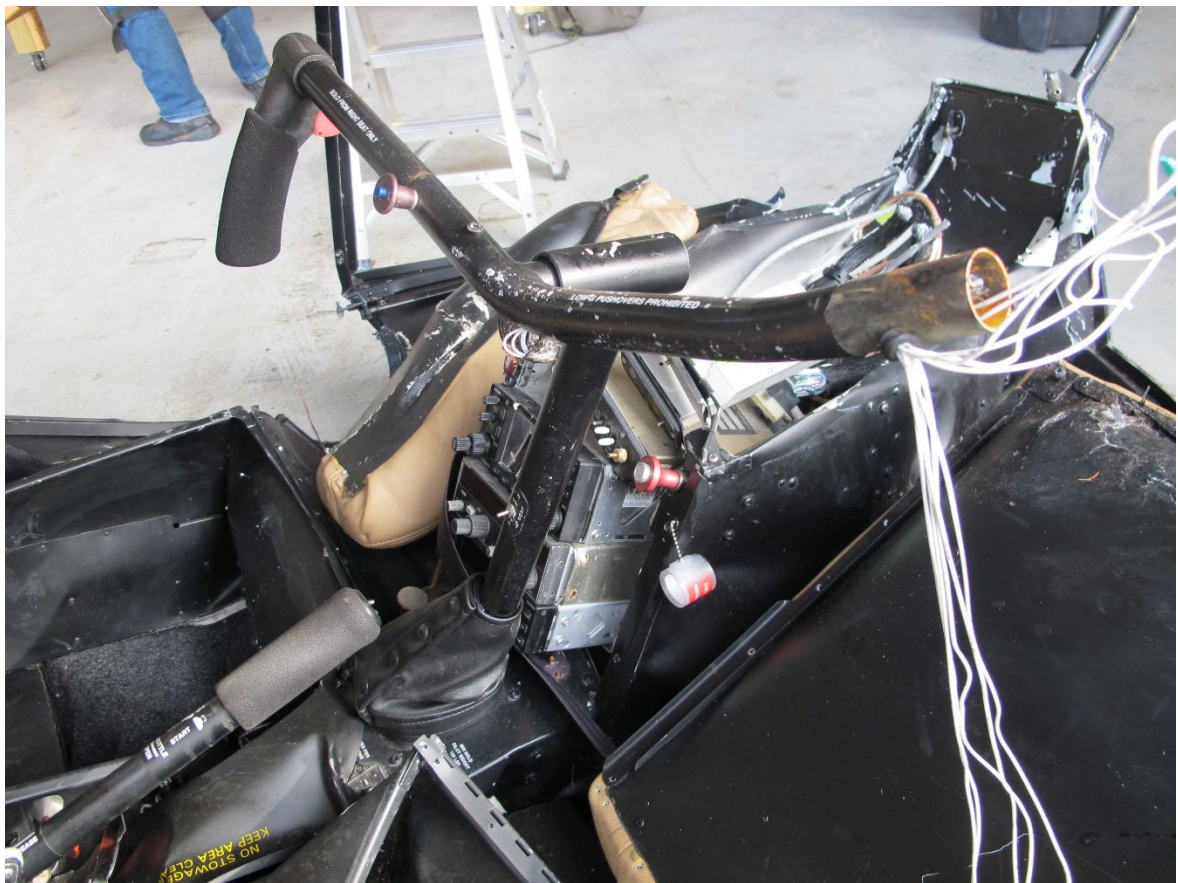
The pilot's cyclic grip was disconnected from the crossbar. The surface of the disconnect was angular and jagged. The left side cyclic control was installed. The collective was positioned approximately mid-travel. The removable collective and tail rotor pedals were recovered on the aft left floor. The pilot's tail rotor pedals were positioned with the left pedal forward.

Cyclic control.

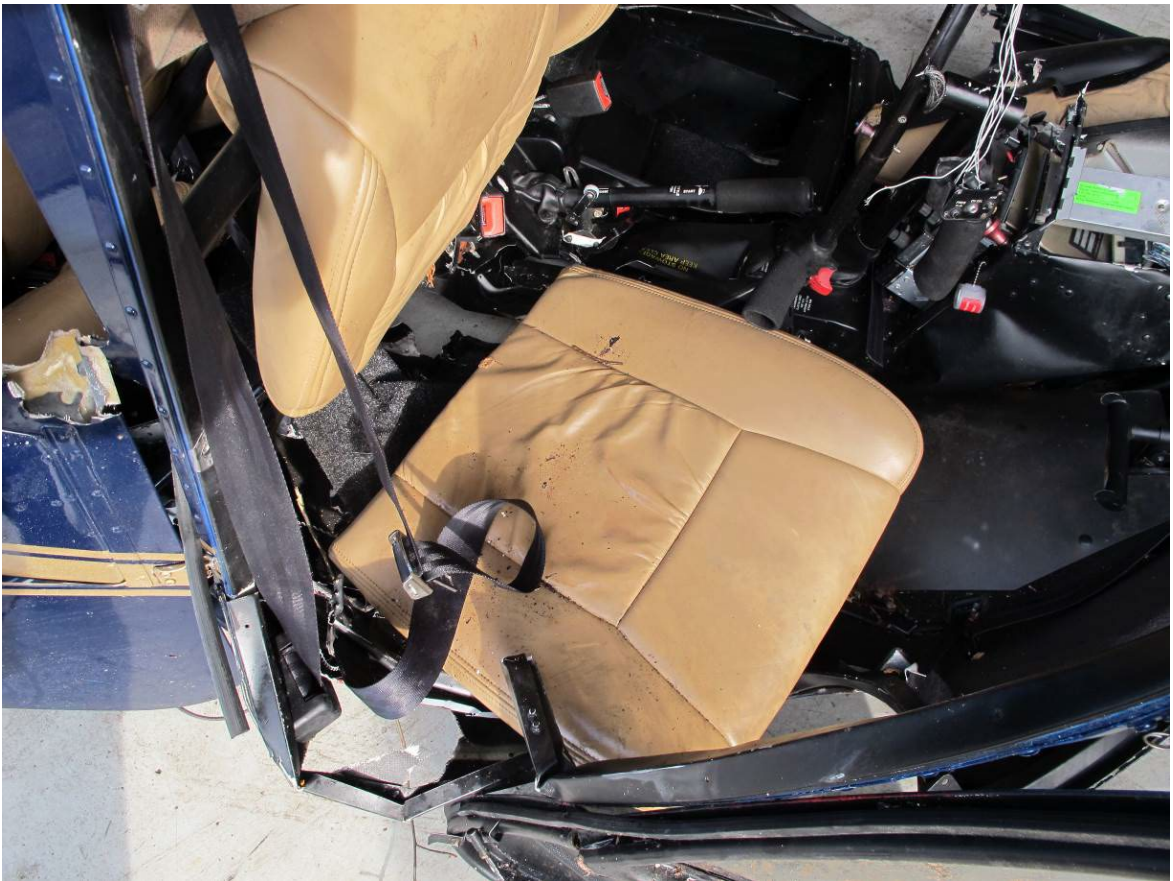
The front right seat structure was severely deformed. The front left seat structure was moderately deformed. Both aft seat structures were severely deformed and the seat backs/bulkhead was folded over the seat bottoms.

The front right seat belt buckle was unlatched (reportedly by first responders), the other three were buckled.

Front right seat.

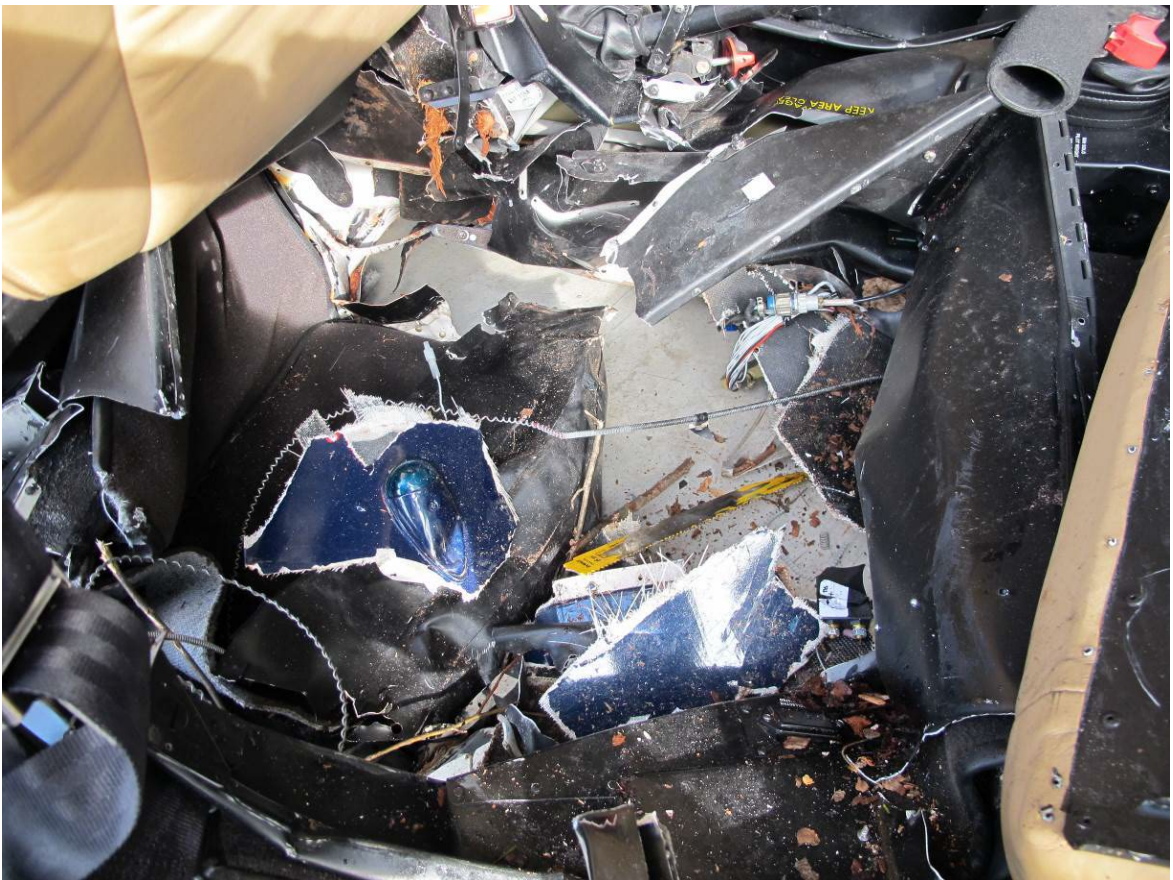
Front right seat structure.

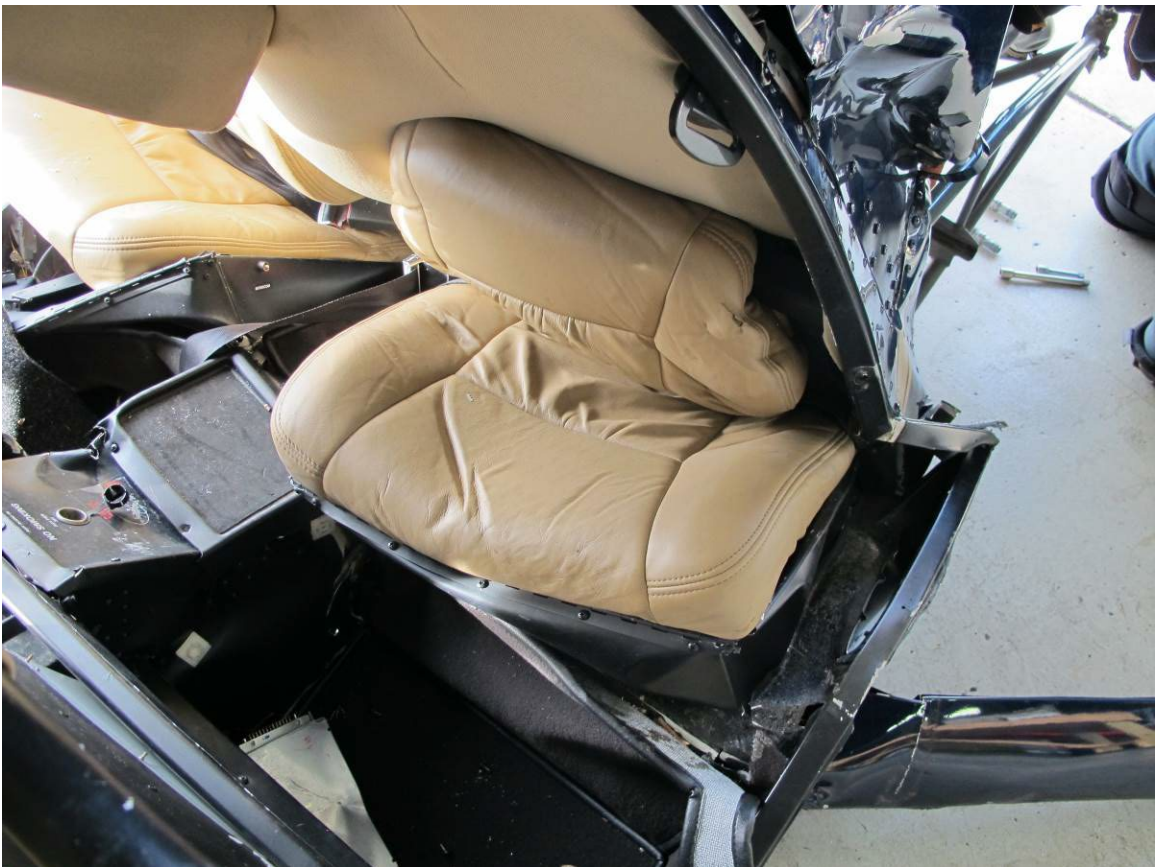
Aft left seat.

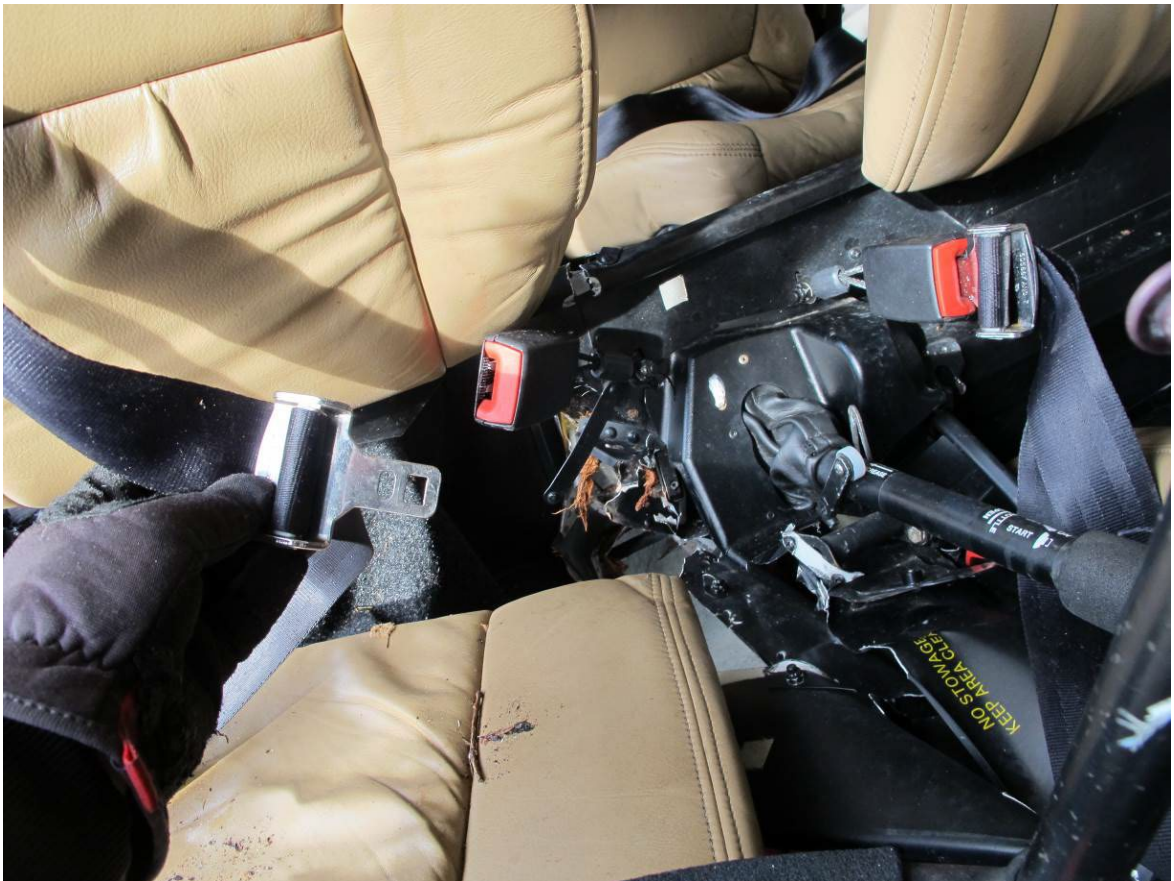
Front seat belt buckles and latches.

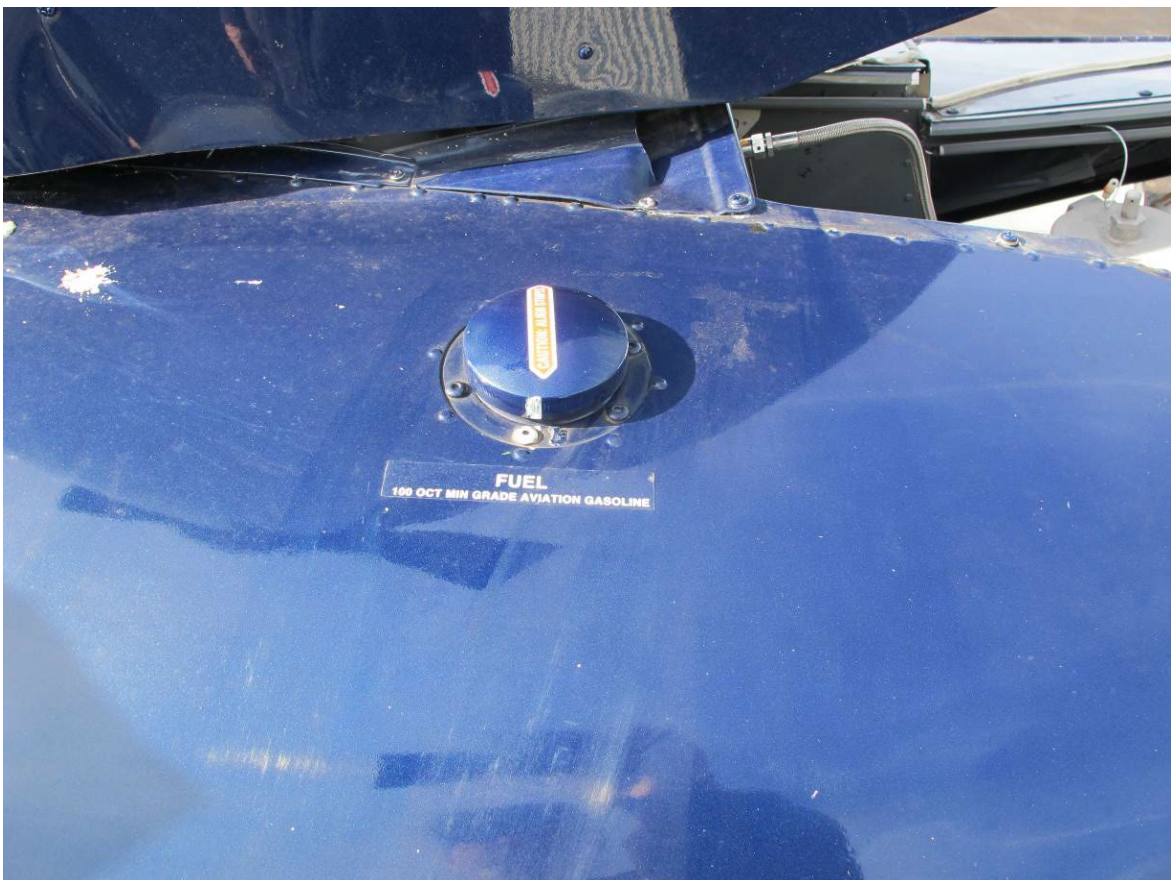
The main fuel tank sustained impact damage to the forward end of the outer shell, but the bladder was not compromised. The filler cap remained secure on the filler neck. The main fuel tank appeared to be half full of 100LL aviation fuel, blue in color with proper aroma. No water was present in the sample taken.

Main fuel tank filler neck and cap.

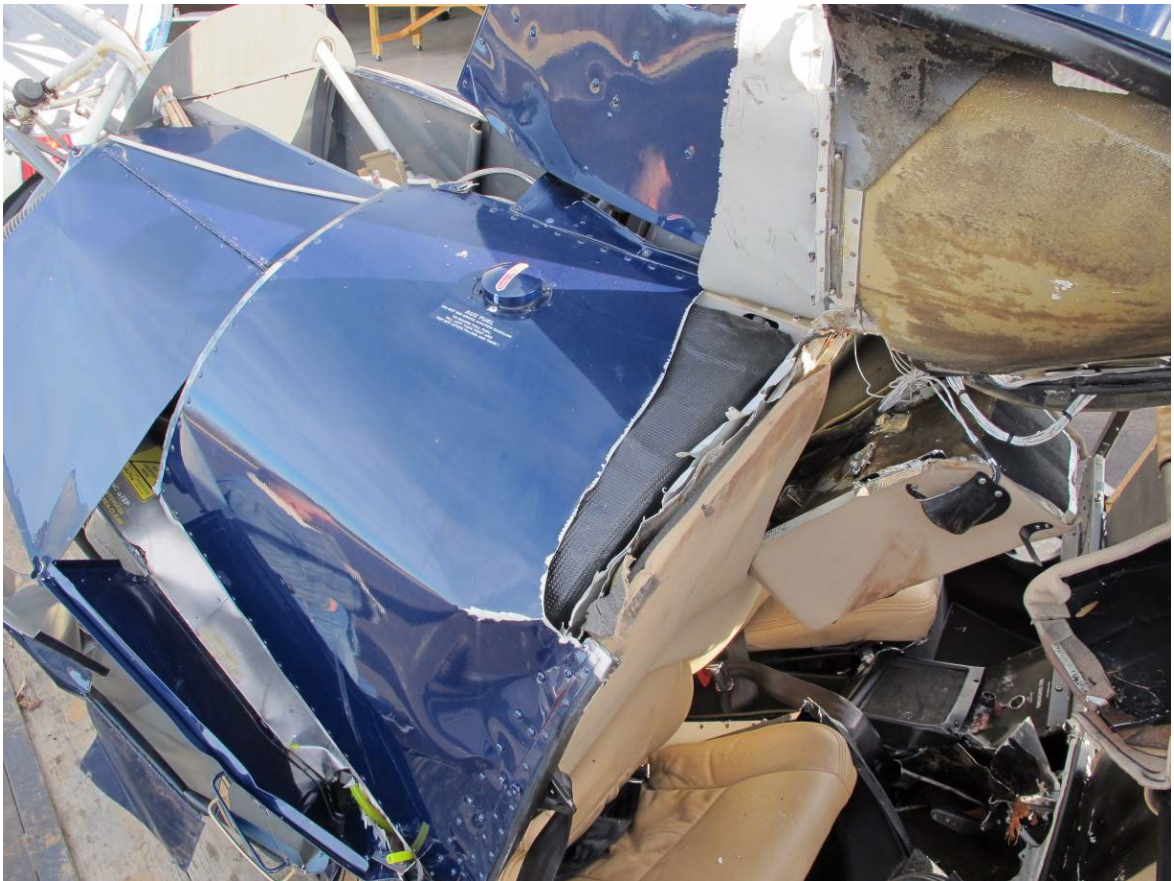
The auxiliary fuel tank sustained impact damage to the forward end of the outer shell, but the bladder was not compromised. The filler cap remained secure on the filler neck. The auxiliary fuel tank appeared to be full of 100LL aviation fuel, blue in color with proper aroma. No water was present in the sample taken.

Auxiliary fuel tank.

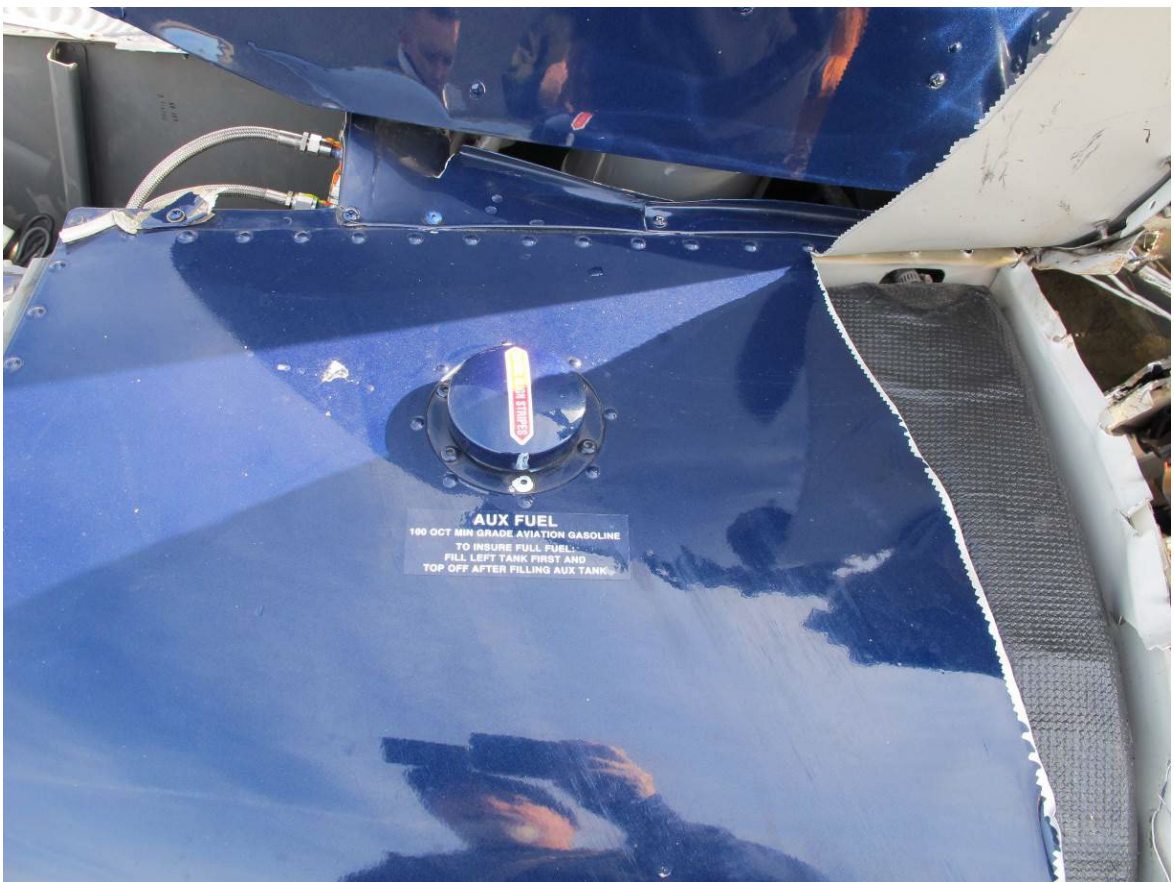
Auxiliary fuel tank filler neck and cap.

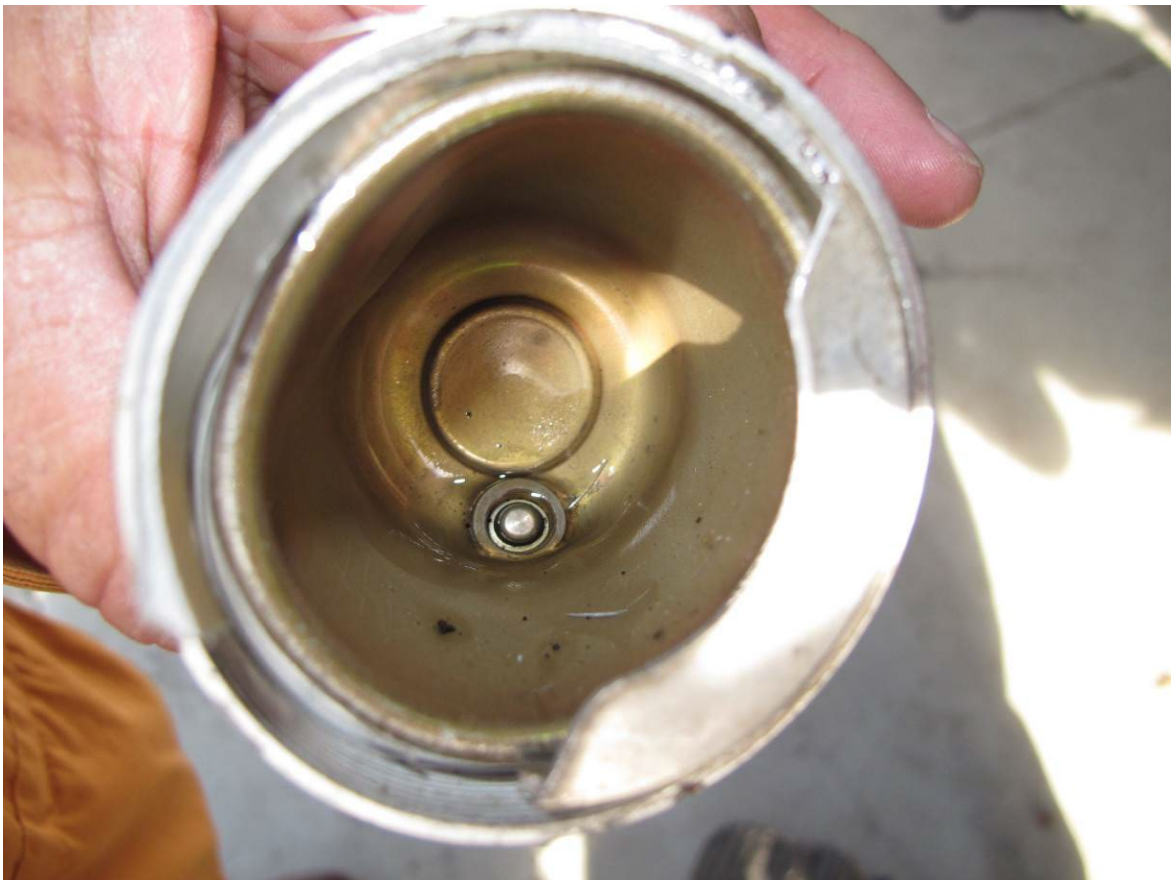
The gascolator sustained impact damage. The bowl contained no fuel. The screen was clean.

Gascolator bowl.

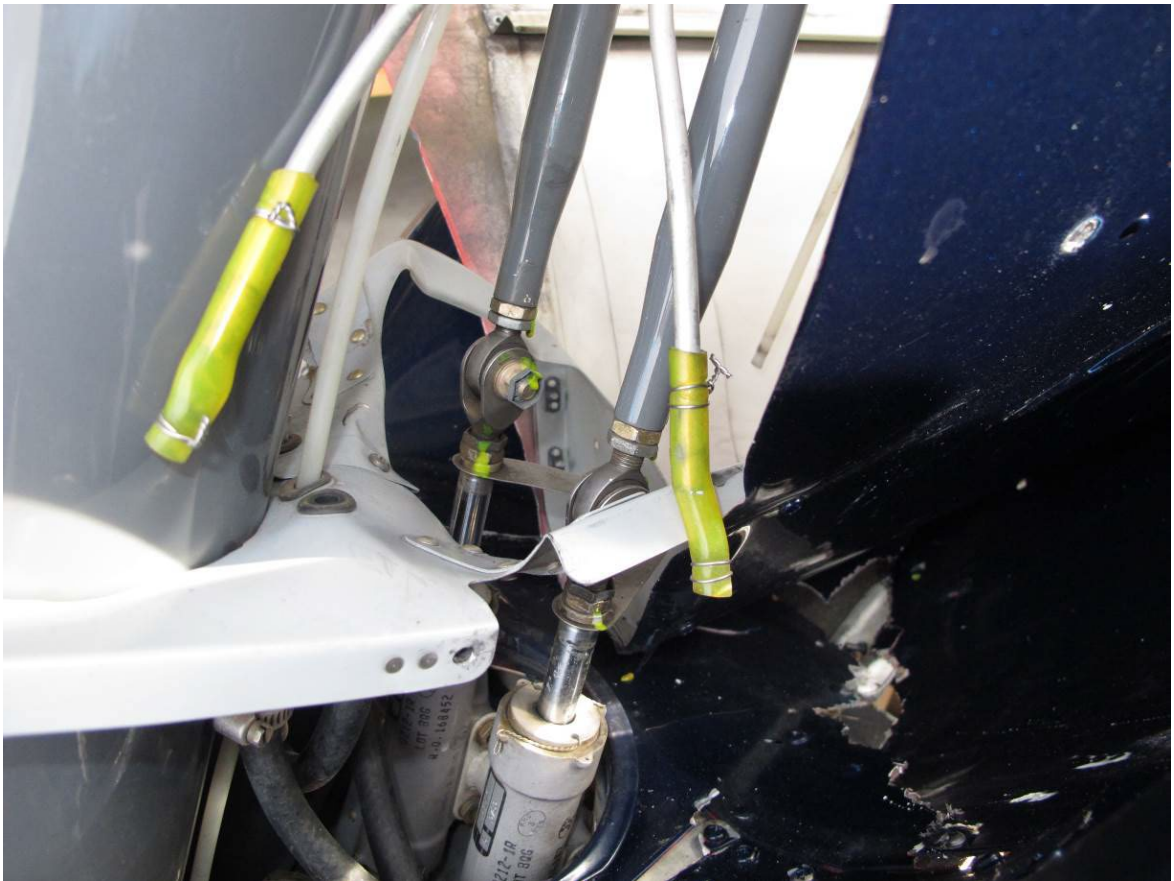
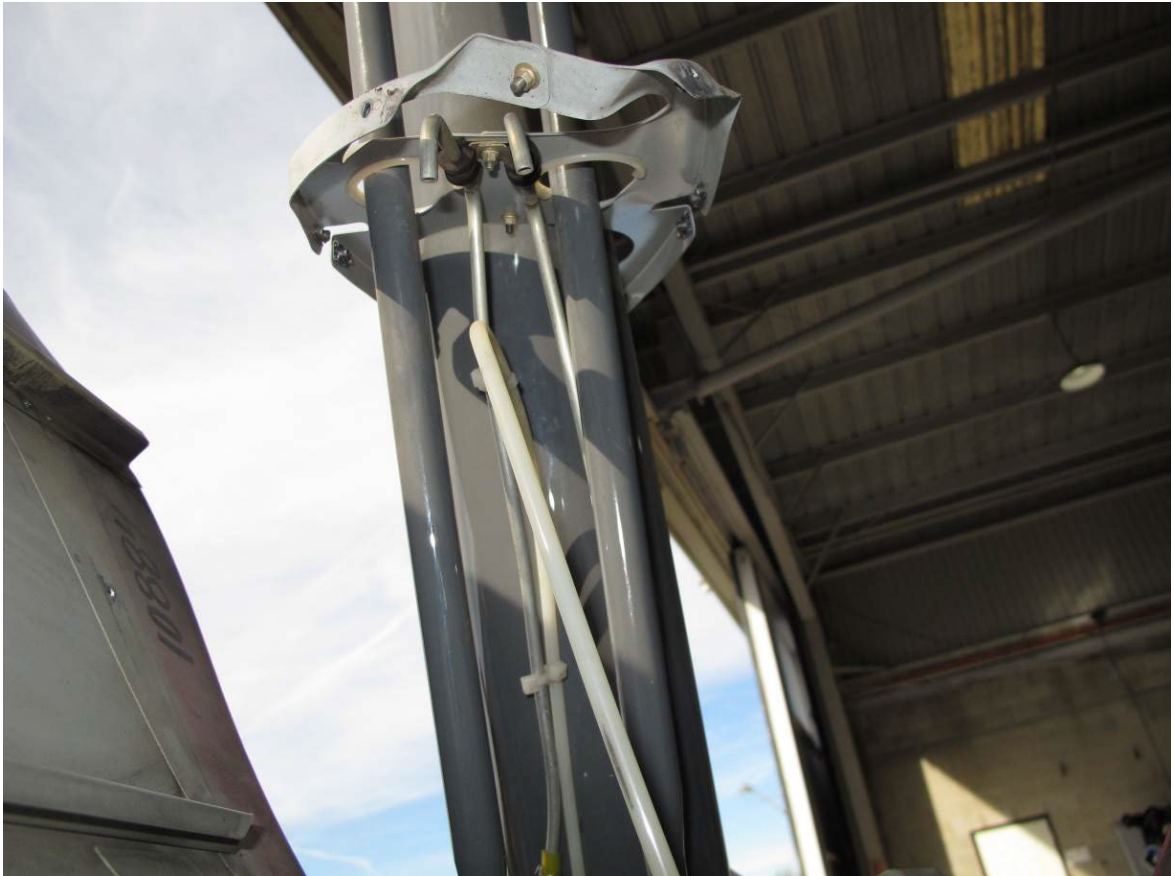
The fuel tank vent tubes were separated from the rollover valves. The tubes and hoses were clear when blown through. The rollover valves operated properly.

Above and below: Fuel vent tubes and hoses.

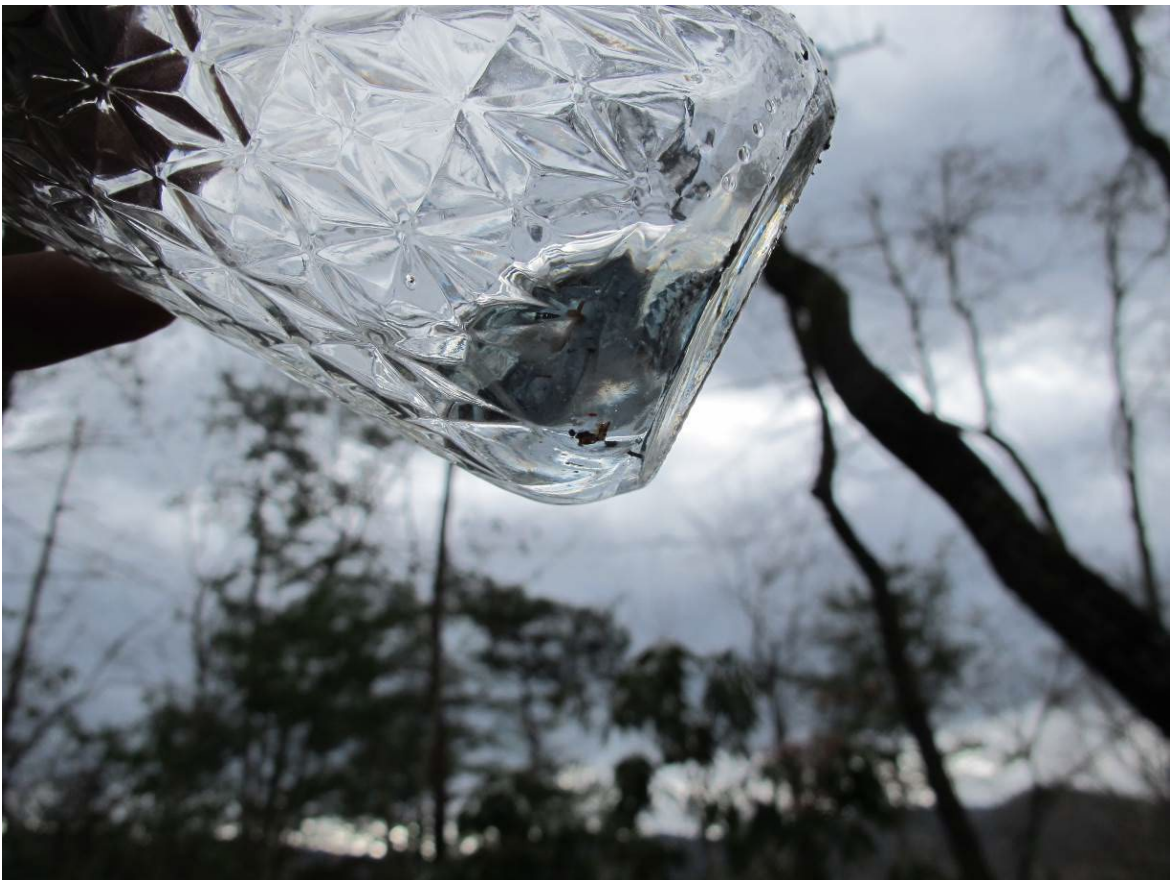
Fuel sample from auxiliary fuel tank.

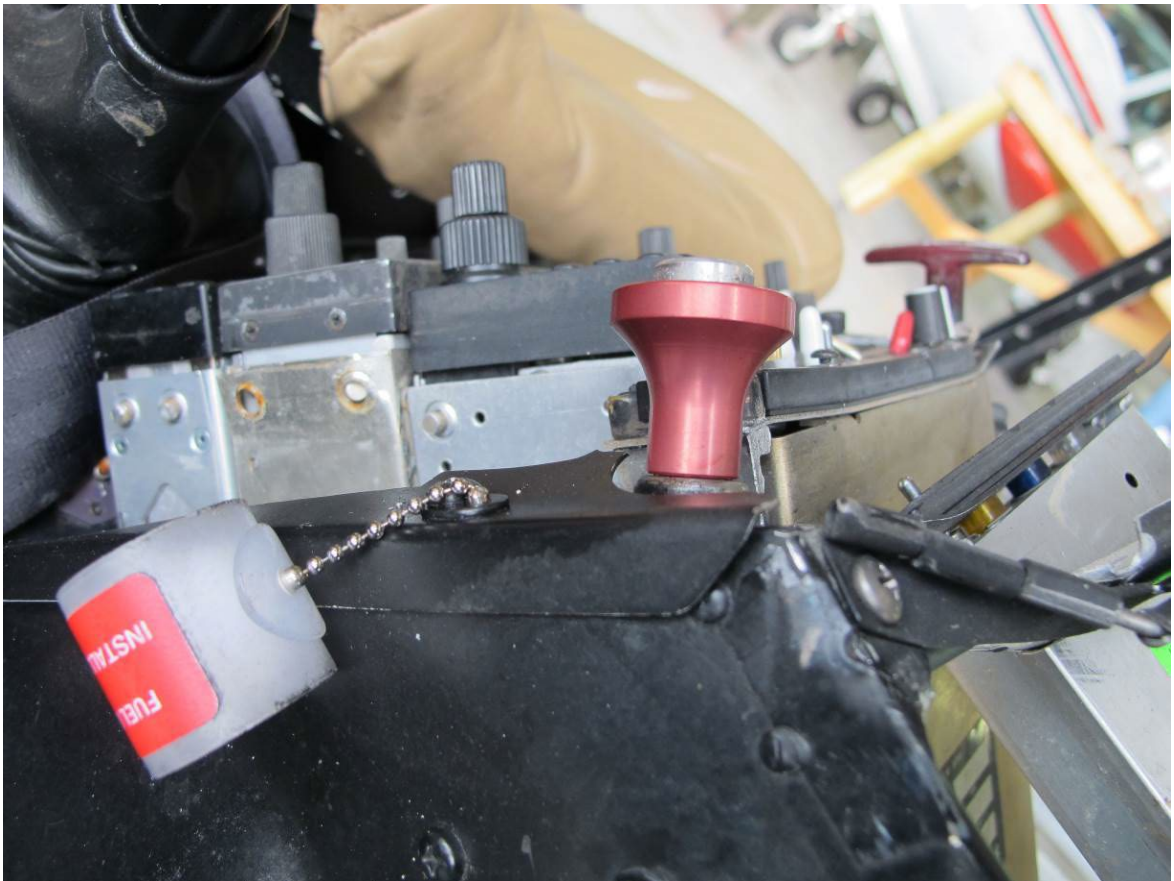
The fuel mixture control knob was in the full rich position. The fuel mixture guard was hanging on the console. The fuel mixture arm on the fuel control unit was in the cutoff position. The control wire sheathing was secure in the mounting clamps. The control wire sheathing was stretched due to impact damage.

Fuel mixture control knob.

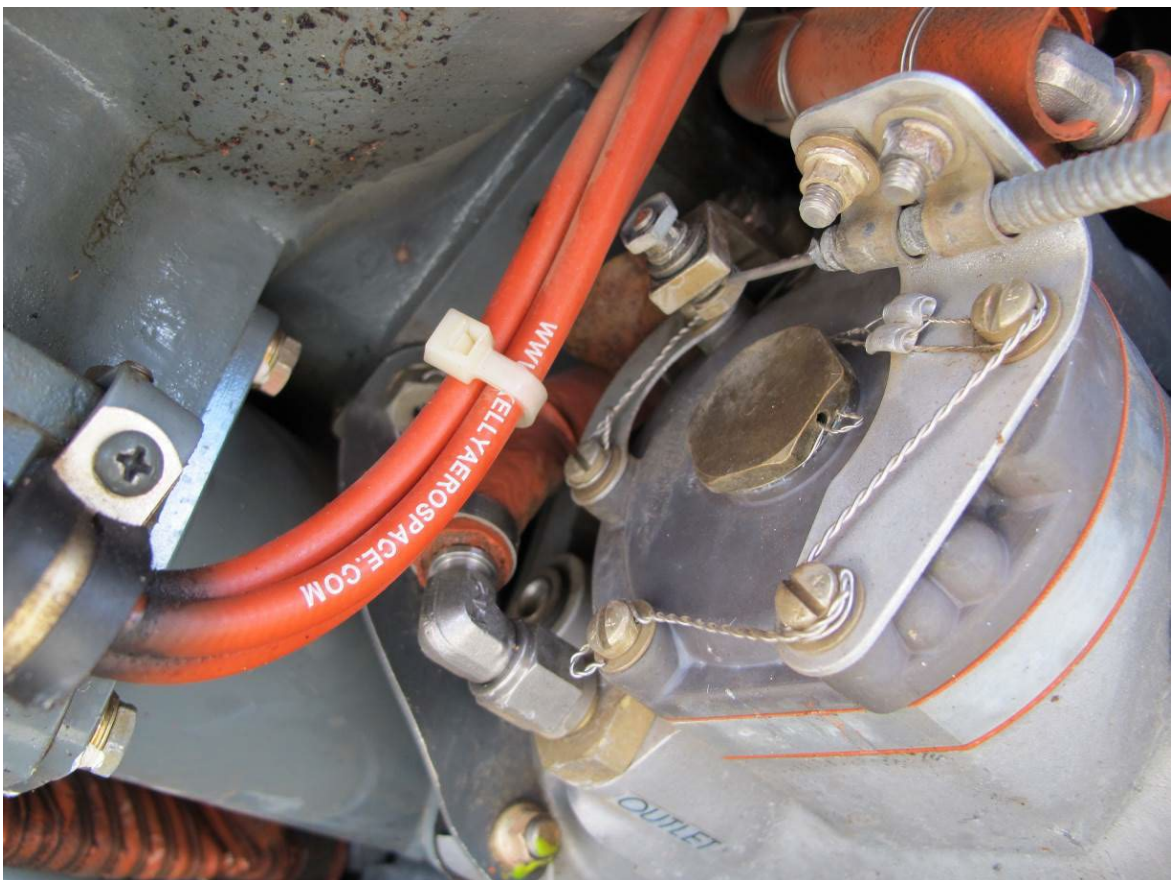
Fuel mixture arm on fuel control unit.

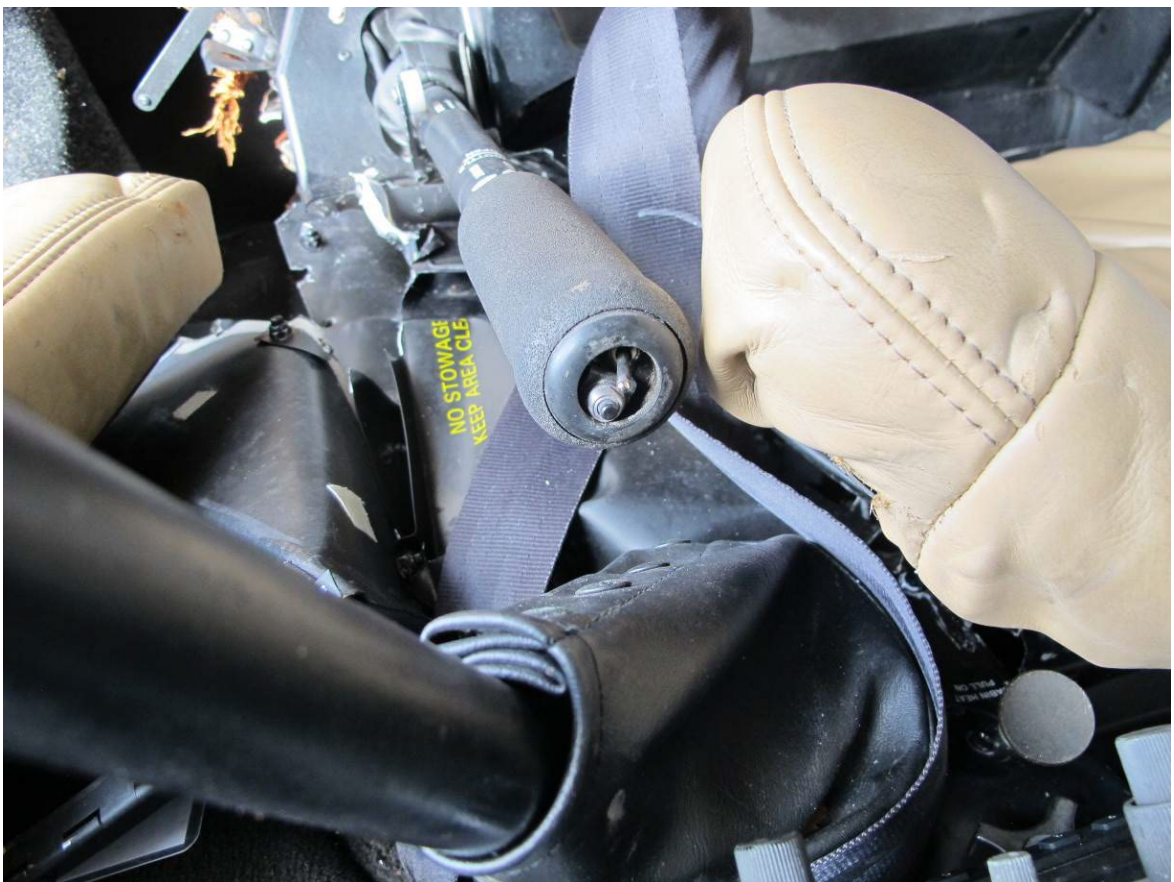
The throttle grip was in a fully open position as was the throttle valve in the fuel control unit.

Throttle grip position.

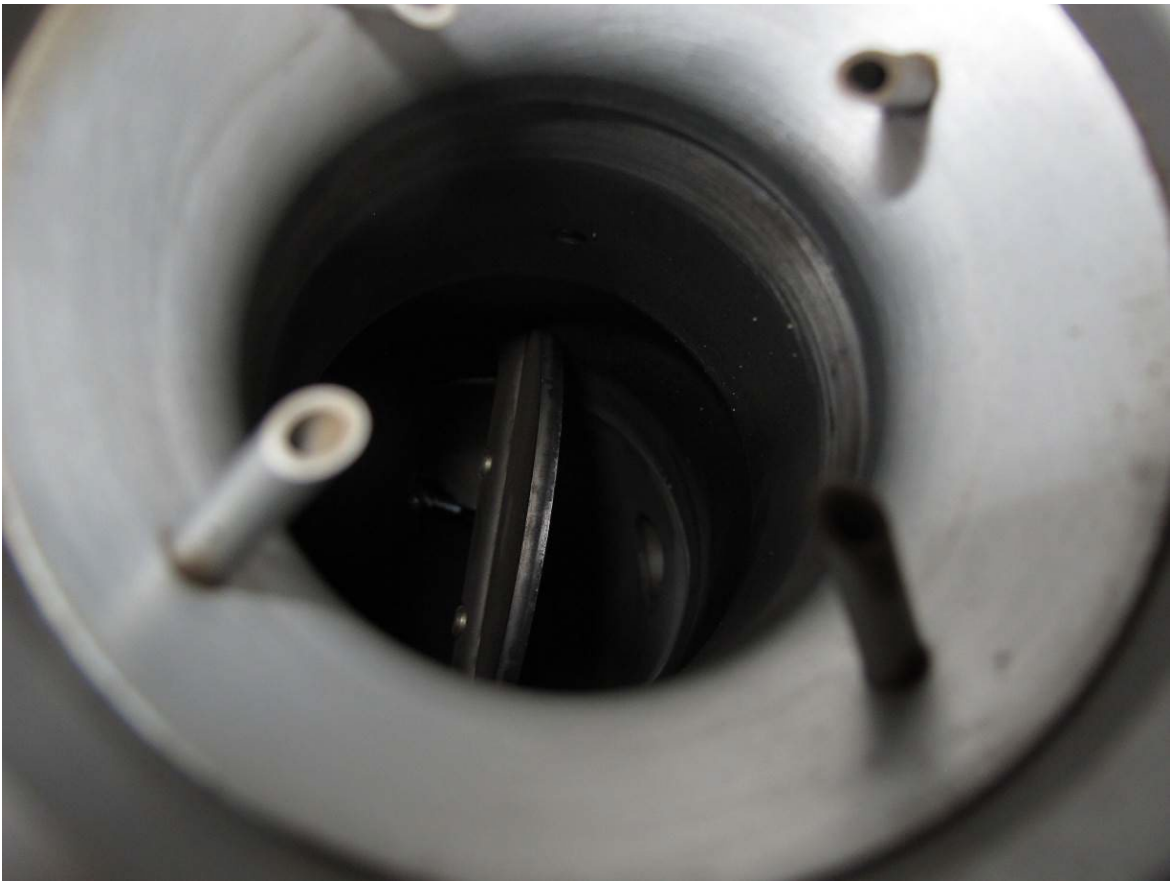
Throttle valve position.

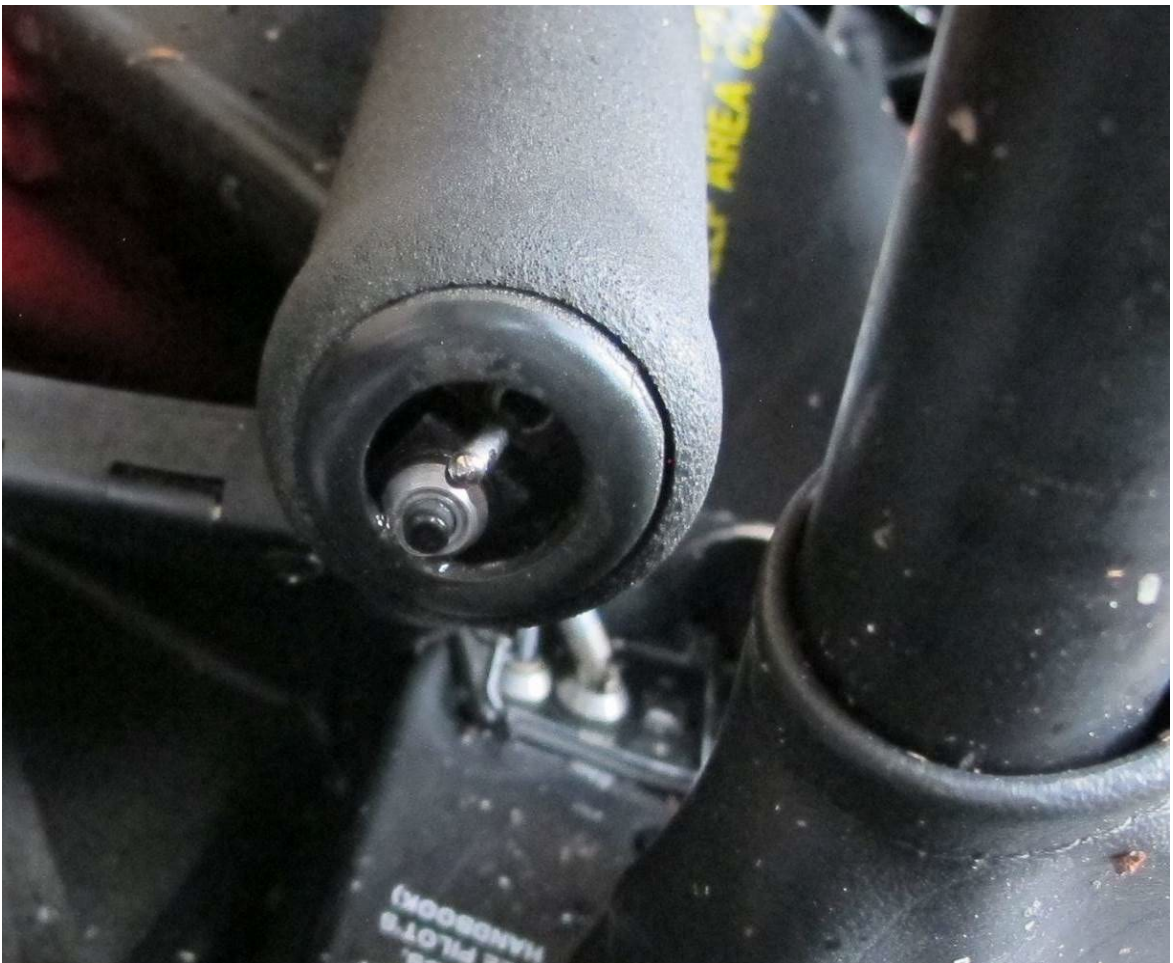
The governor switch was in the on position.

Governor switch.

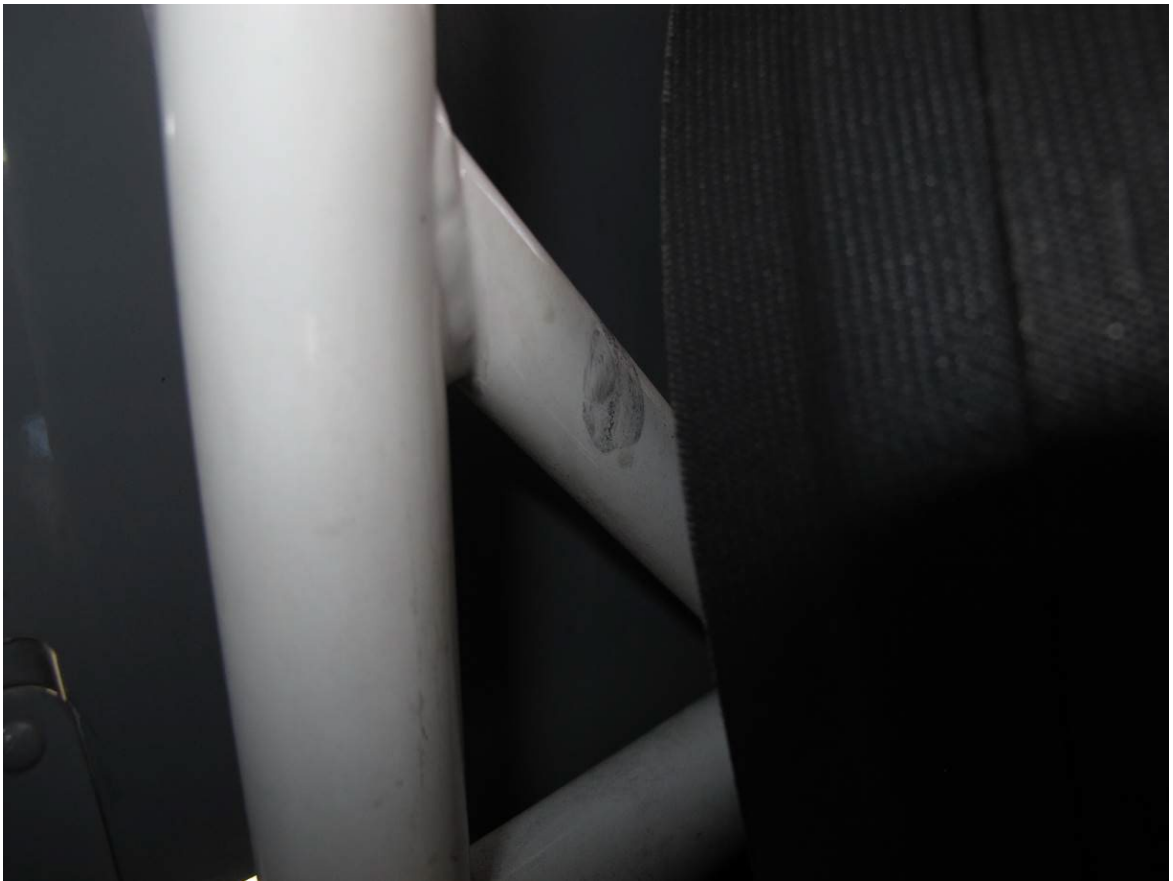
Rubber transfer on left side of upper frame.

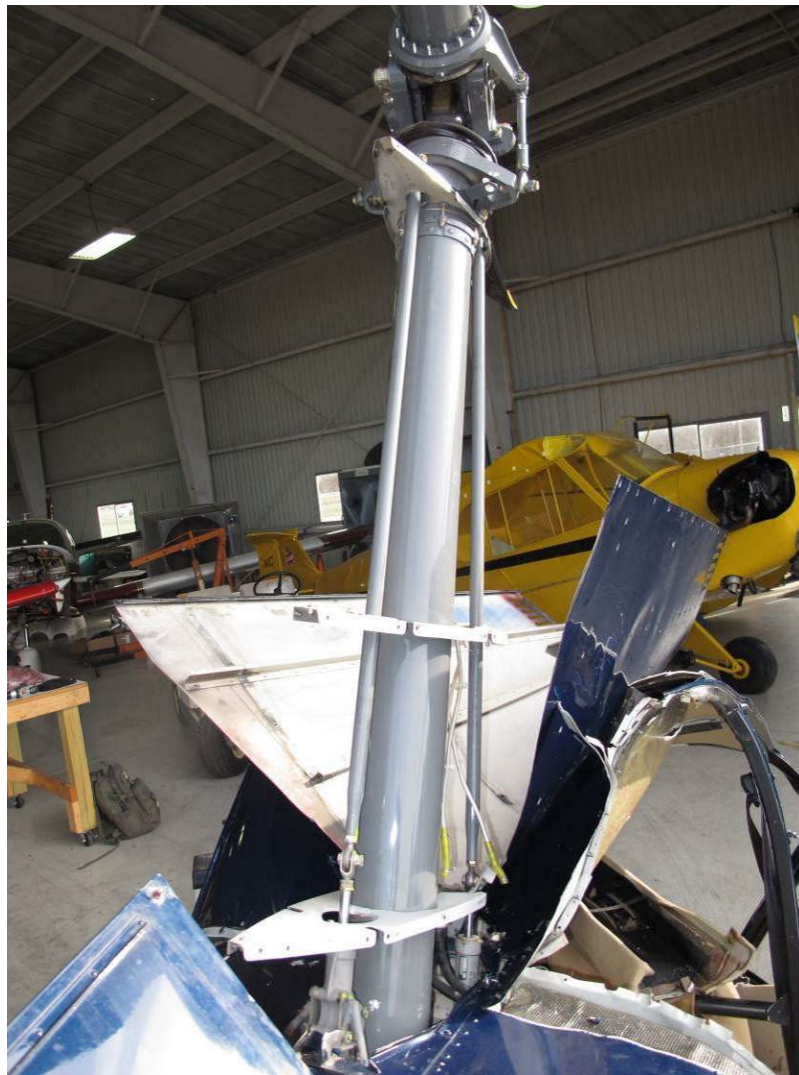
Main rotor gearbox.
