## Robinson Helicopter Company Accident Report

| AIRCRAFT MODEL: | <u>R44 Raven II</u> |
| REGISTRATION: | <u>N544SC</u> |
| NTSB IDENTIFICATION: | <u>ERA22FA096</u> |

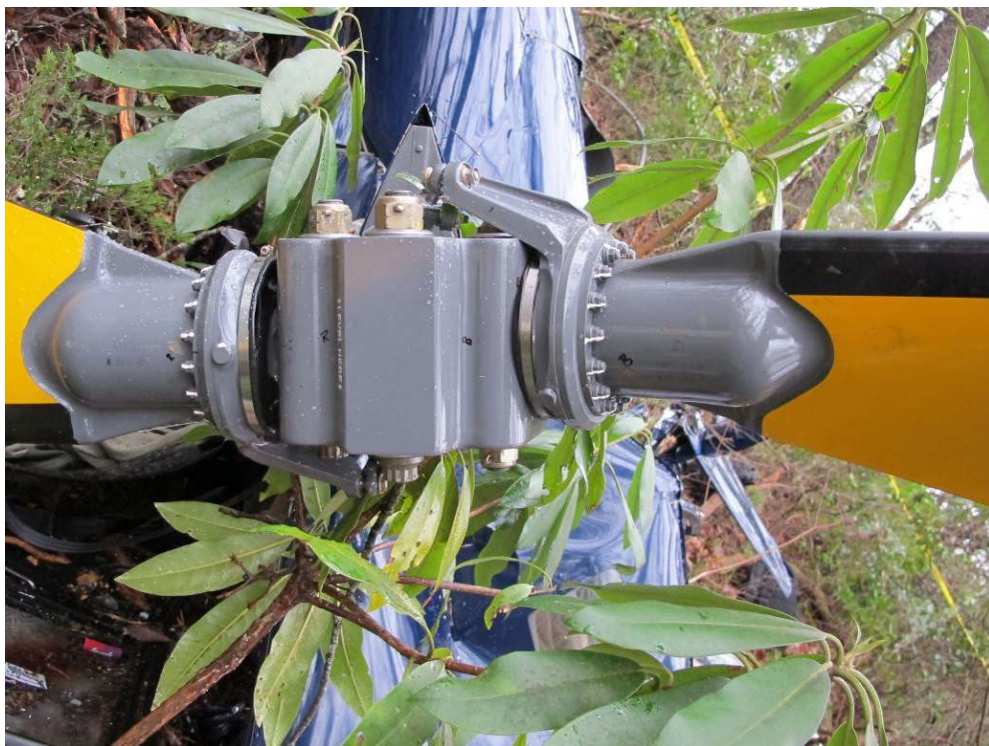
Main rotor mast tube.

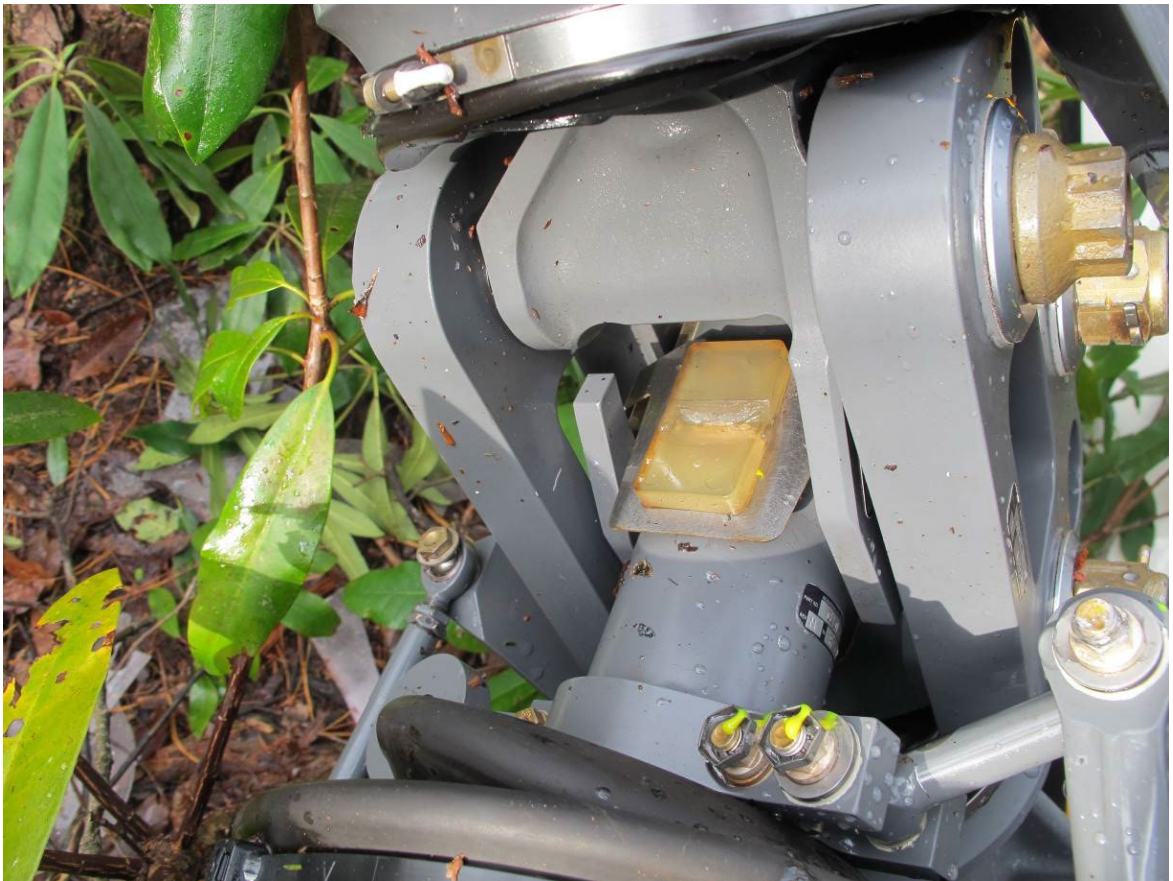
The main rotor hub had no contact marks from the main rotor blade spindle boots. Both elastomeric teeter stops were dented across the centers with no damage to their brackets. The droop stops and tusks appeared to be undamaged.

Top of the main rotor hub.

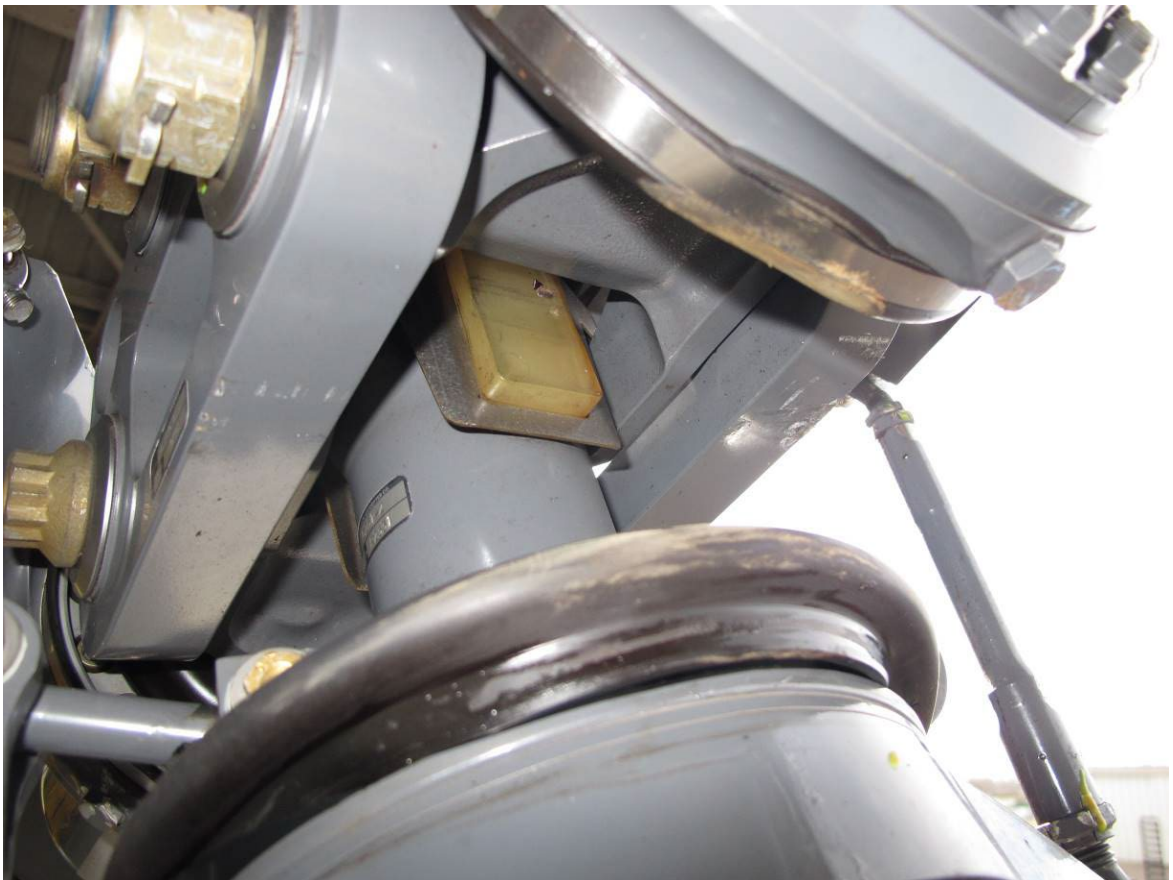
Elastomeric teeter stop for main rotor blade serial number 12234.

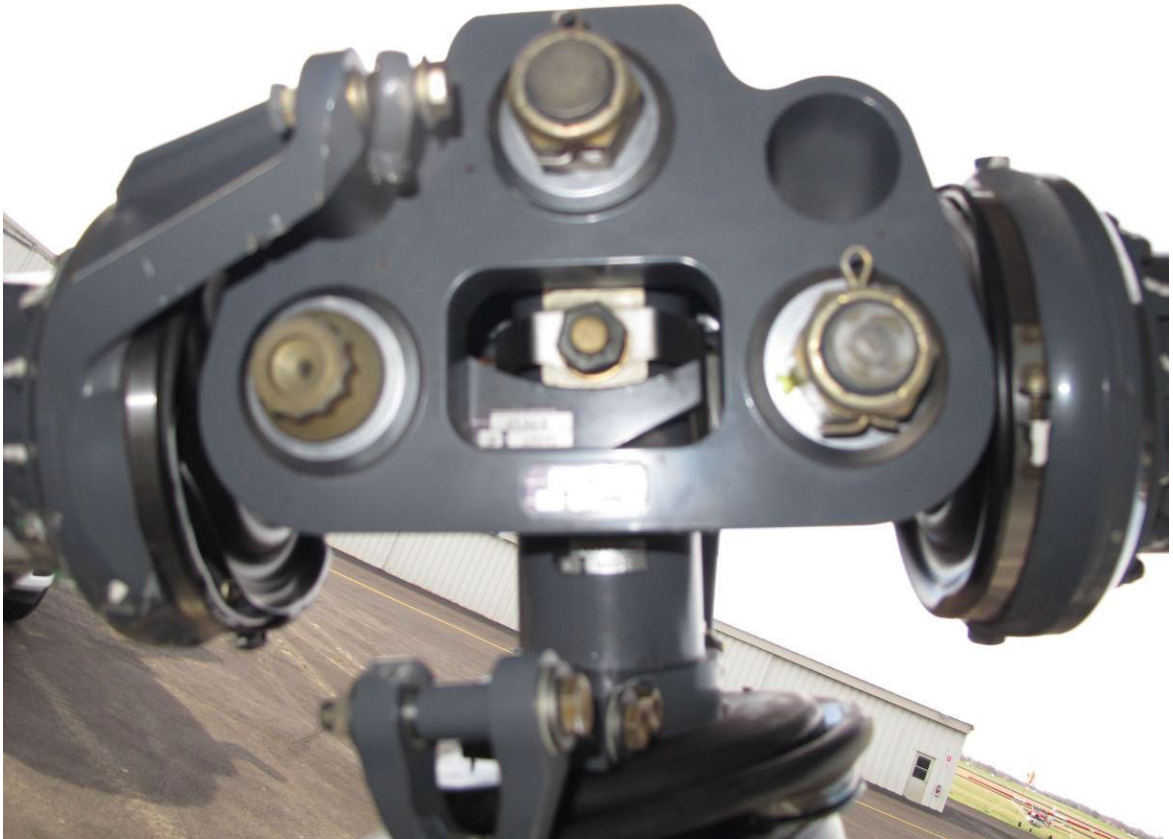
Elastomeric teeter stop for main rotor blade serial number 12227.

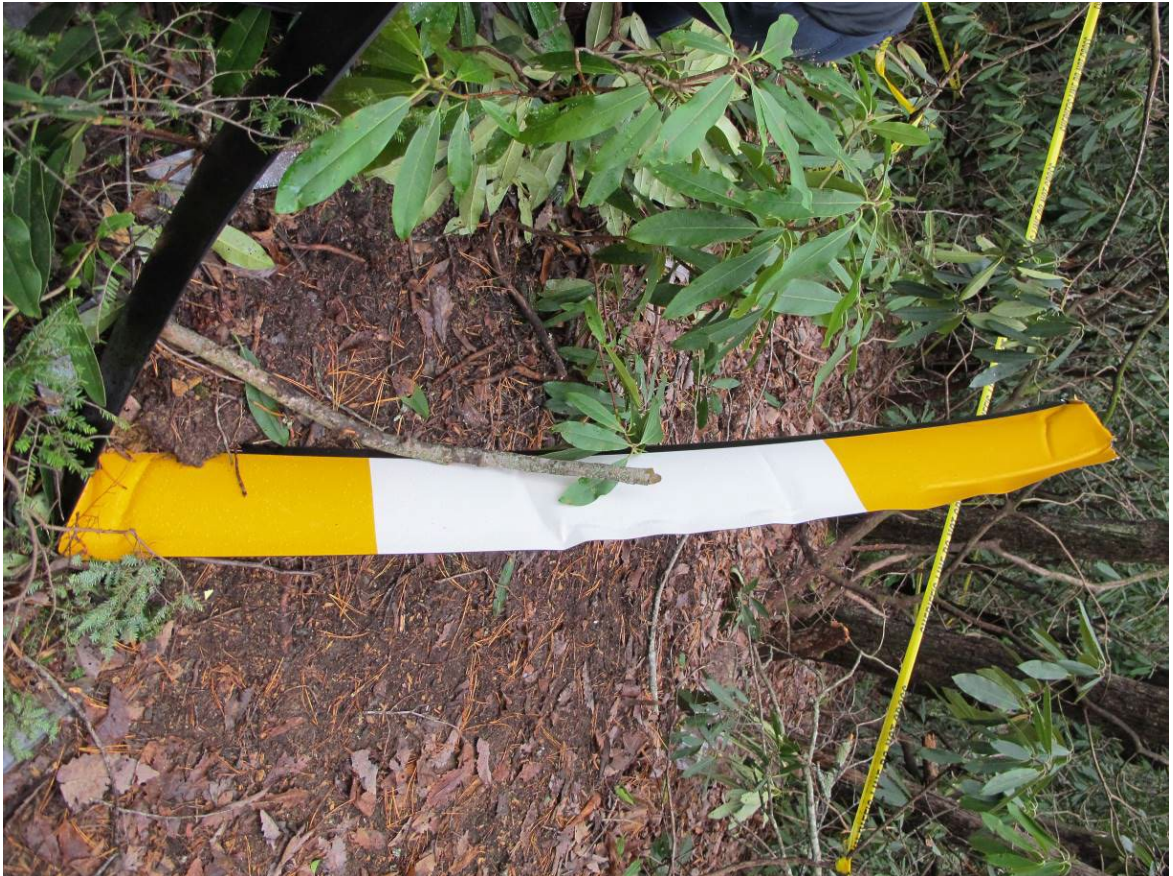
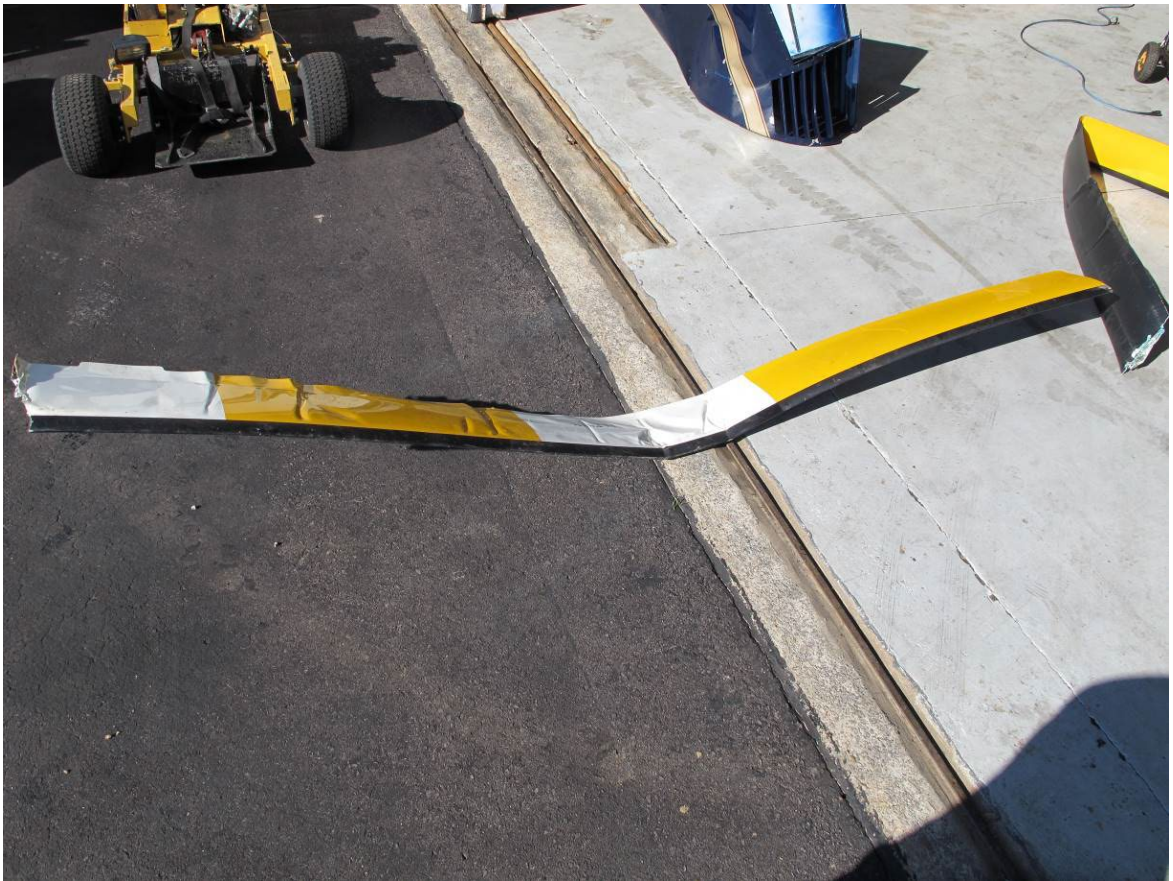
Above and below: Main rotor blades at the accident site.

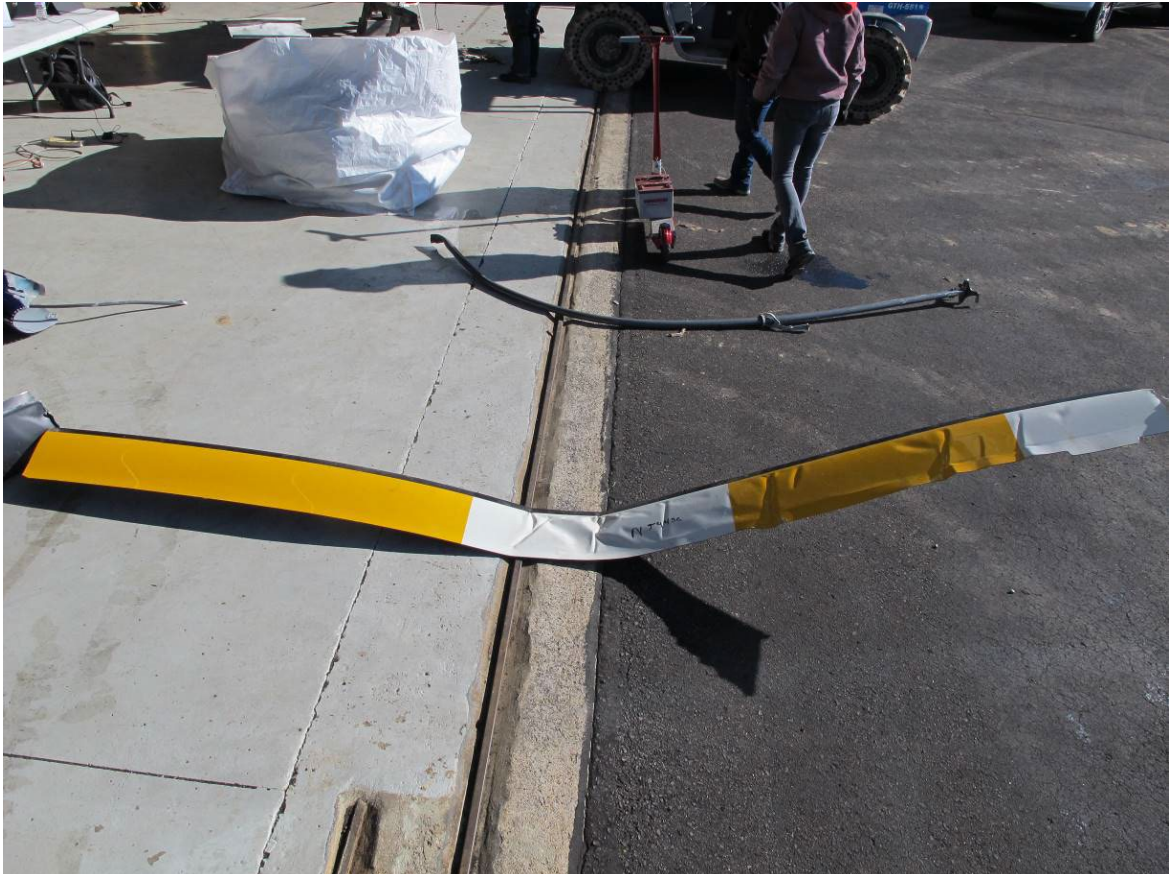
Above and below: Main rotor blade serial number 12234.

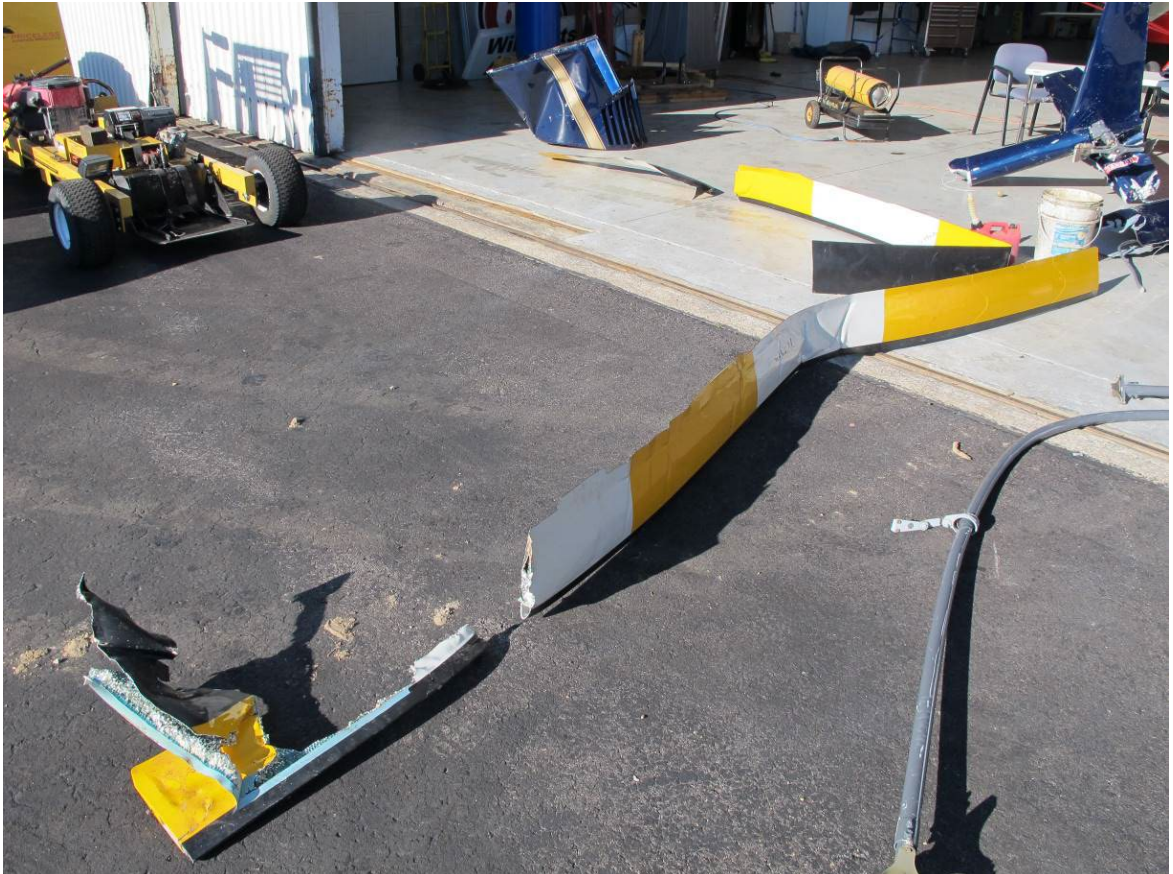
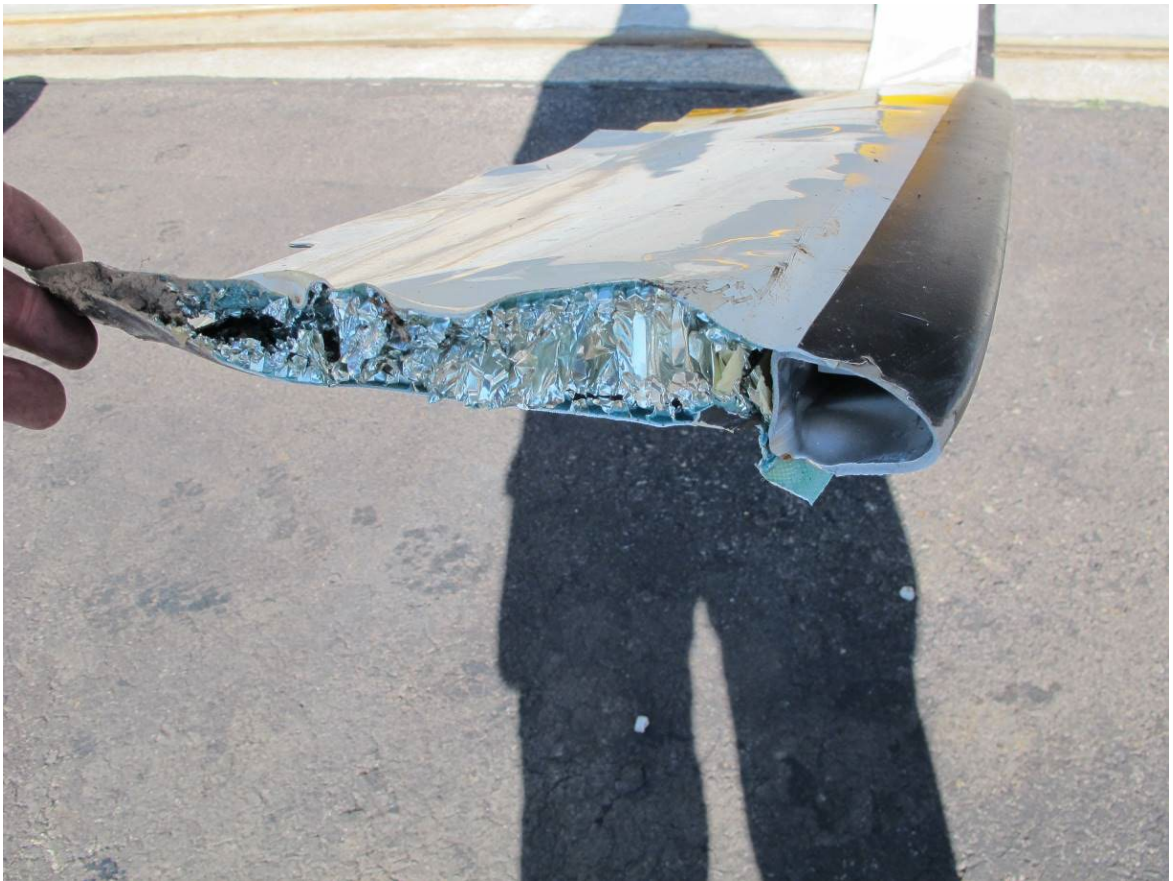
Above and below: Main rotor blade serial number 12234.

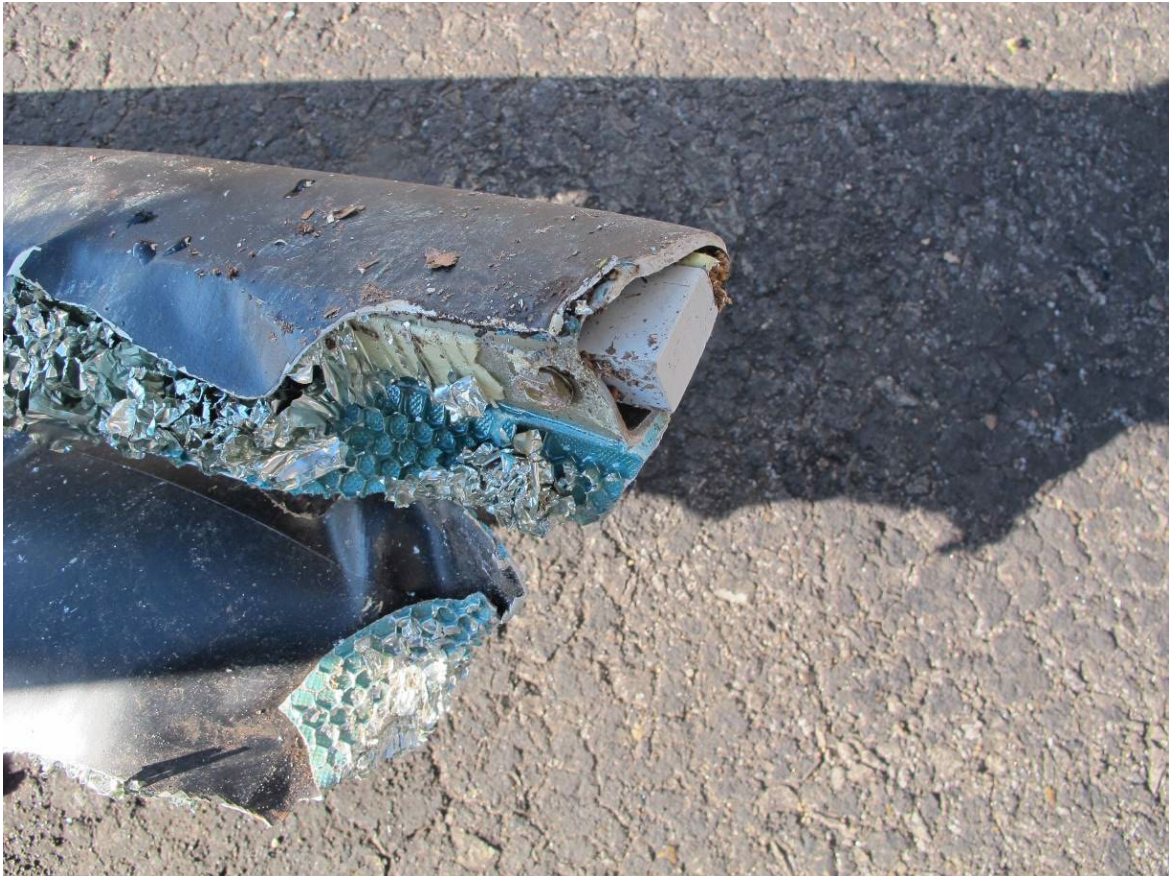
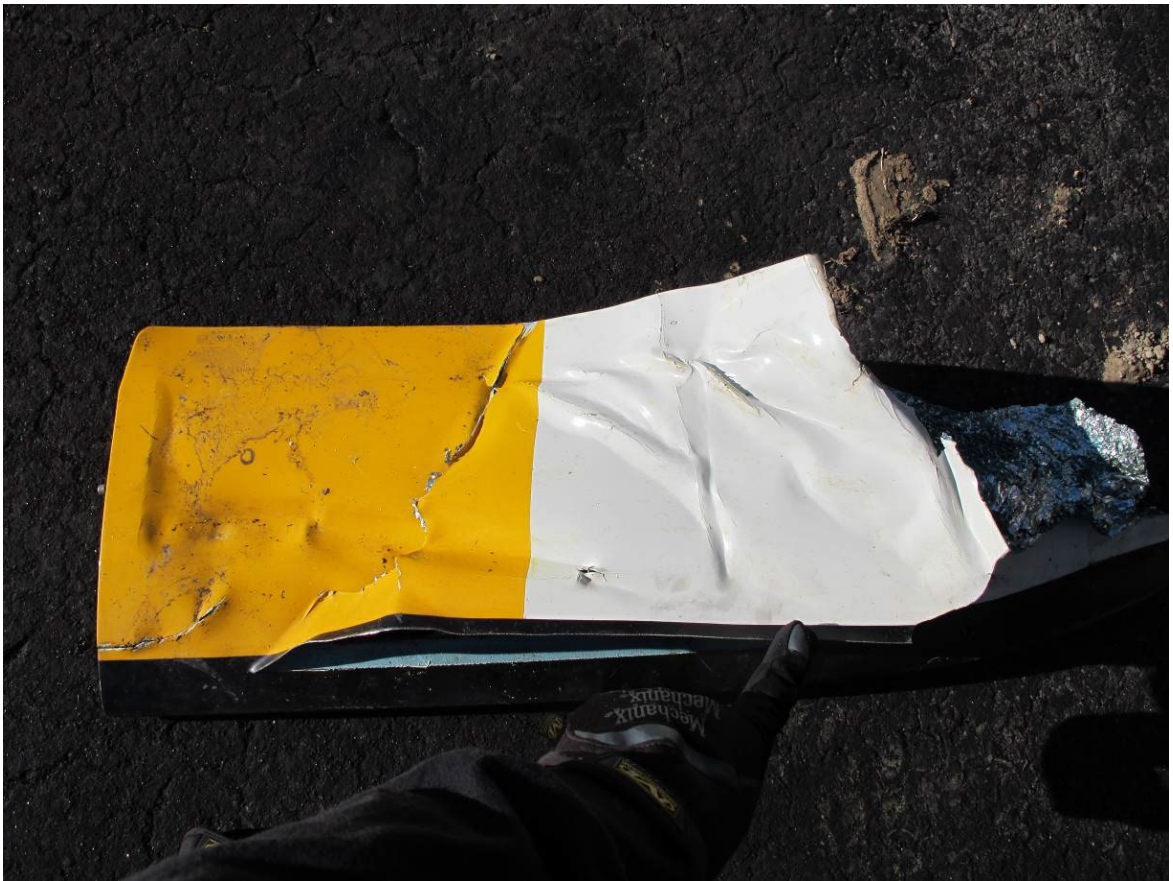
Above and below: Disconnect surfaces of main rotor blade serial number 12234.

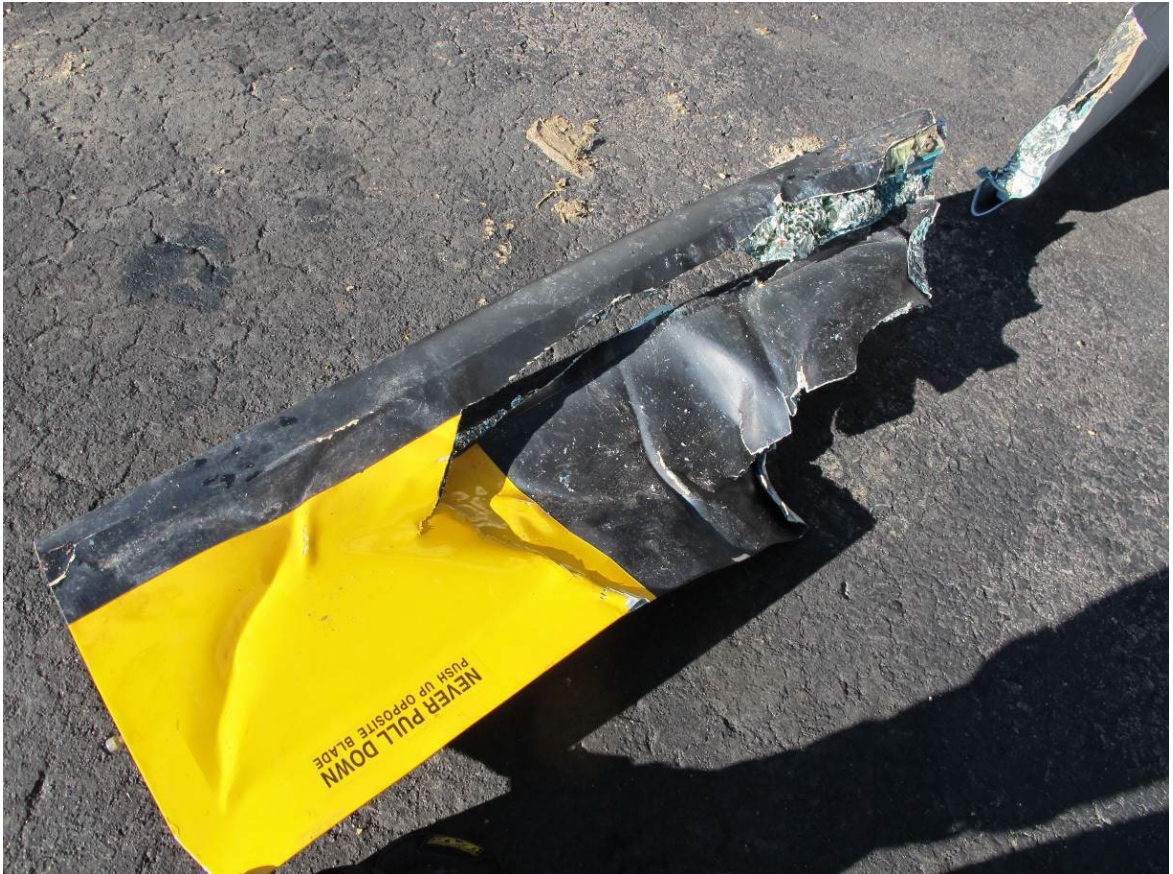
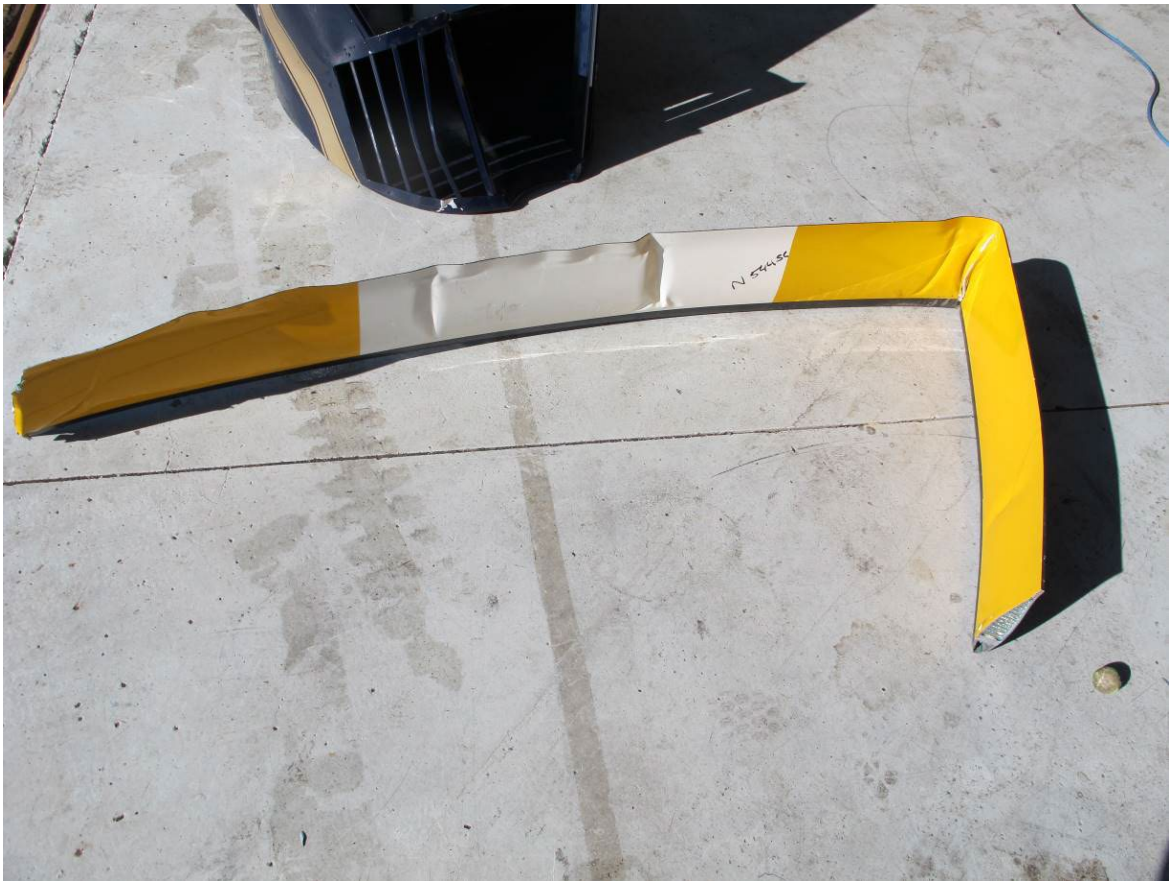
Above and below: Tip section of main rotor blade serial number 12234.

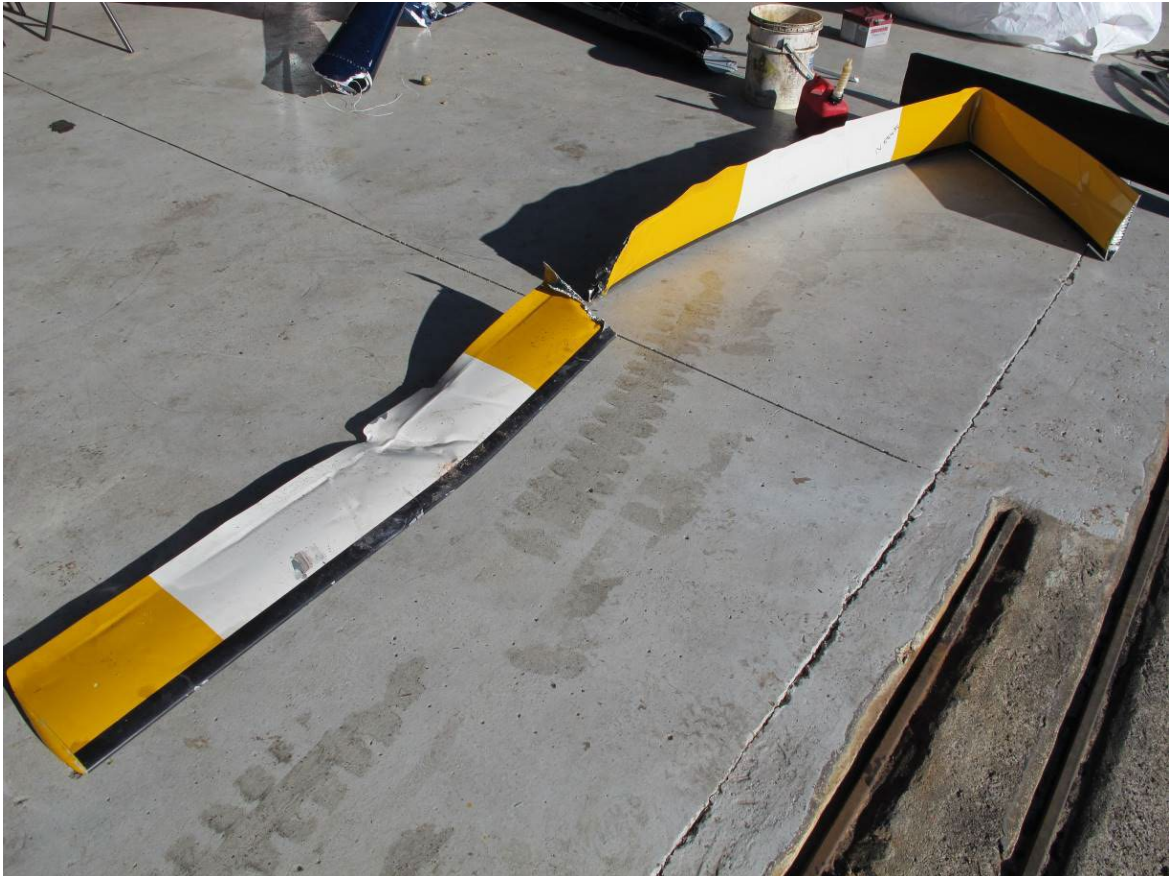
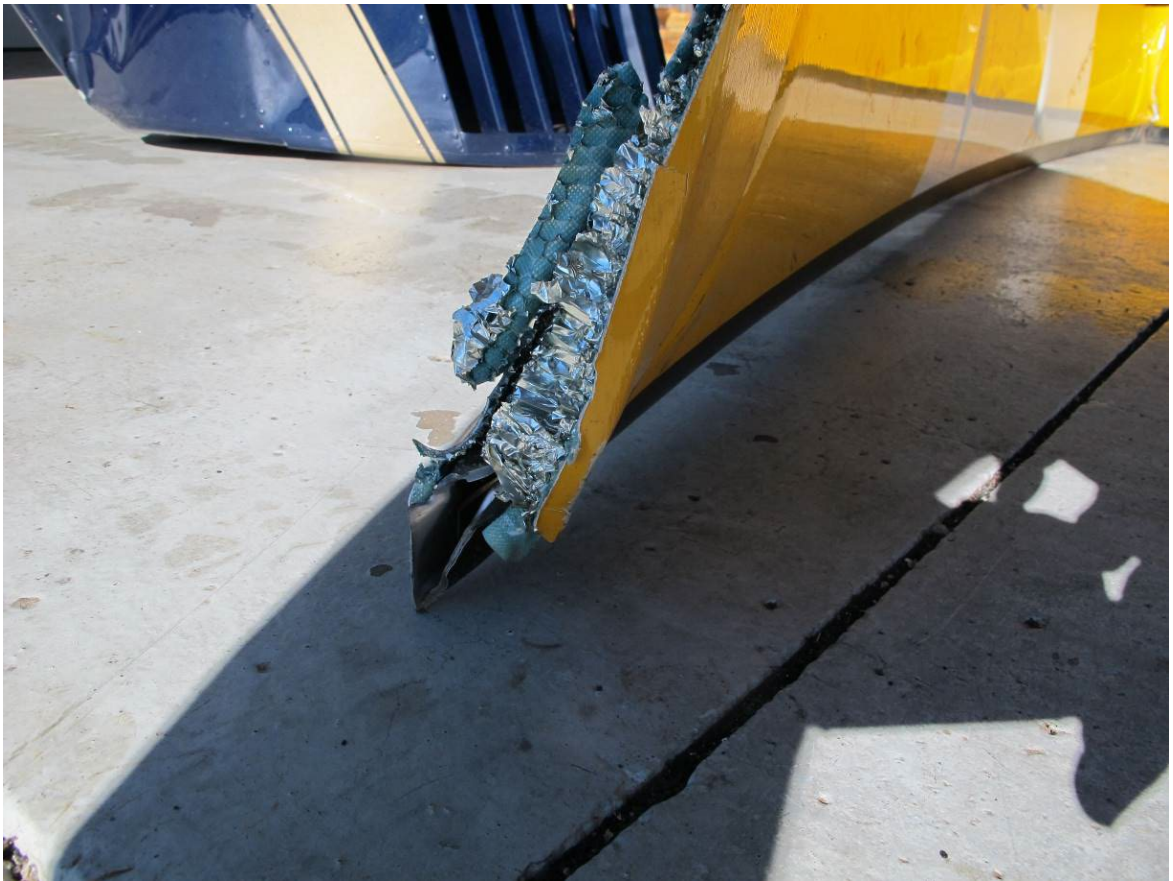
Above and below: Main rotor blade serial number 12227.

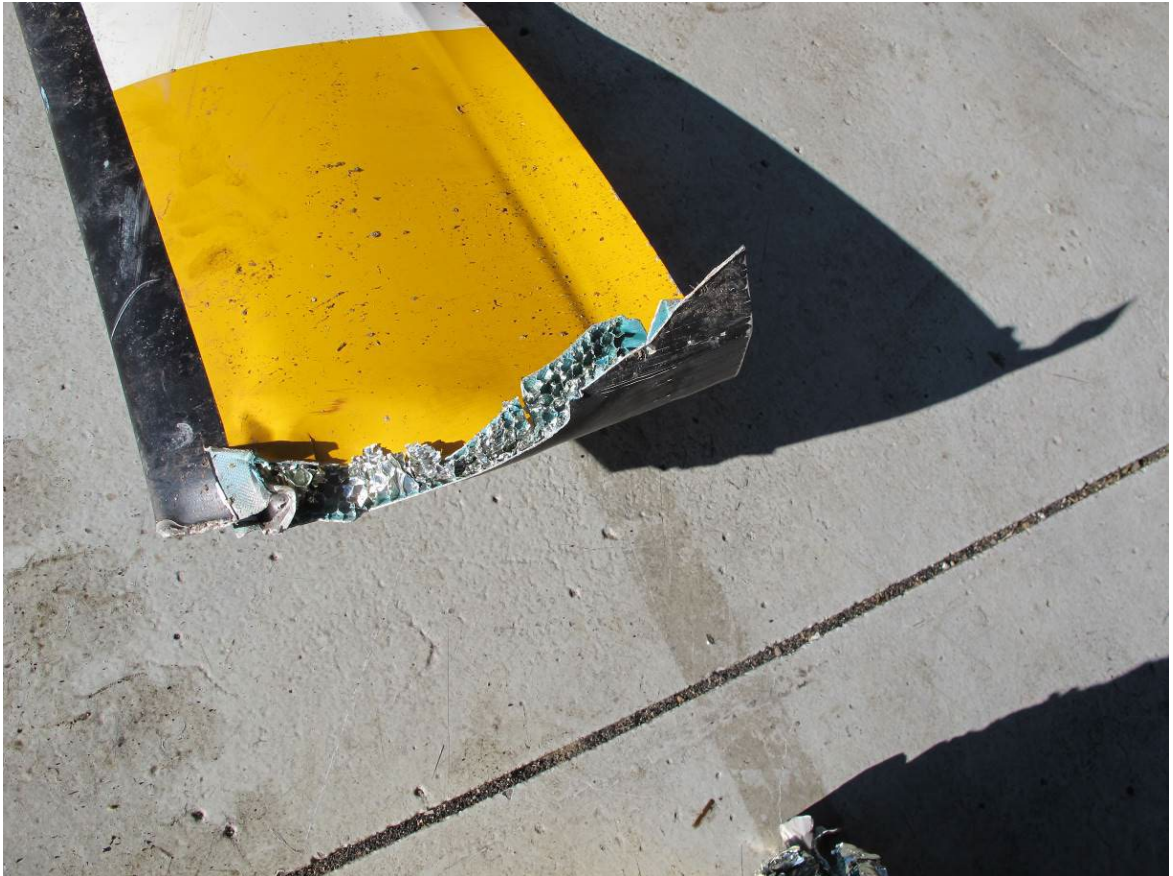
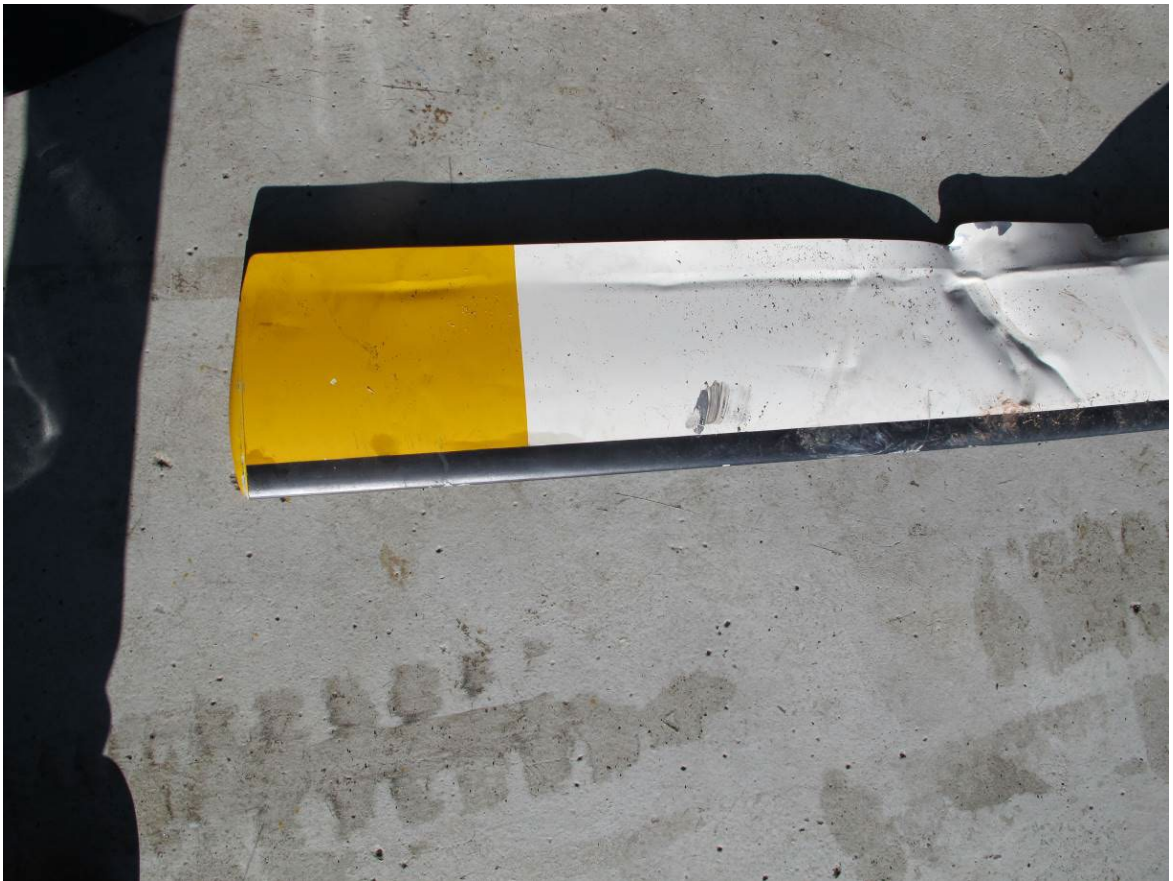
Above and below: Disconnect surfaces of main rotor blade serial number 12227.

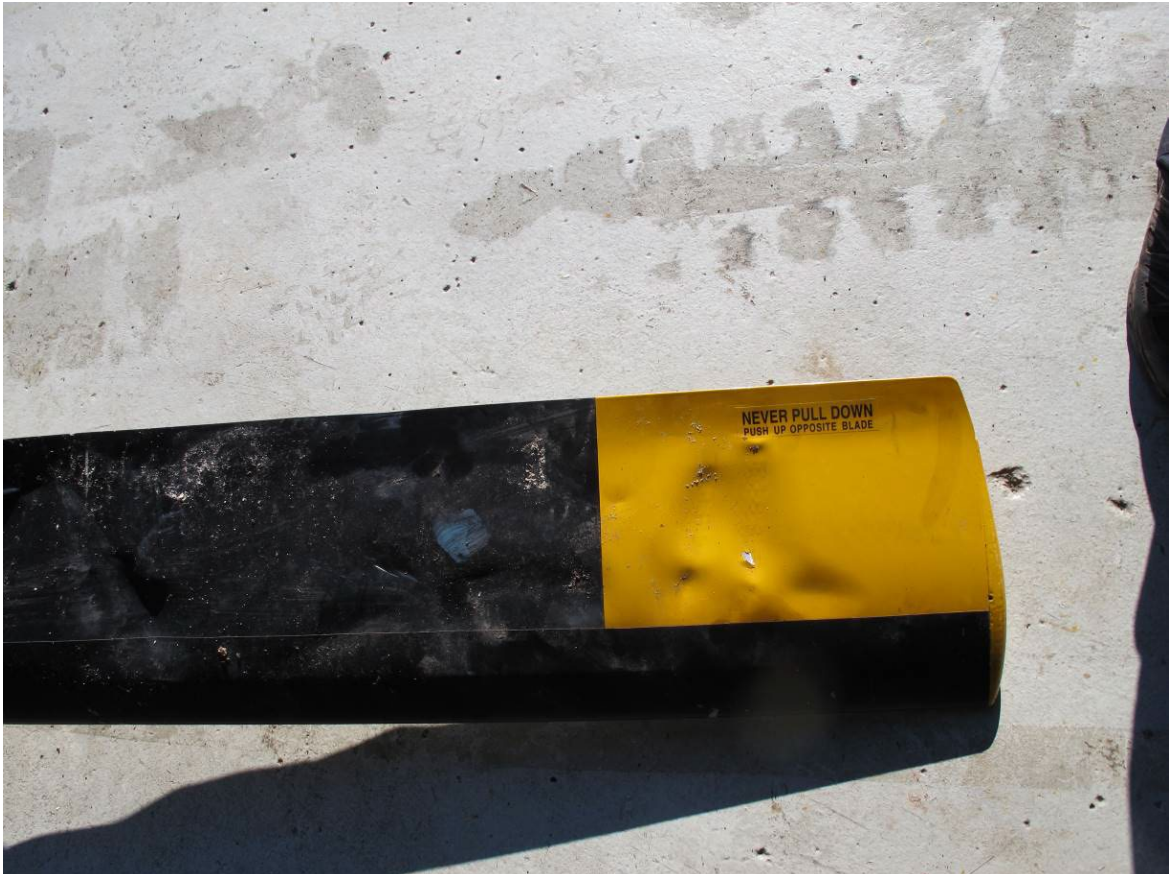
Above and below: Tip section of main rotor blade serial number 12227.

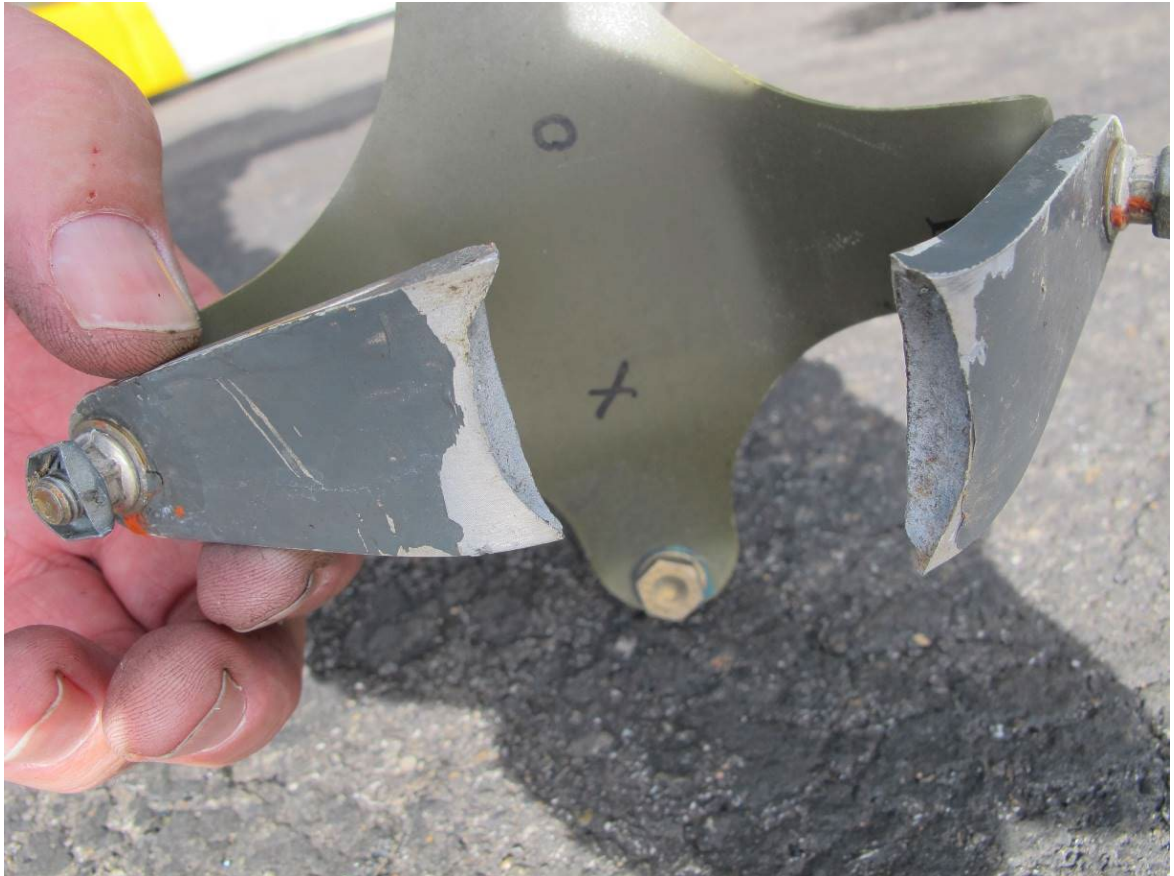
Above and below: Disconnect in intermediate flex coupling.

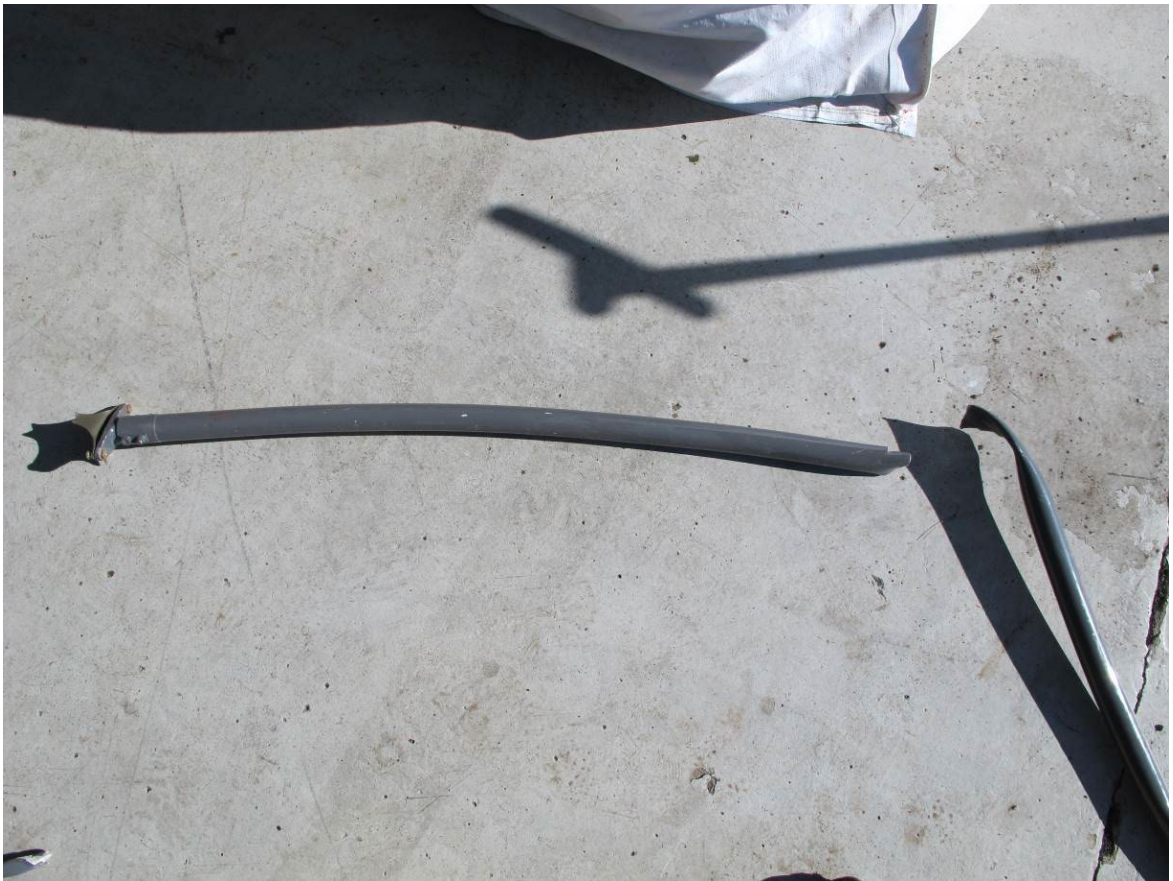
Tail rotor driveshaft damper bearing and hanger support.

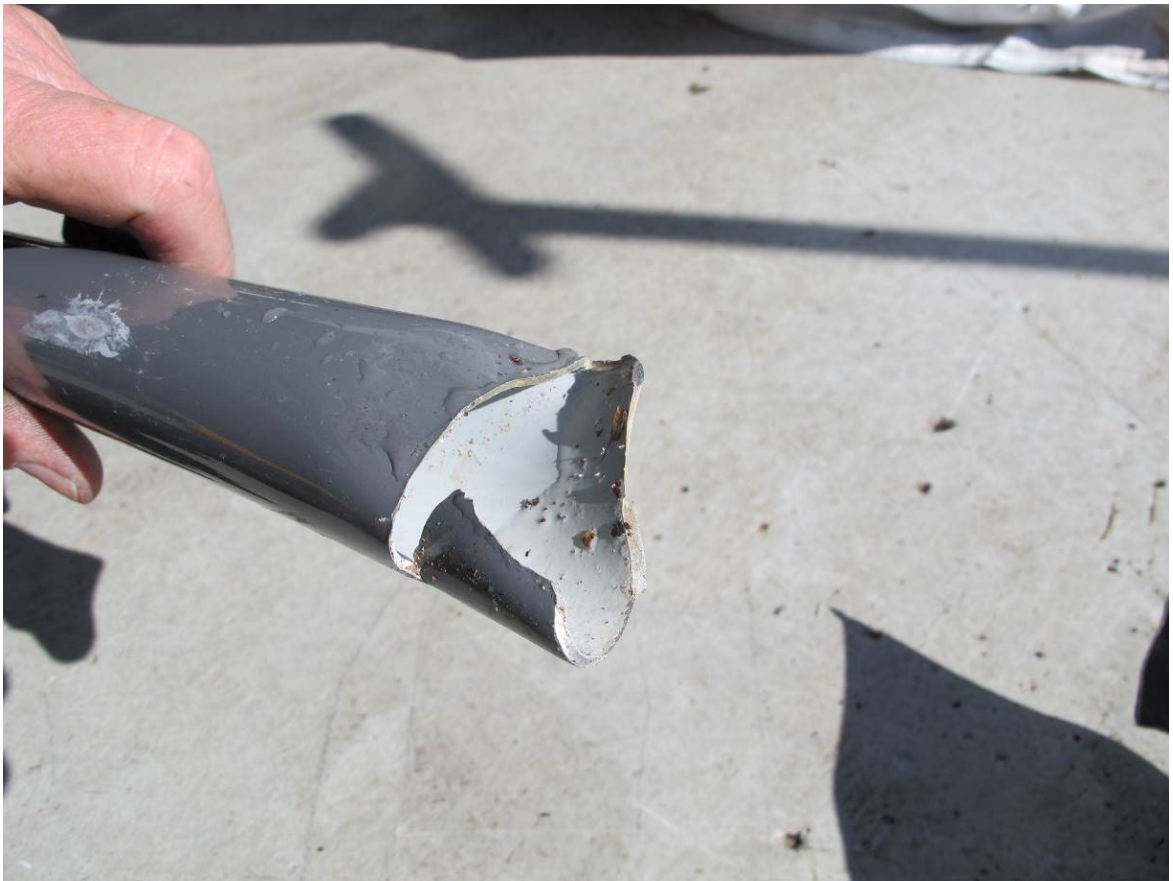
Disconnect surface on forward section of tail rotor driveshaft.

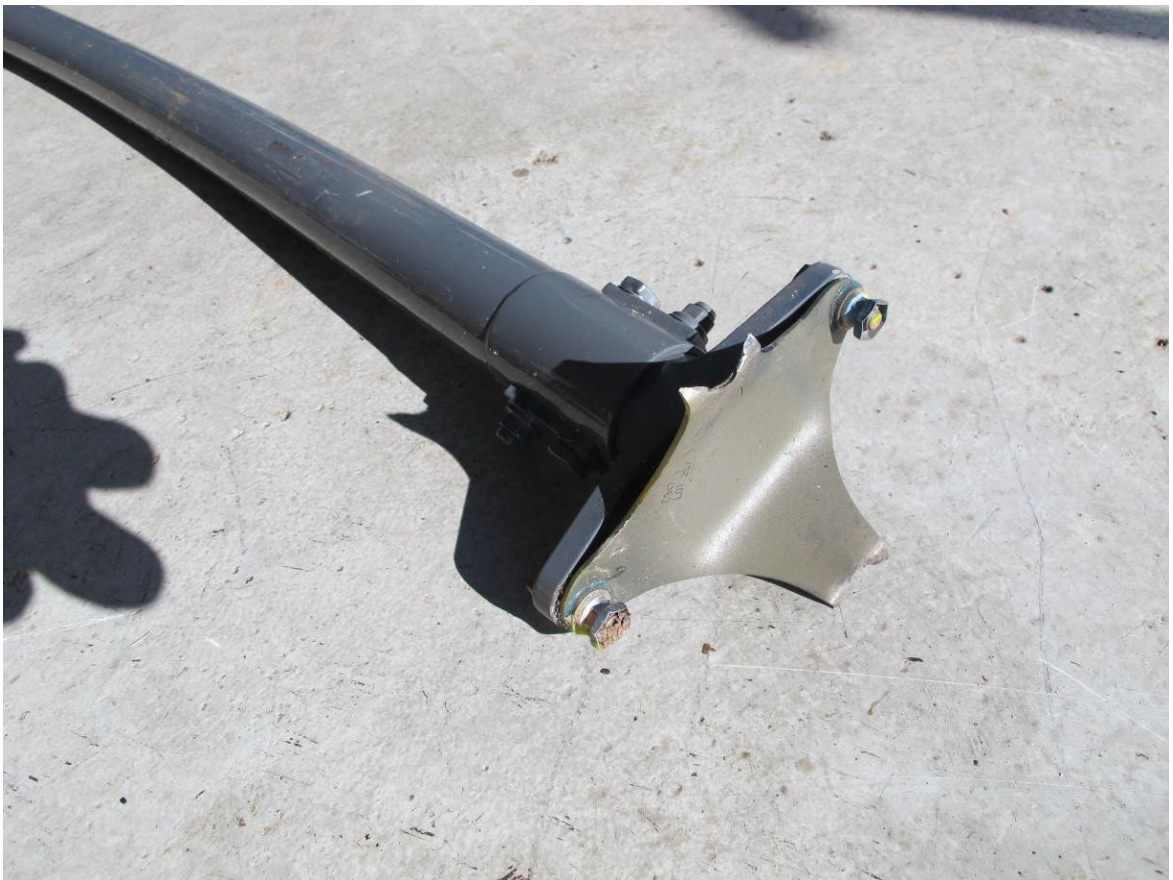
Disconnect surface on aft section of tail rotor driveshaft.
