## Robinson Helicopter Company Accident Report

| AIRCRAFT MODEL: | <u>R44 Raven II</u> |
| REGISTRATION: | <u>N544SC</u> |
| NTSB IDENTIFICATION: | <u>ERA22FA096</u> |

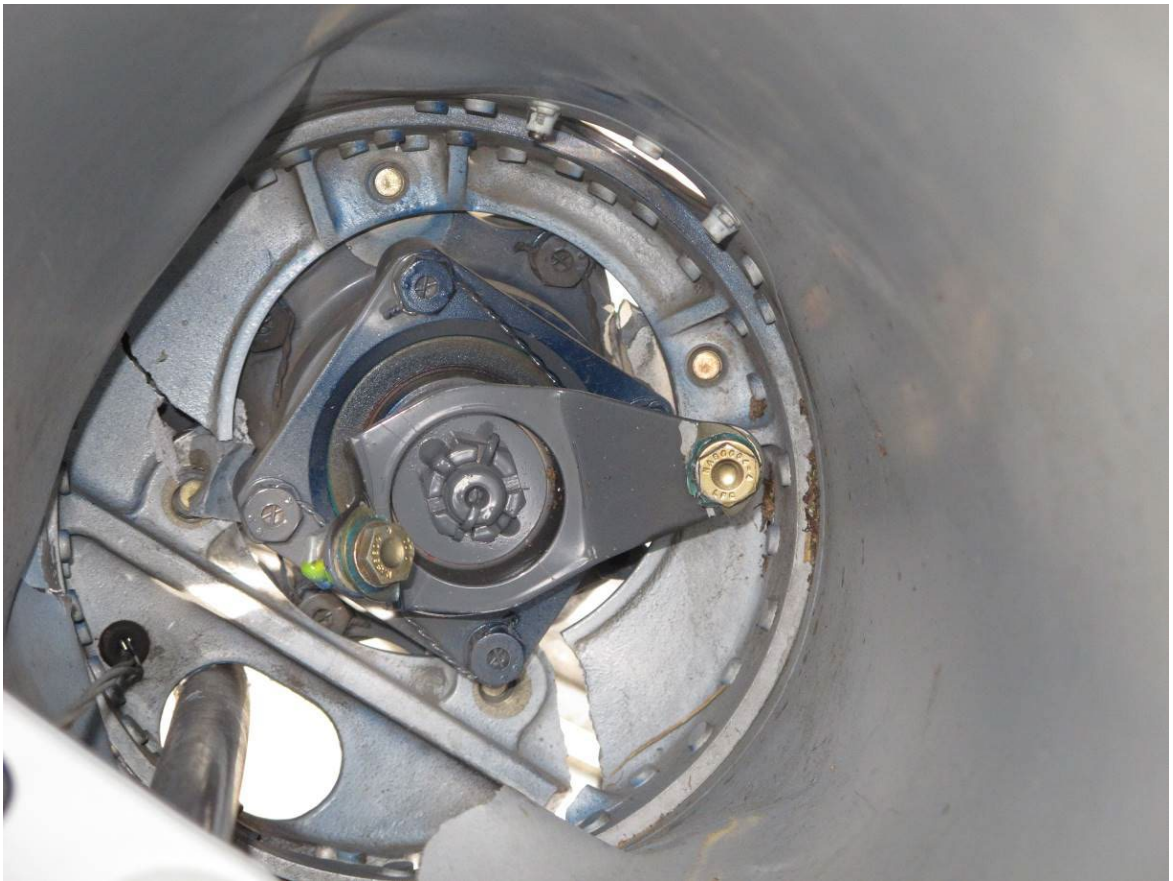
Aft flex coupling.

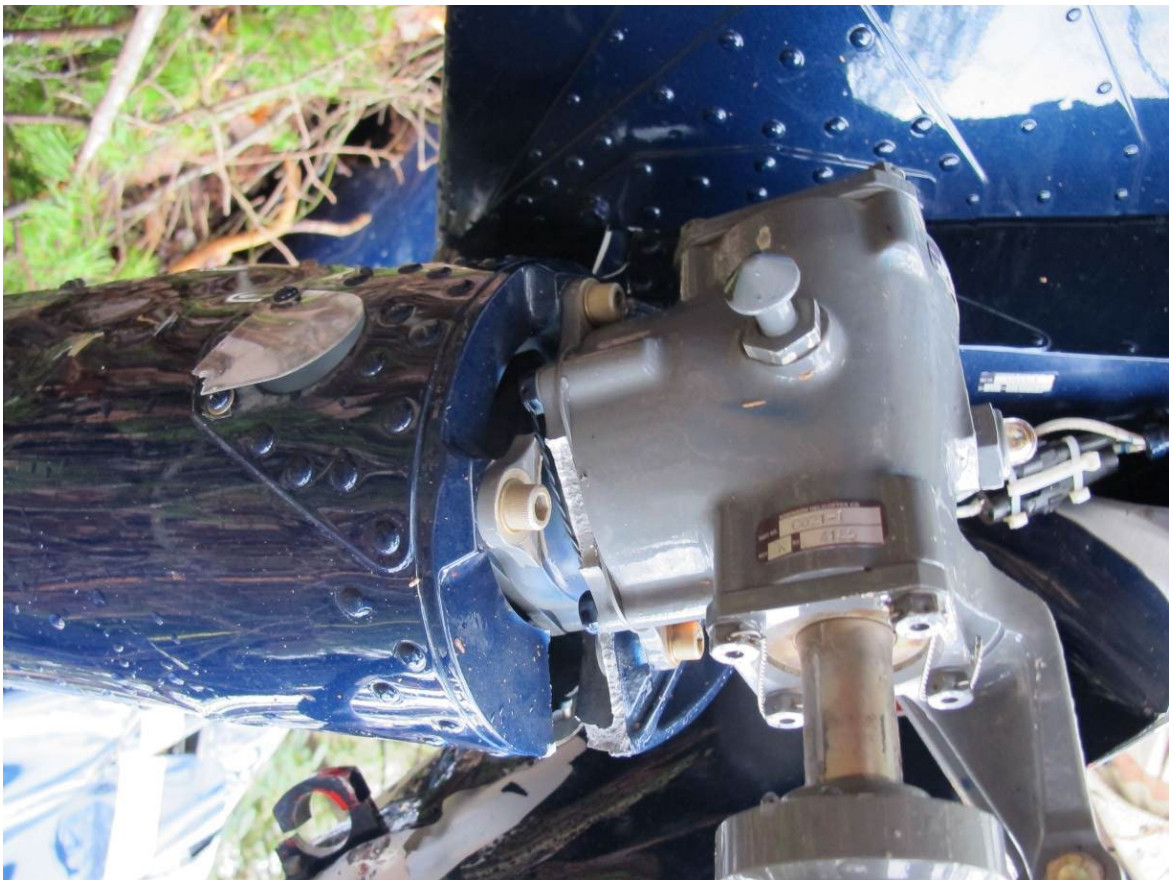
Tail rotor gearbox input yoke portion of aft flex coupling.

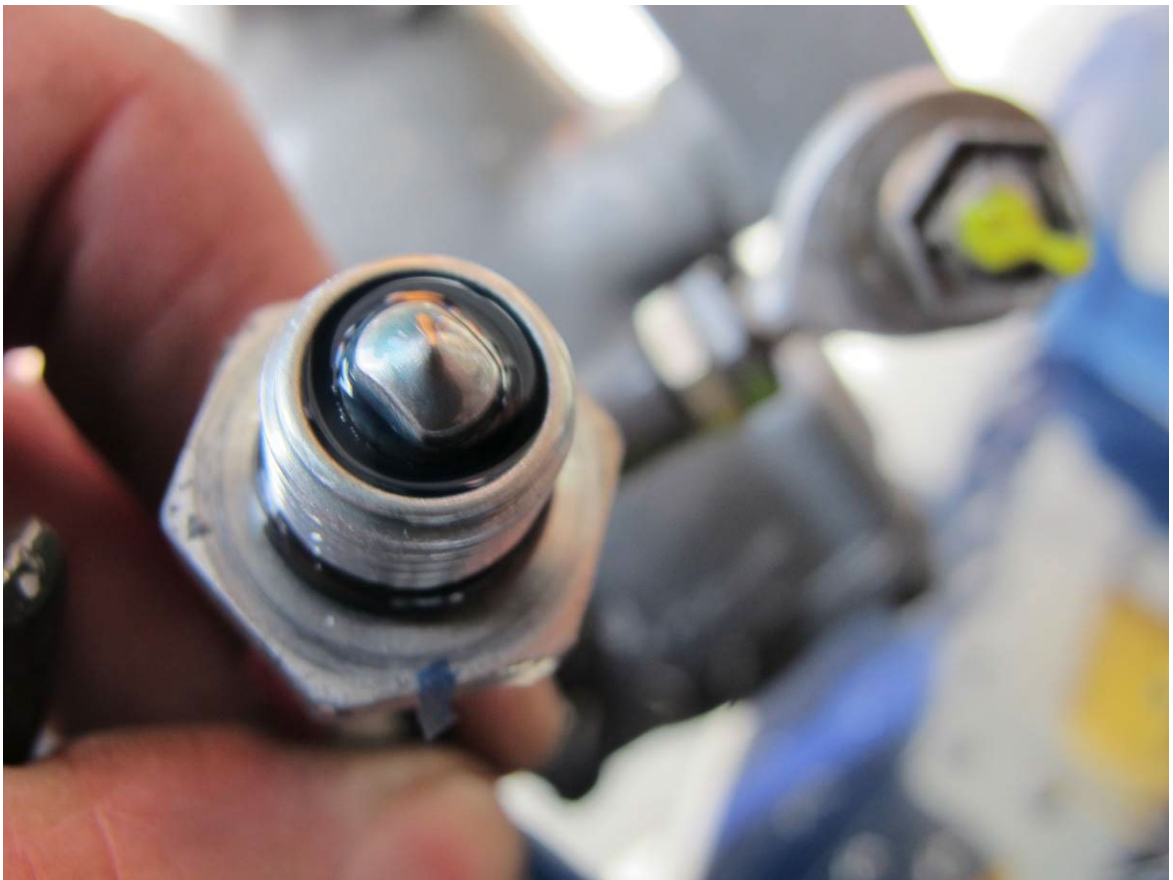
Tail rotor gearbox temperature sensor.

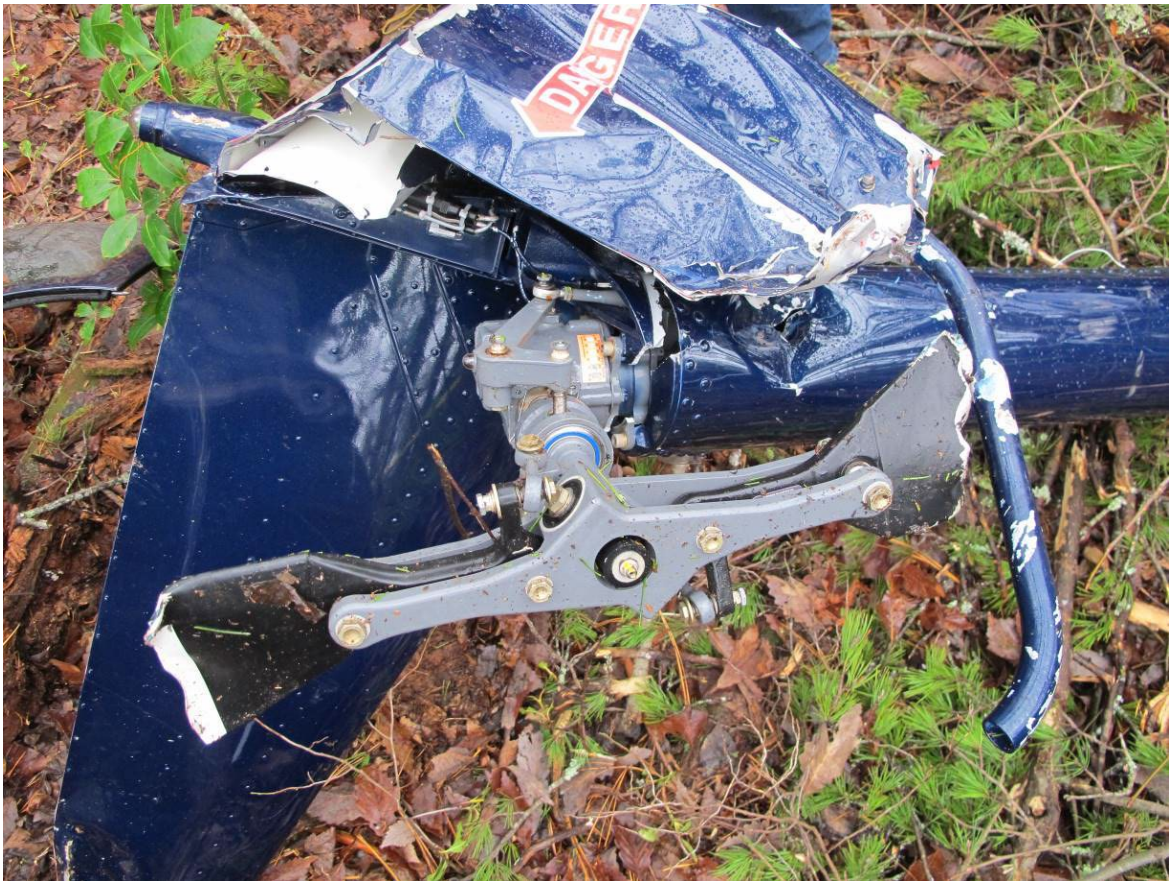
Tail rotor gearbox chip detector.

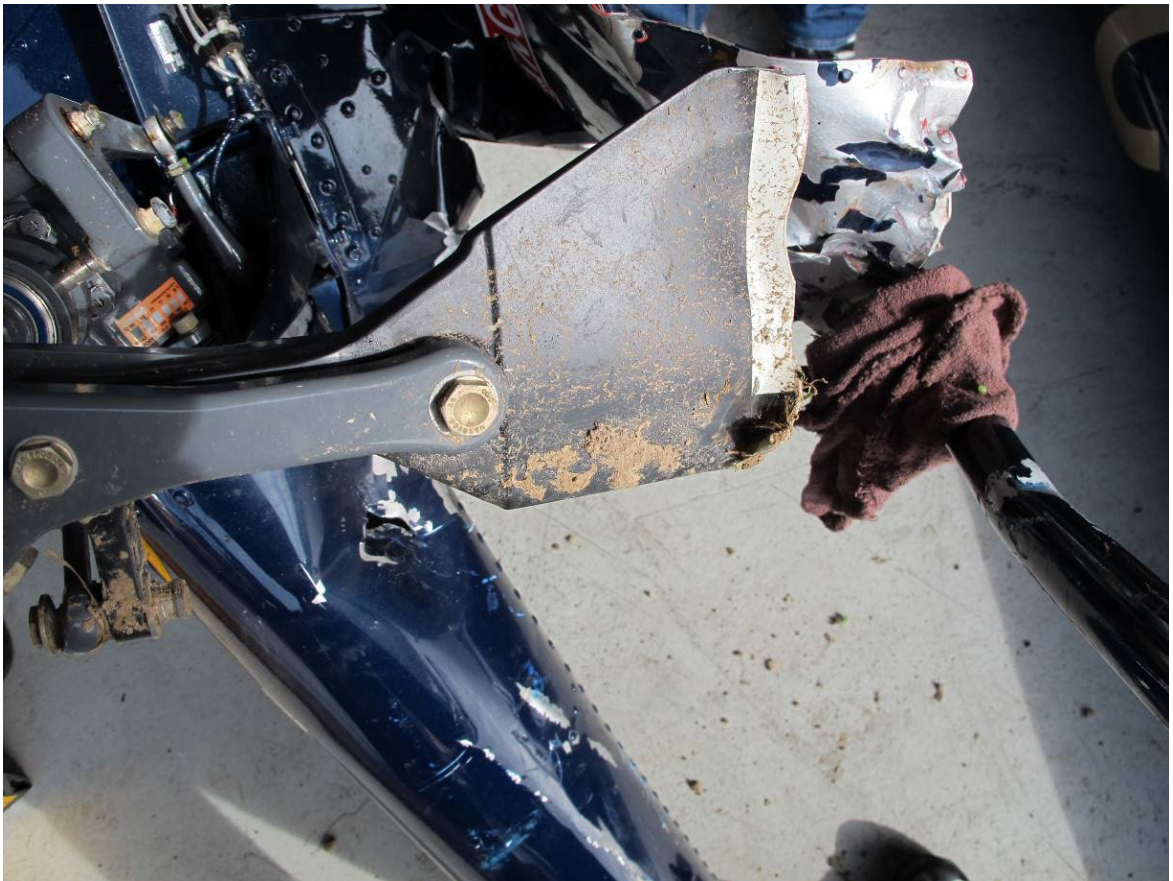
Tail rotor blades.

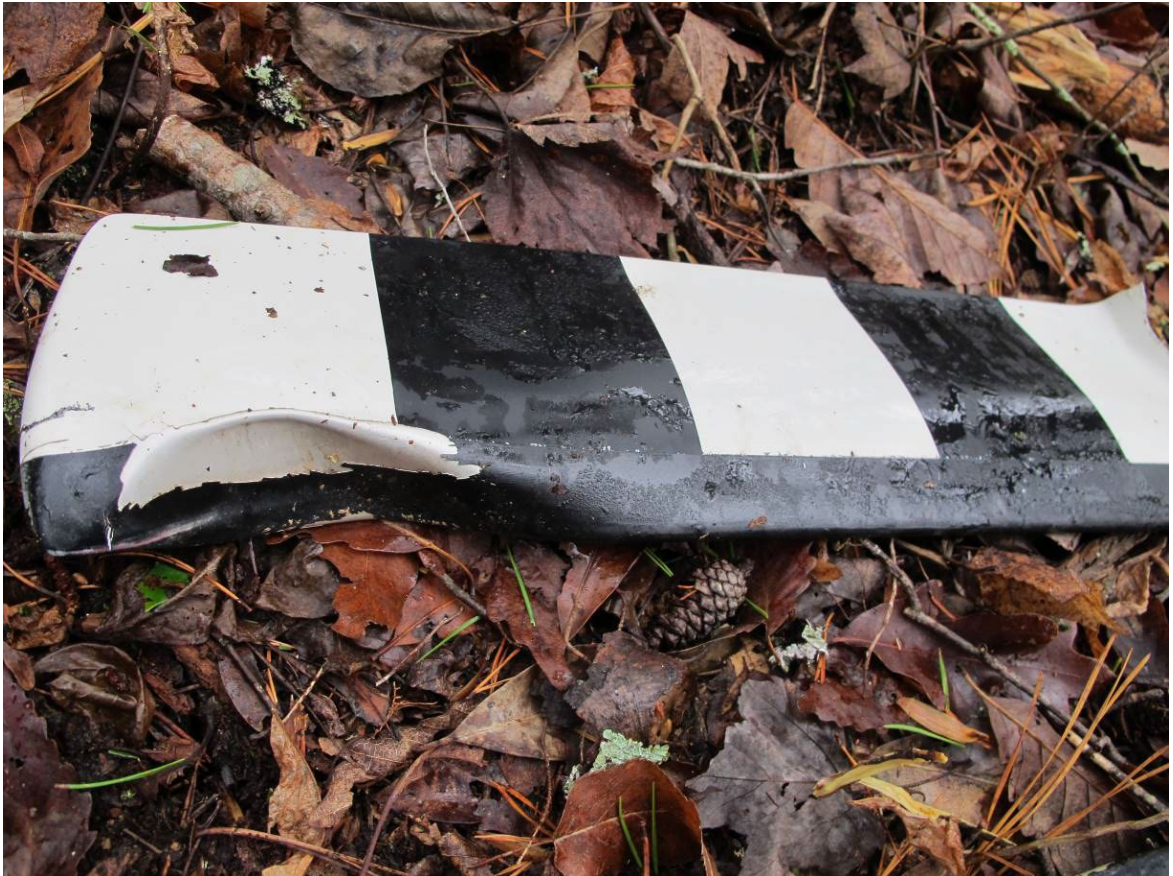
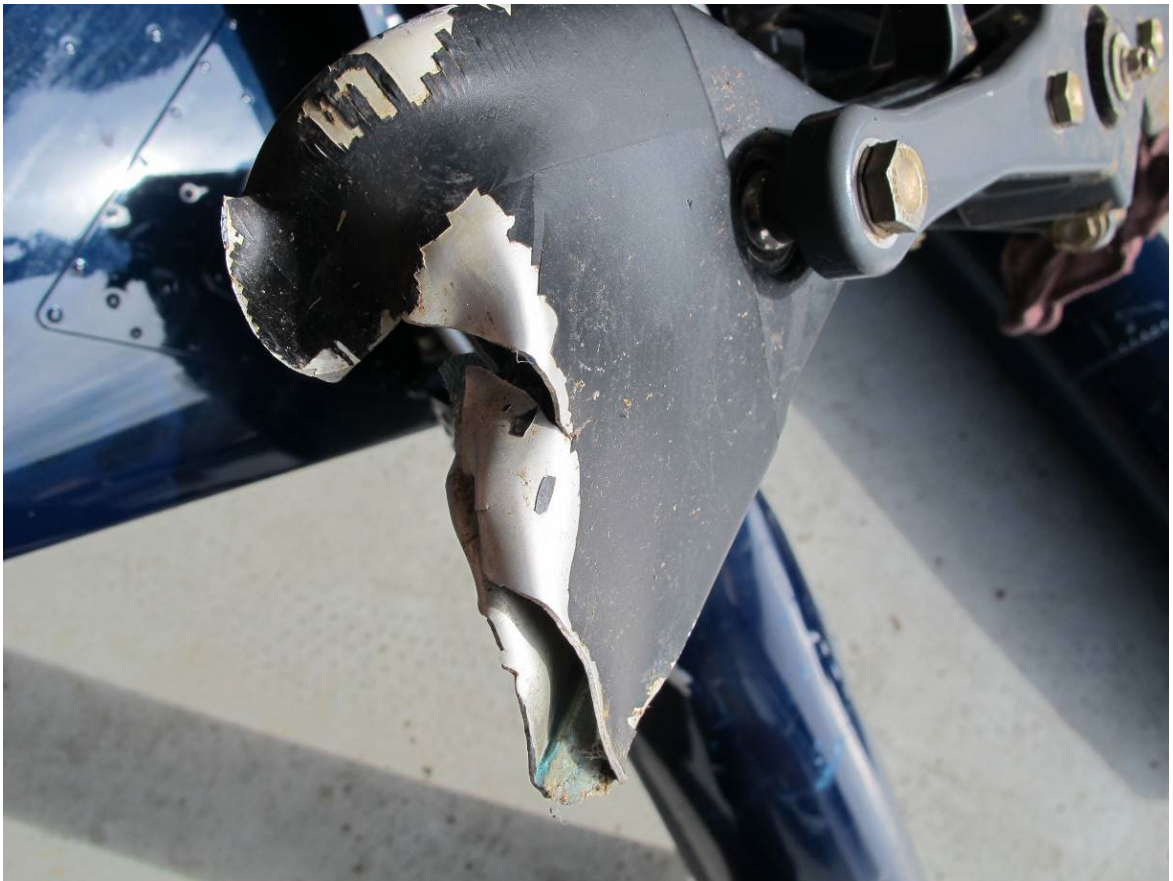
Above and below: Tail rotor blade serial number 10548.

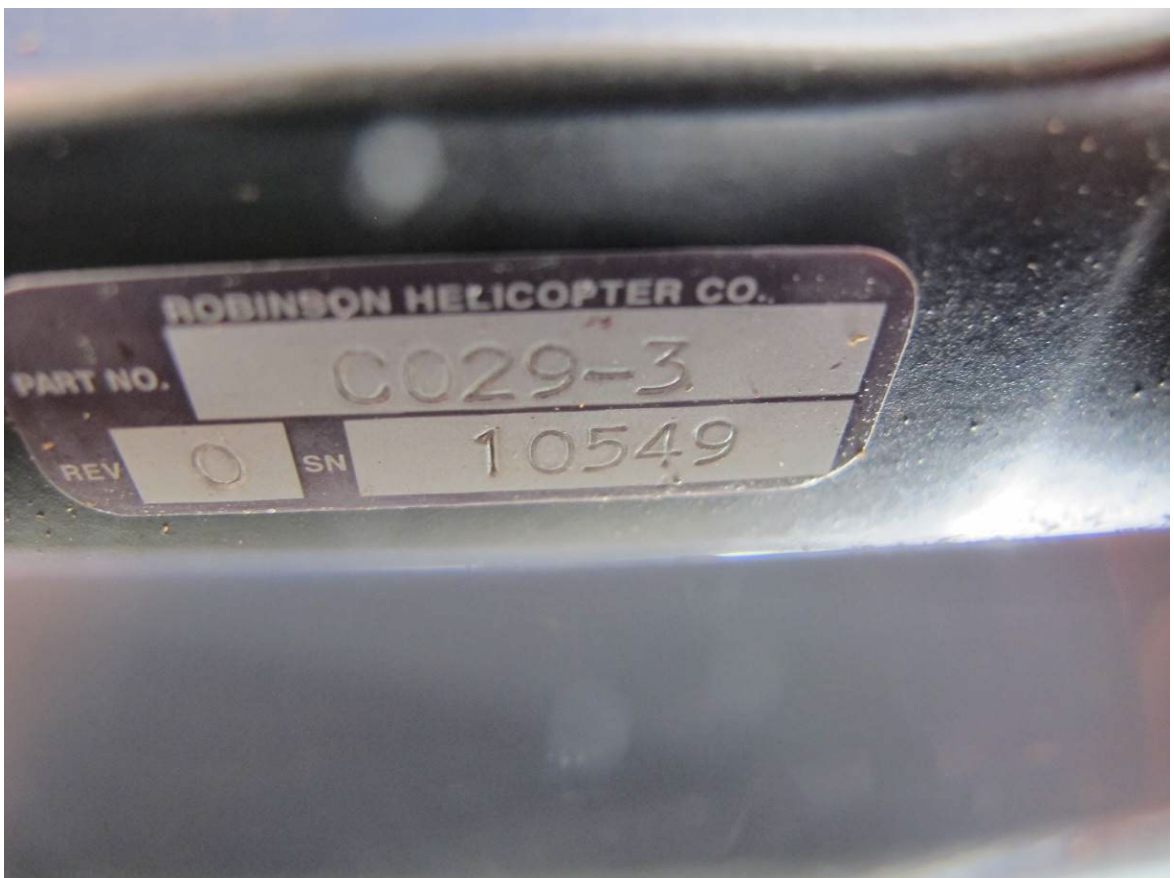
Above and below: Tail rotor blade data plates.

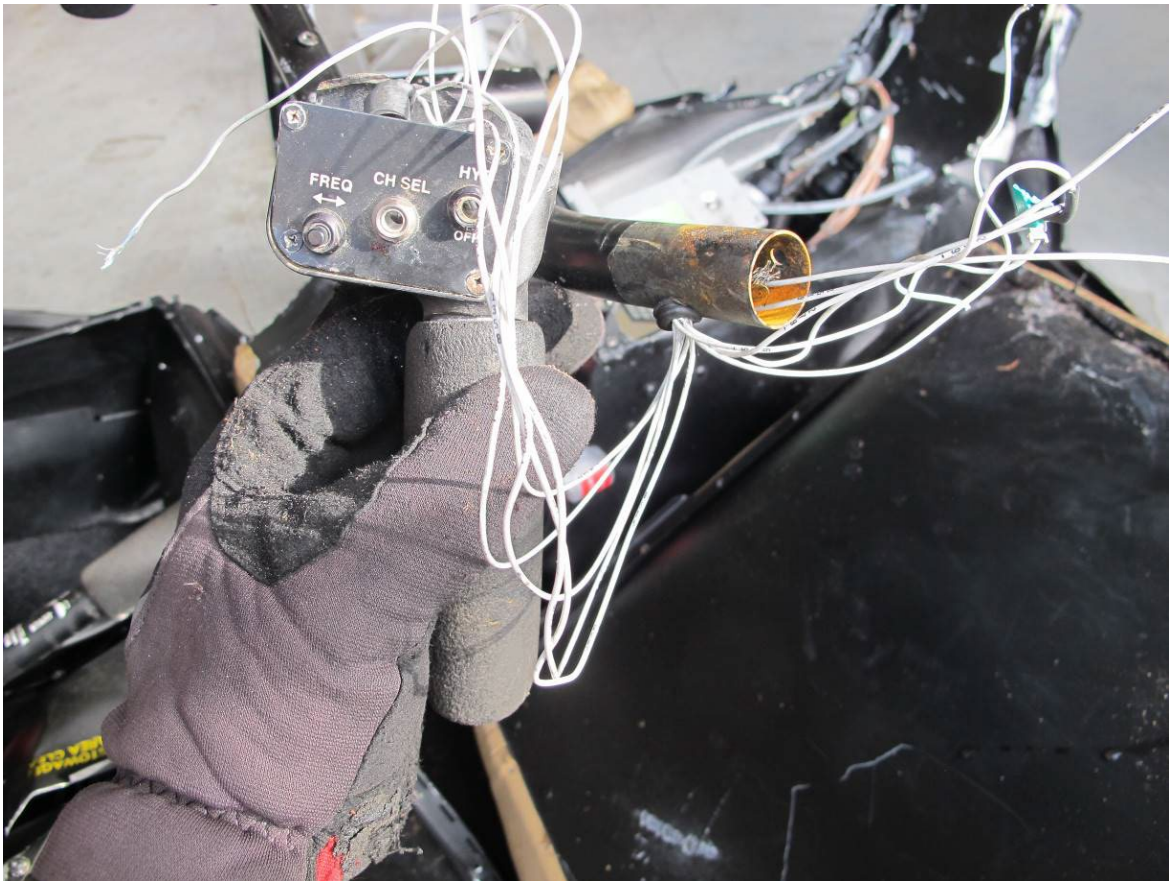
Above and below: Disconnect A in pilot's cyclic grip.

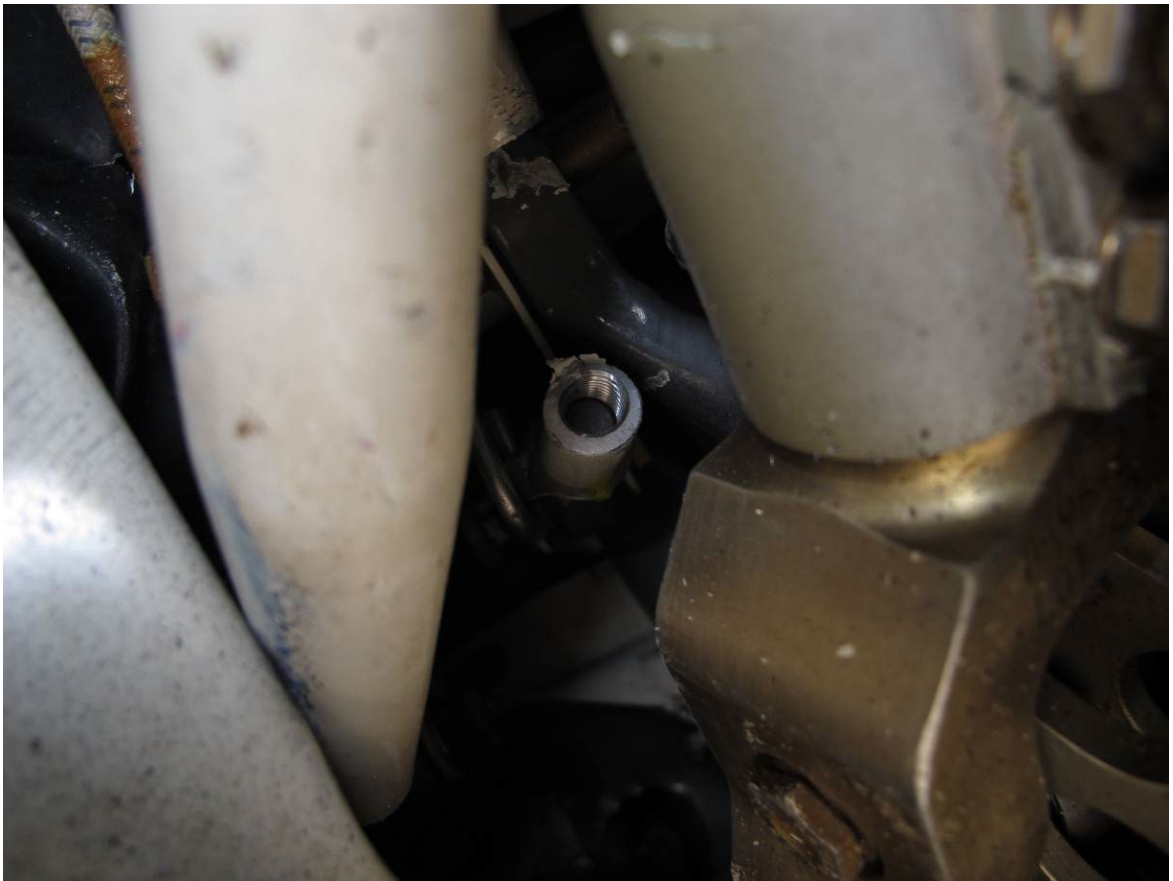
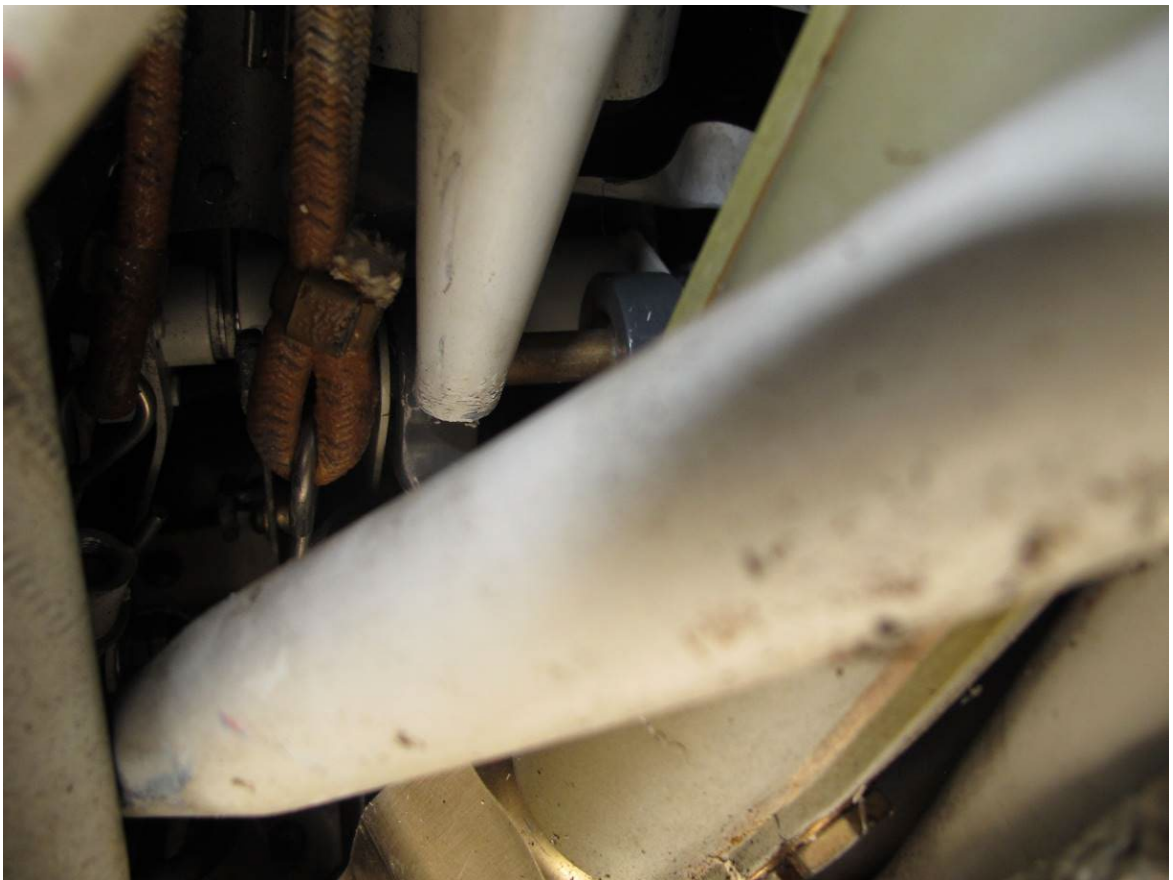
Disconnect B at aft end of C121-19 push pull tube.

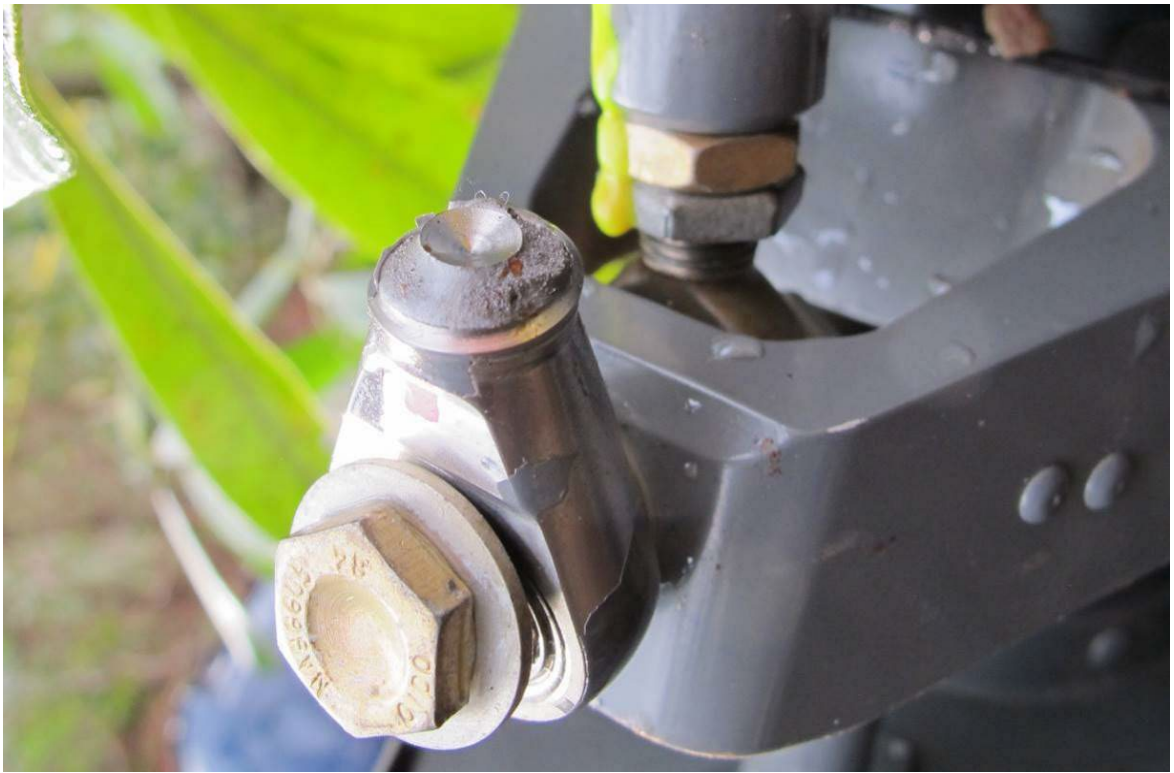
The flight control system had discontinuities at the locations indicated on the diagrams on pages 12.2 and 12.8. The disconnects are shown individually in the photographs that follow. No evidence of pre-impact failures of the flight control system was found. The center section of pitch link between disconnects C and D was not recovered.

Disconnect C in lower rod end of C258-6 pitch link.

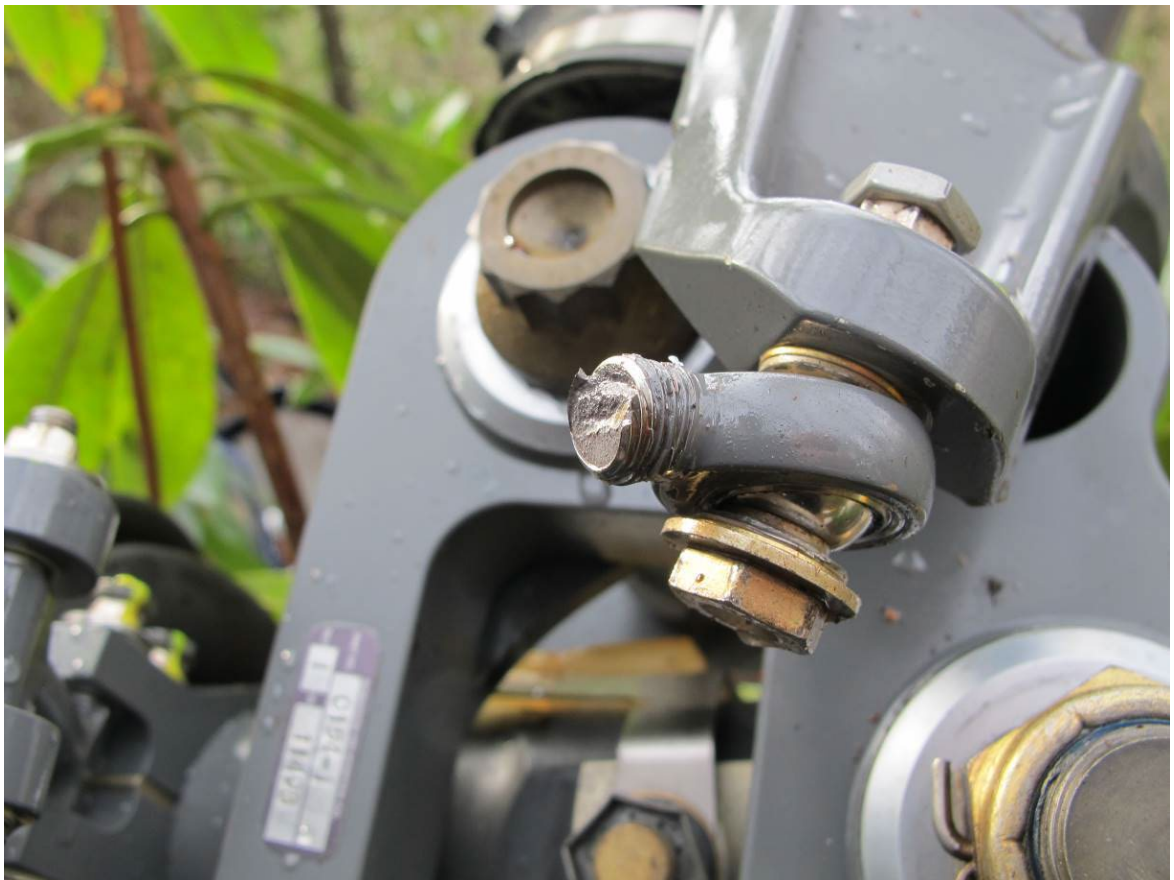
Disconnect D in upper rod end of C258-6 pitch link.

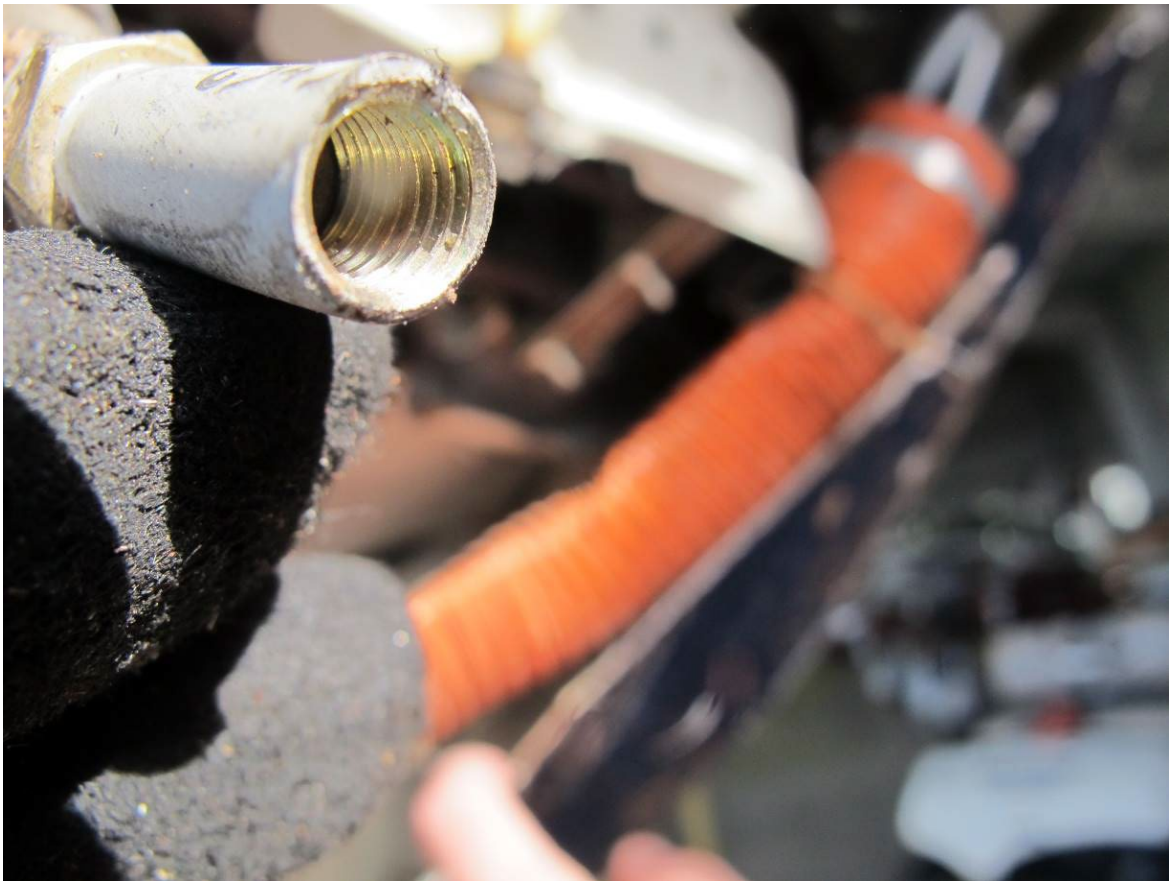
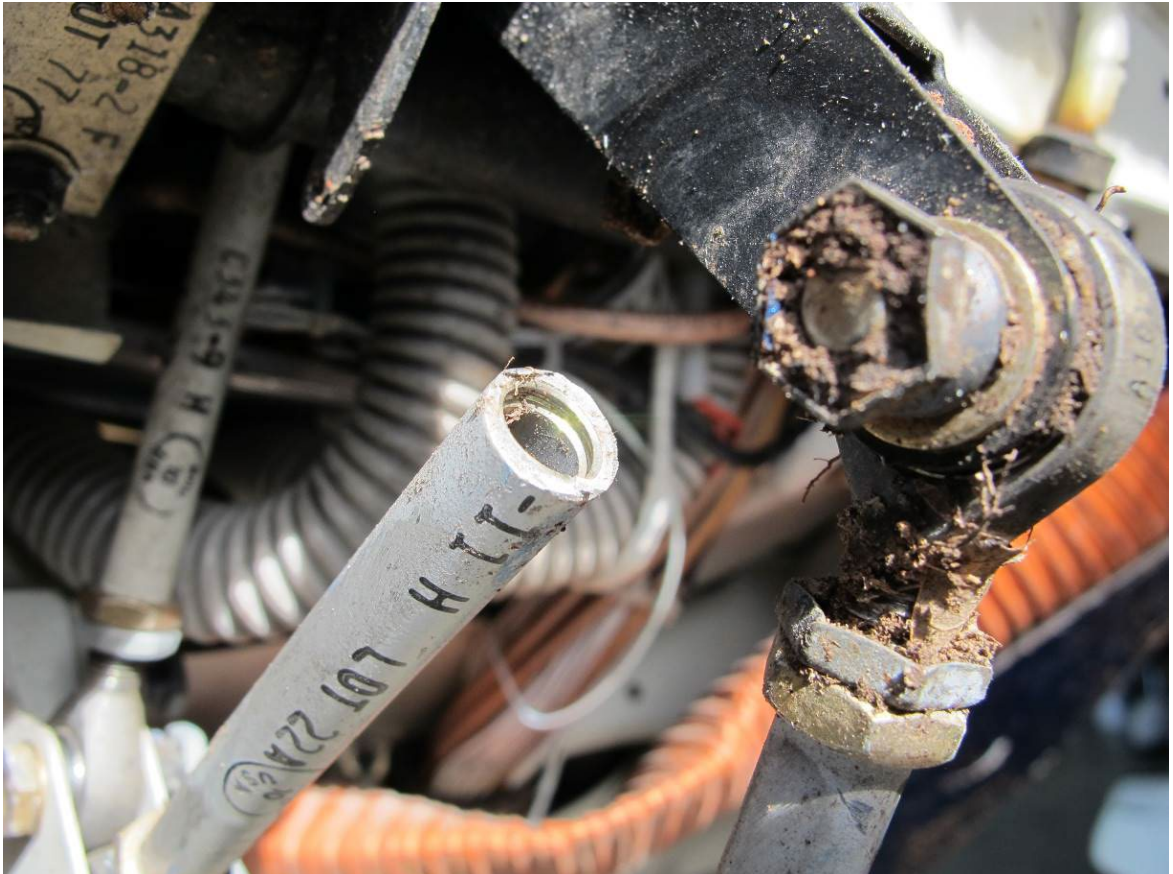
Above and below: Disconnect TA at forward end of C343-11 push pull tube.

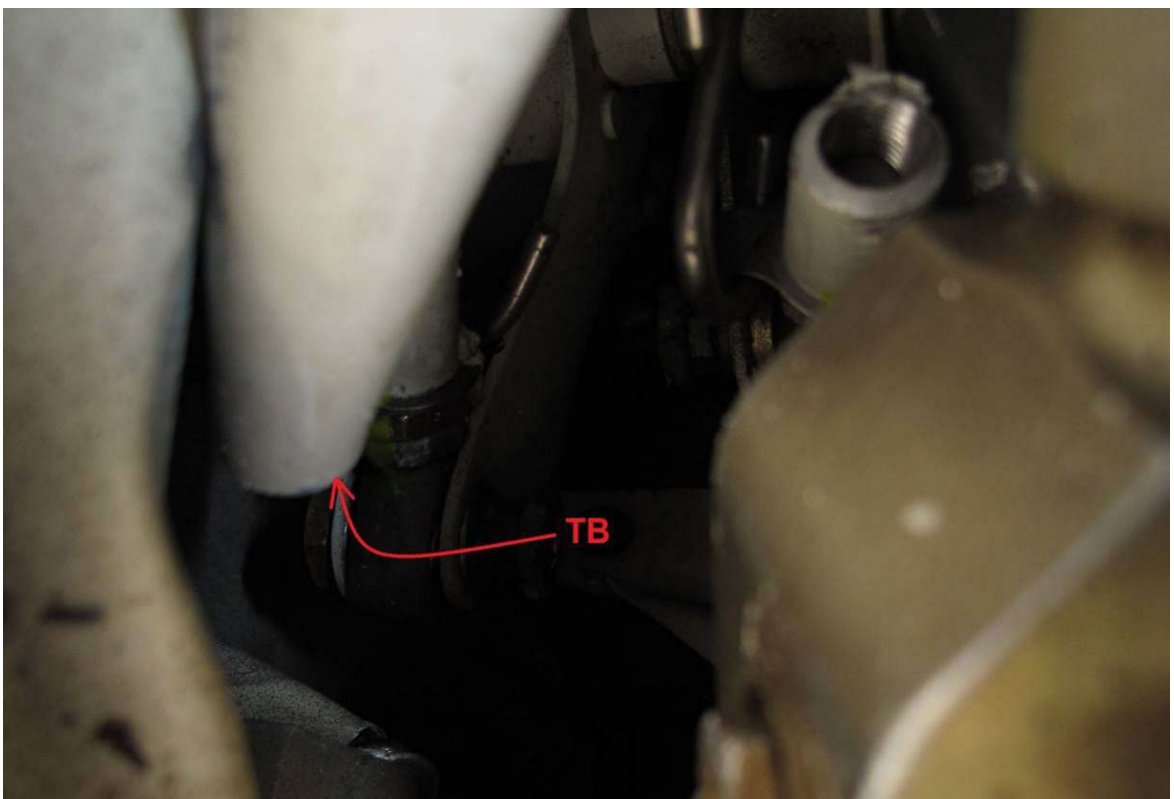
Above and below: Disconnect TB at aft end of C121-9 push pull tube.

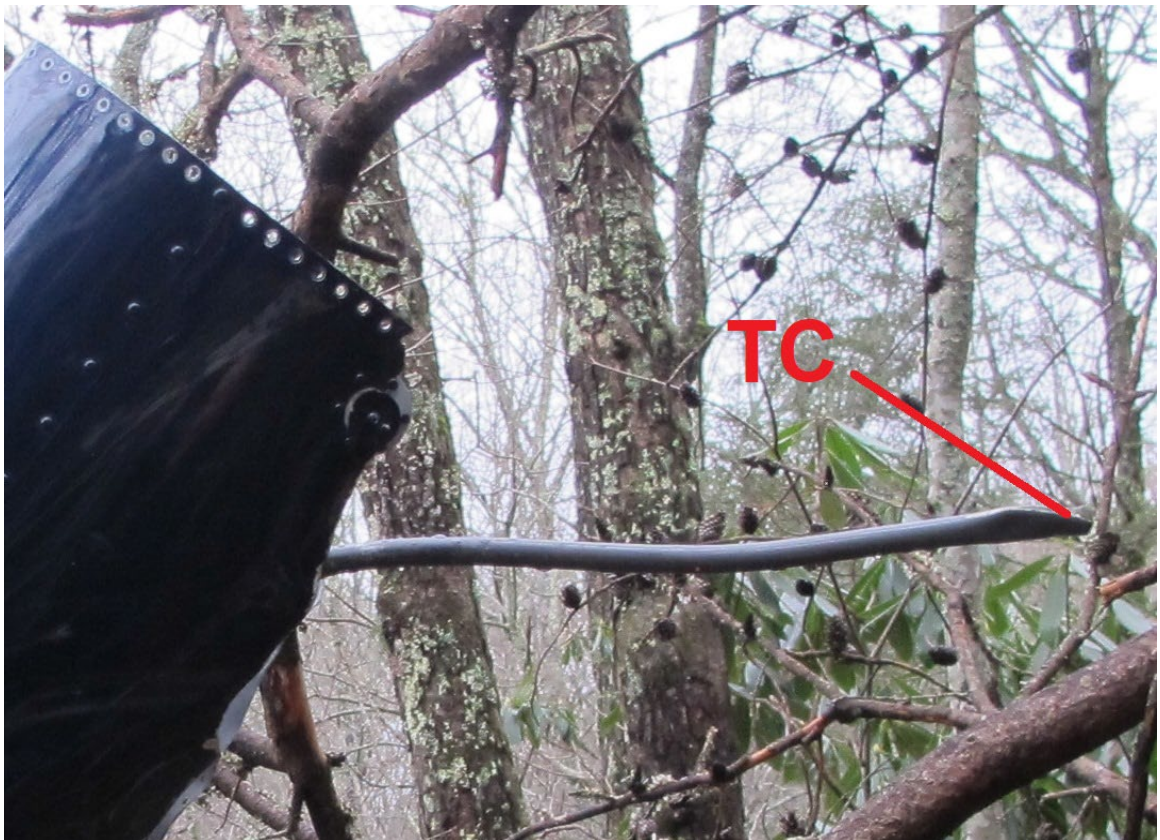
Disconnect TC in forward section of C121-17 push pull tube.

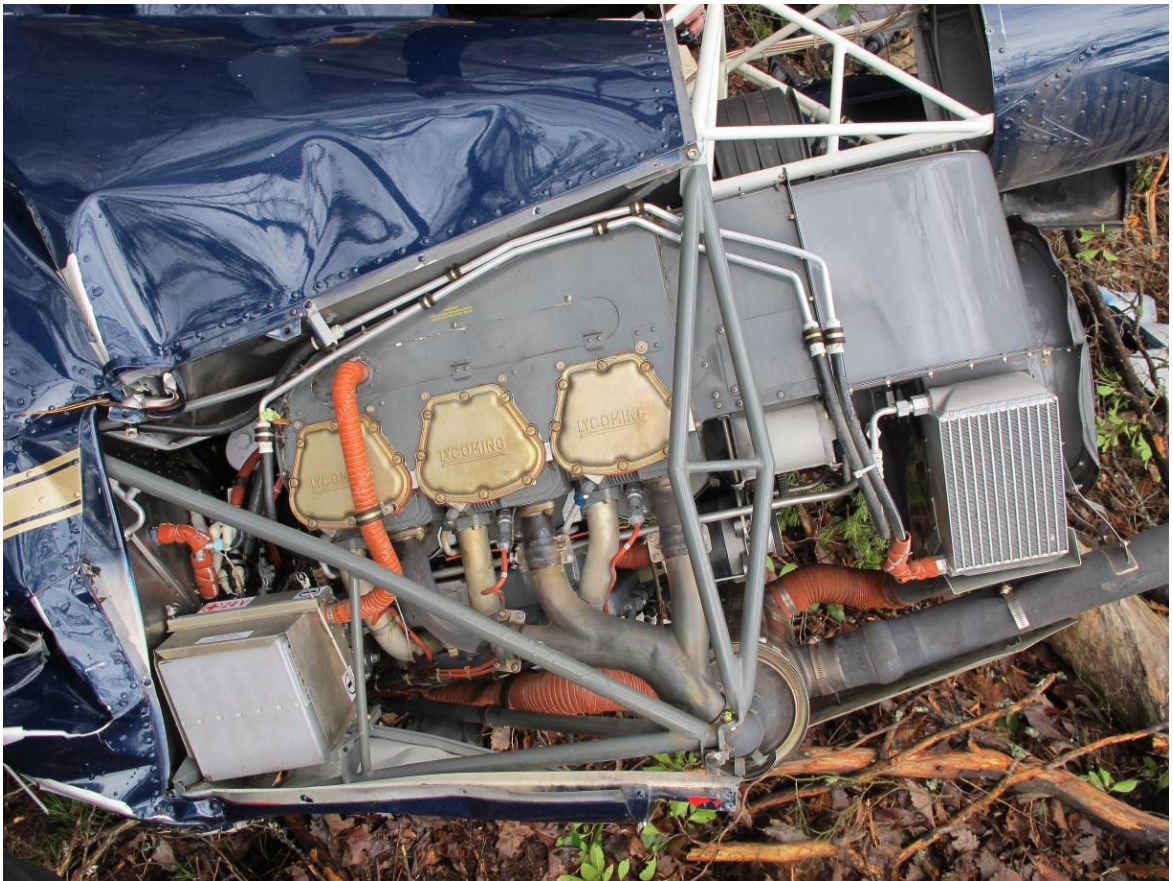
The lower frames were bent slightly.

Lower left frame.

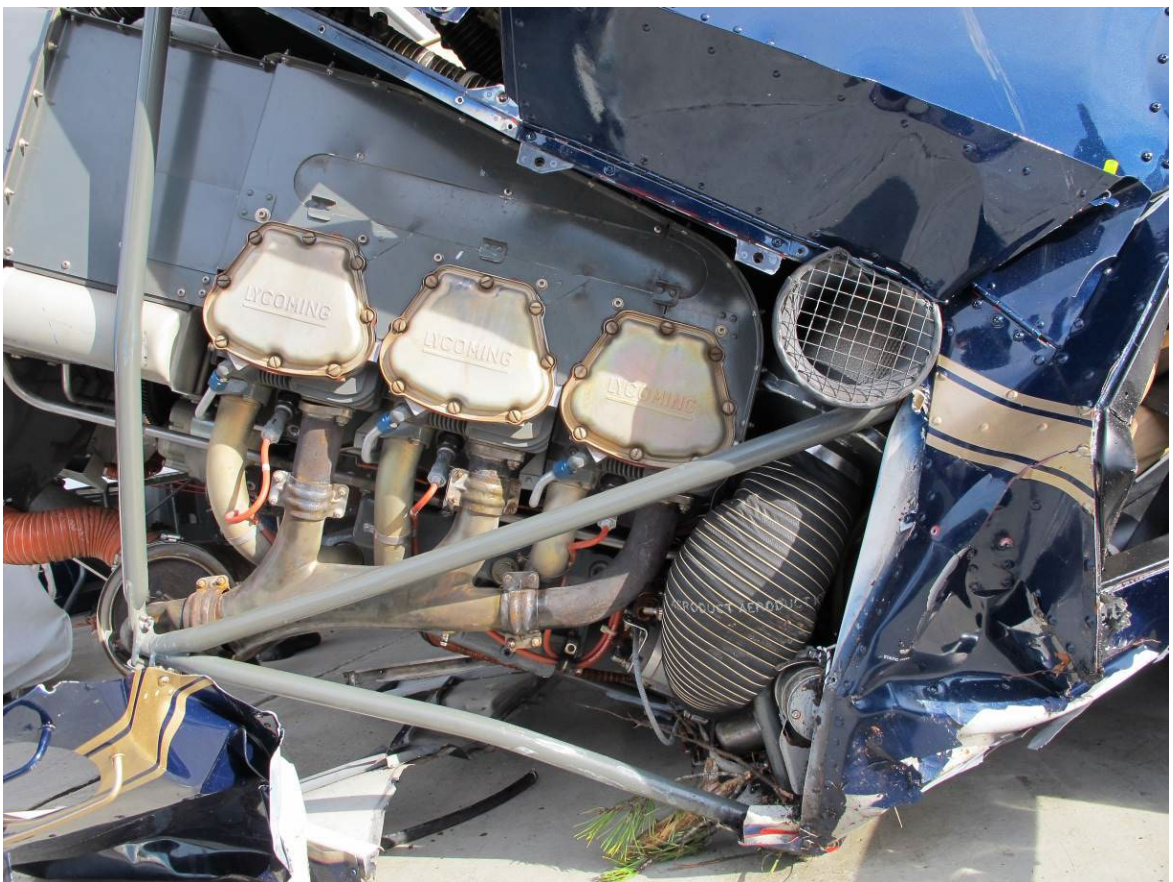
Lower right frame.

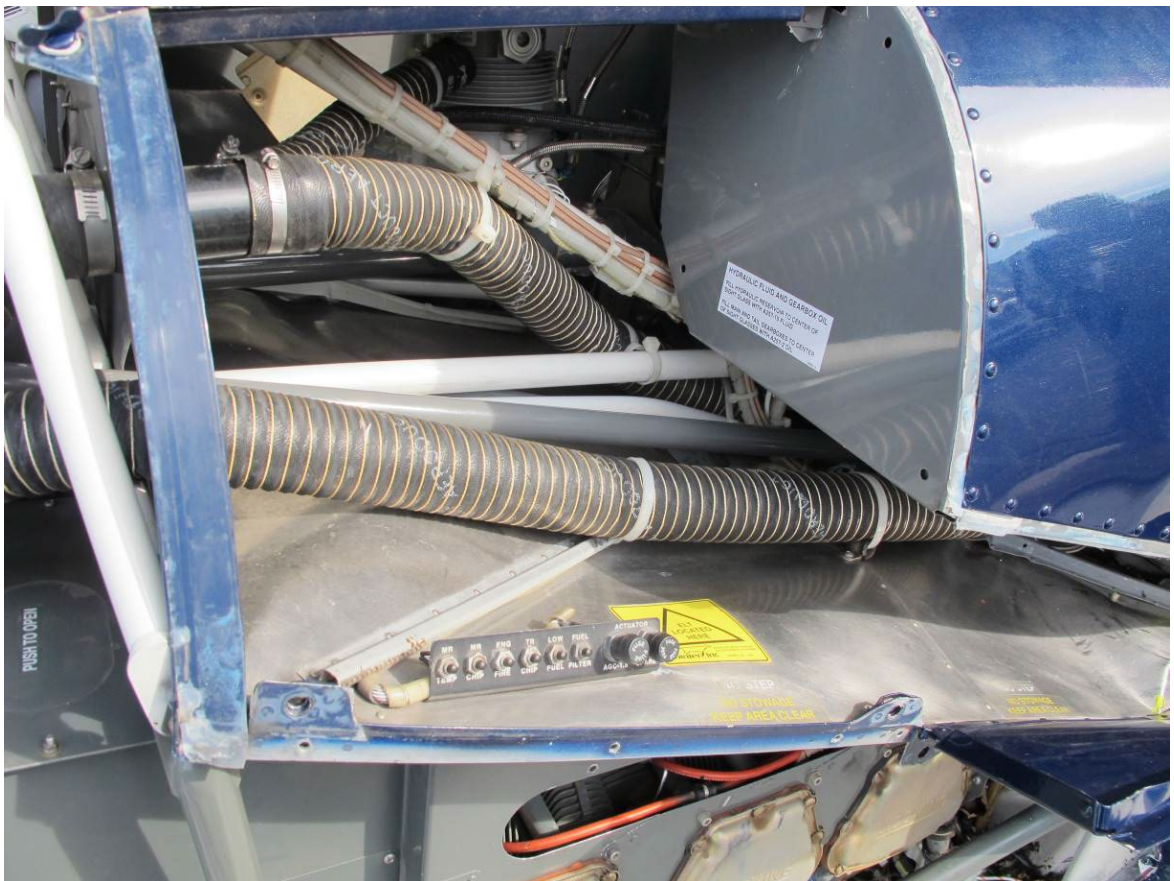
The horizontal and vertical firewalls were distorted and wrinkled.

Above and below: Horizontal firewall.

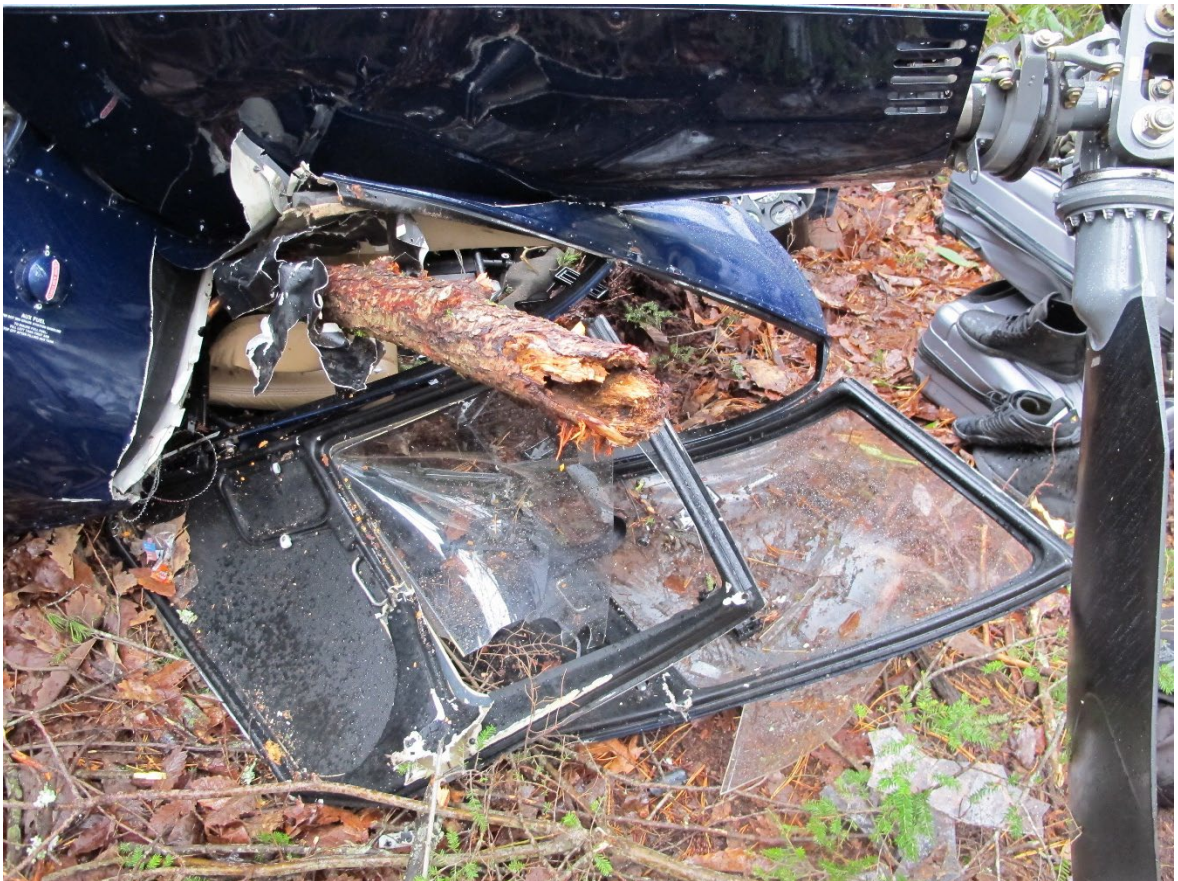
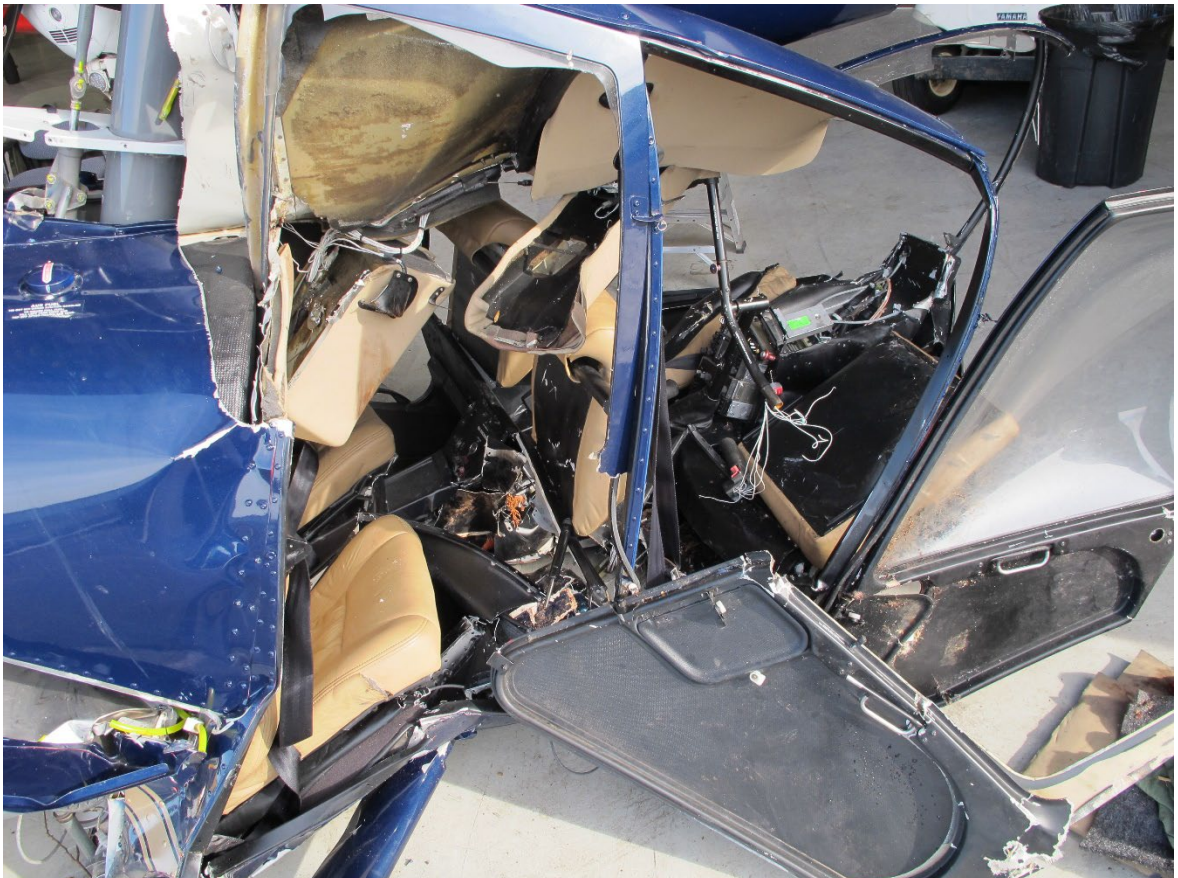
The fuselage and cowlings sustained impact damage with the belly and chin being deformed upward and aft. The door frames were distorted. Three doors remained attached to the cabin, the aft left door was separated. The windshields were shattered.

Above and below: Right side door structure.
