## Robinson Helicopter Company Accident Report

| AIRCRAFT MODEL: | <u>R44 Raven II</u> |
| REGISTRATION: | <u>N544SC</u> |
| NTSB IDENTIFICATION: | <u>ERA22FA096</u> |

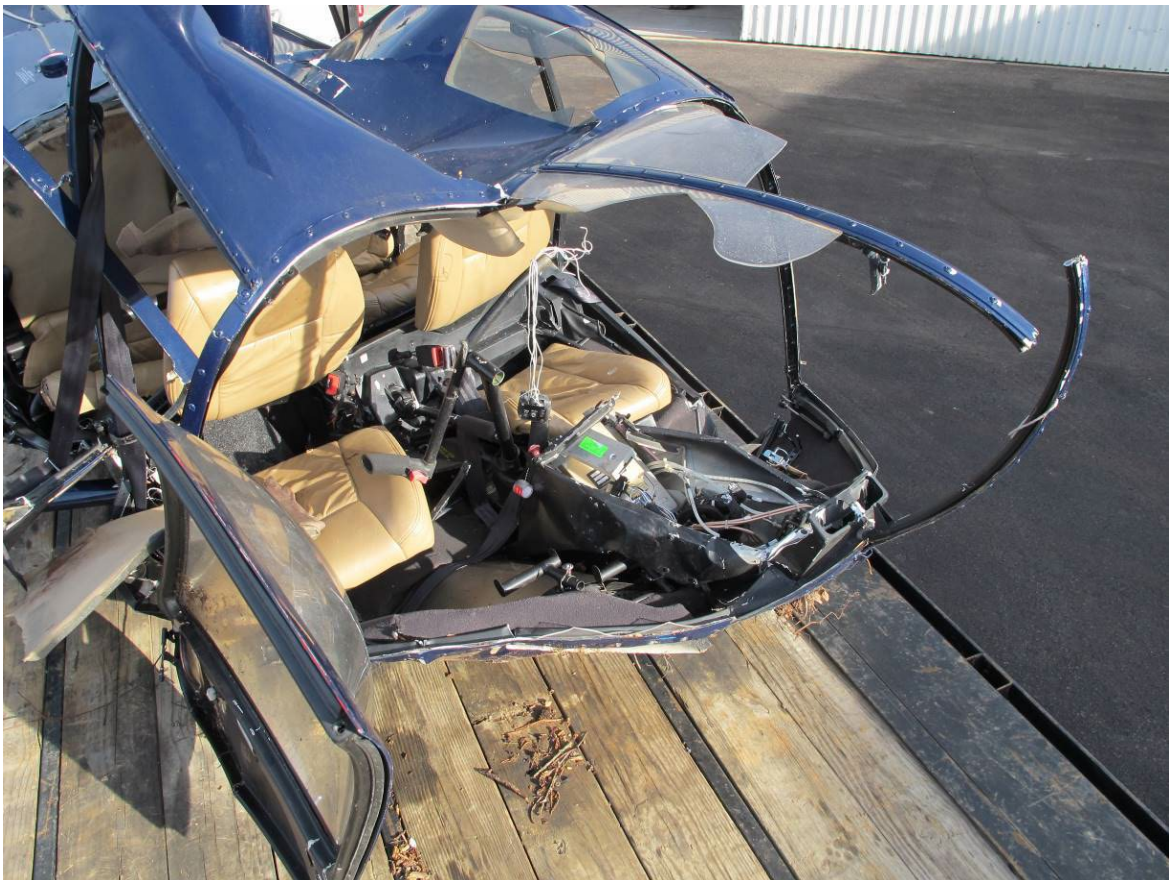
Front and rear right side doors.

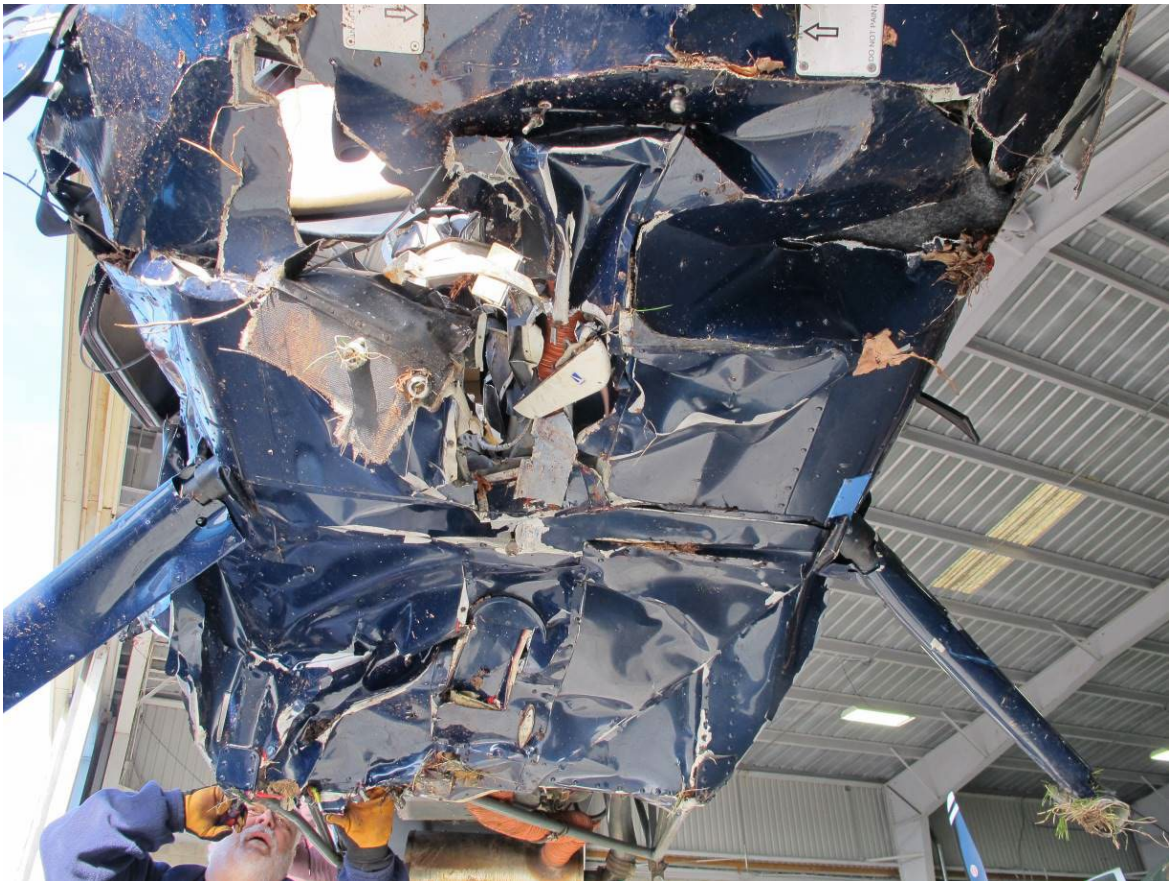
Windshield and roof structure.

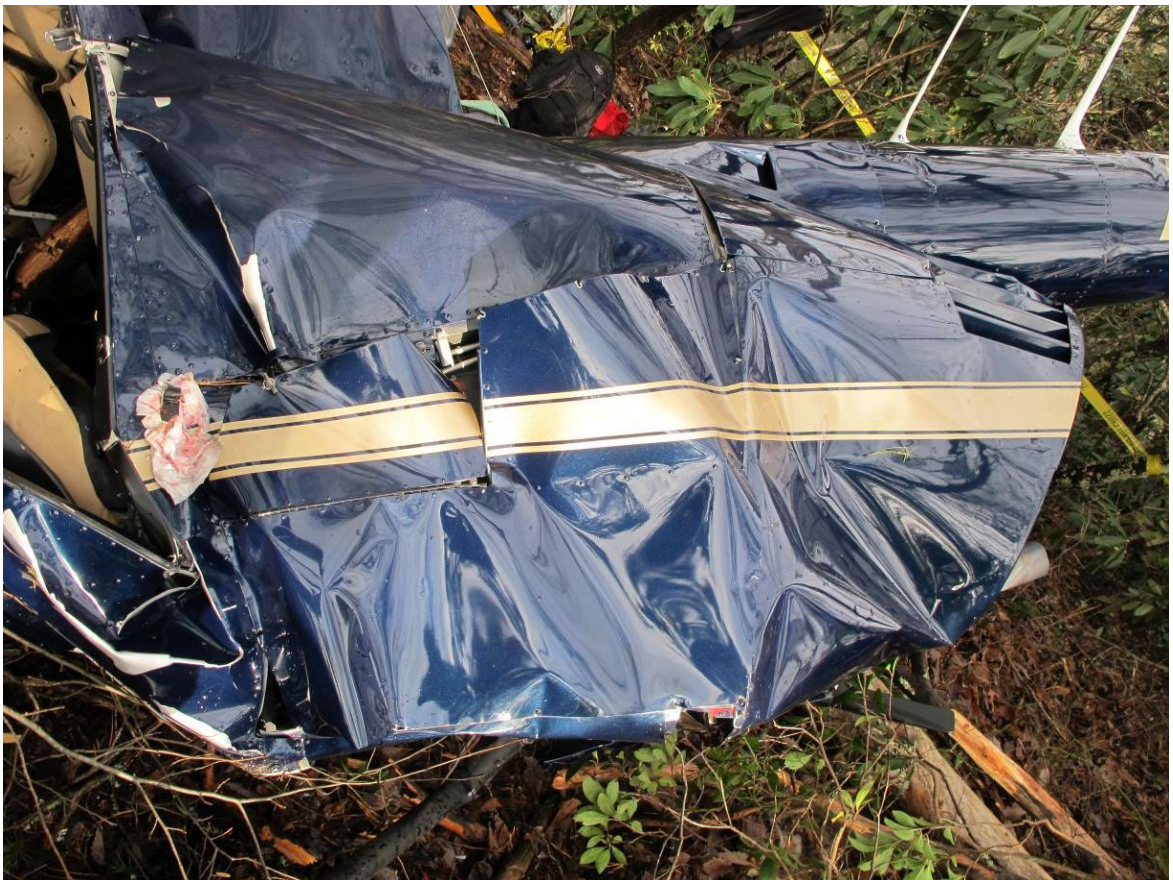
Fuselage belly.

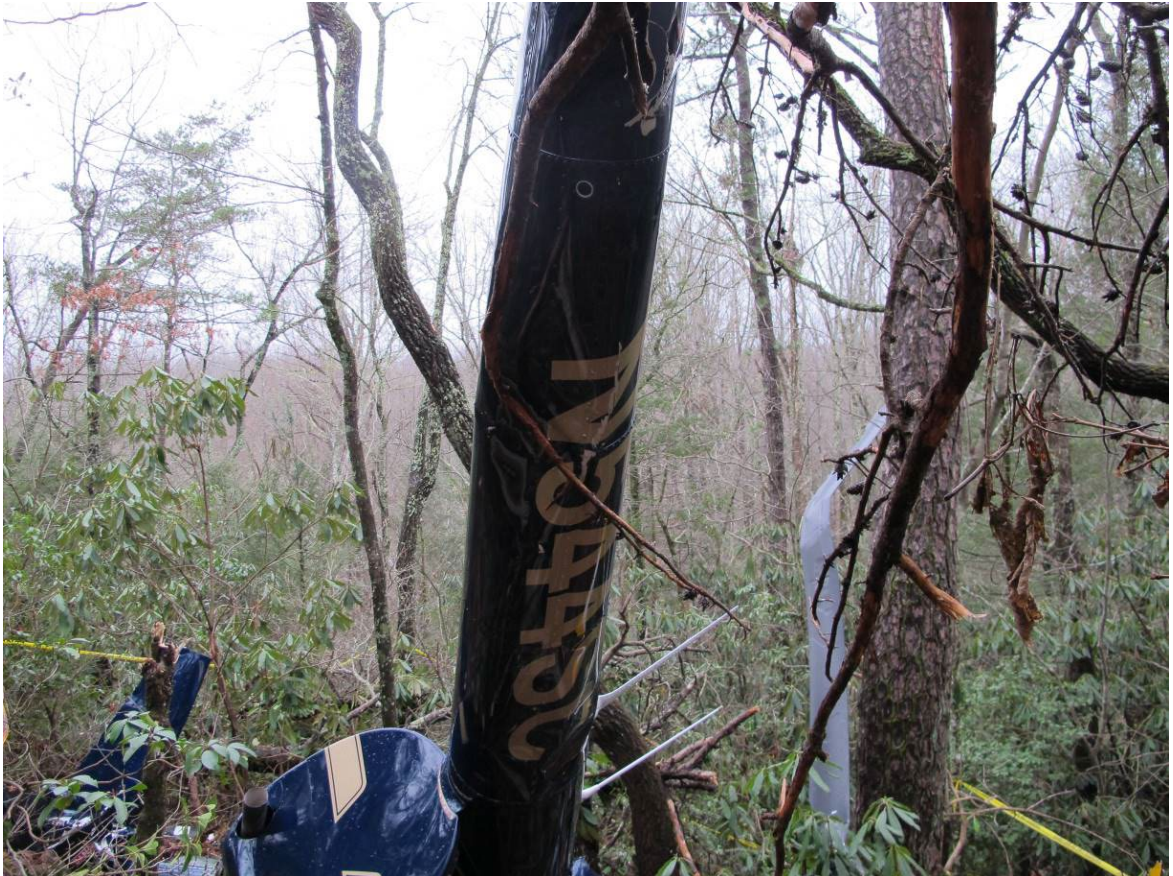
Upper left side of tailcone.

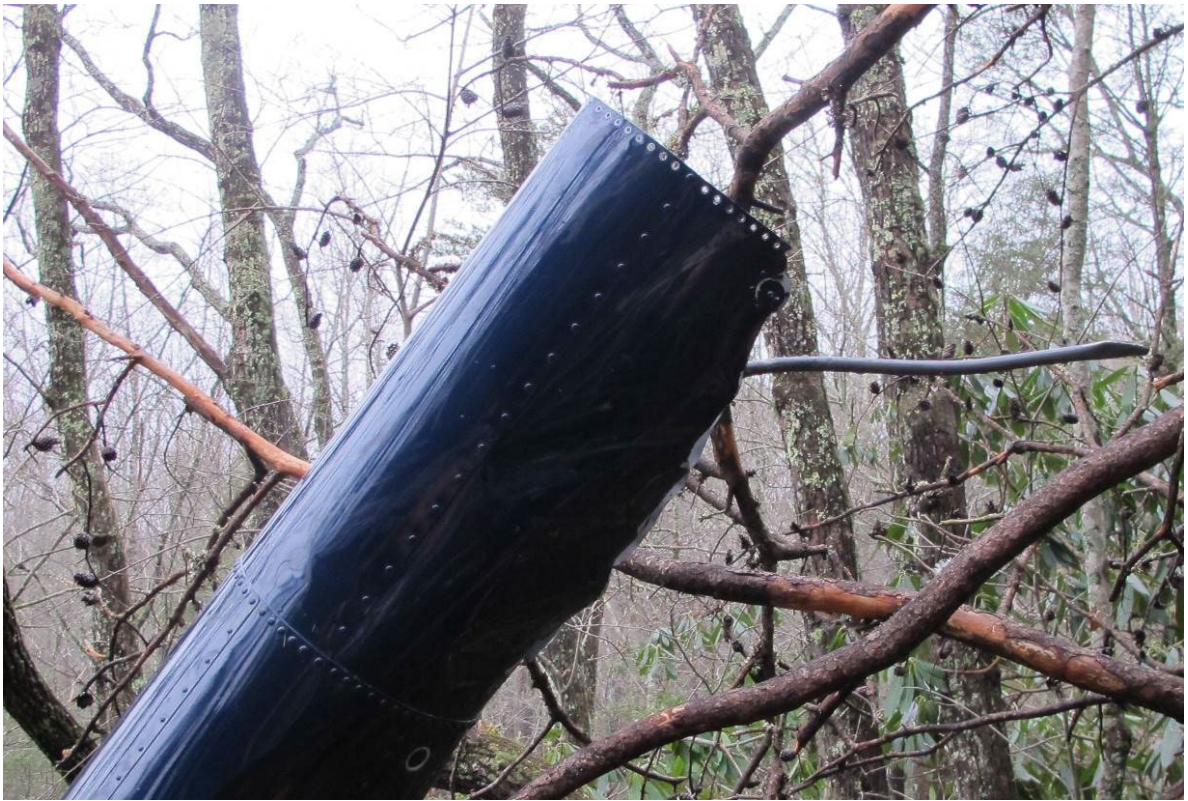
Lower right side of tailcone.

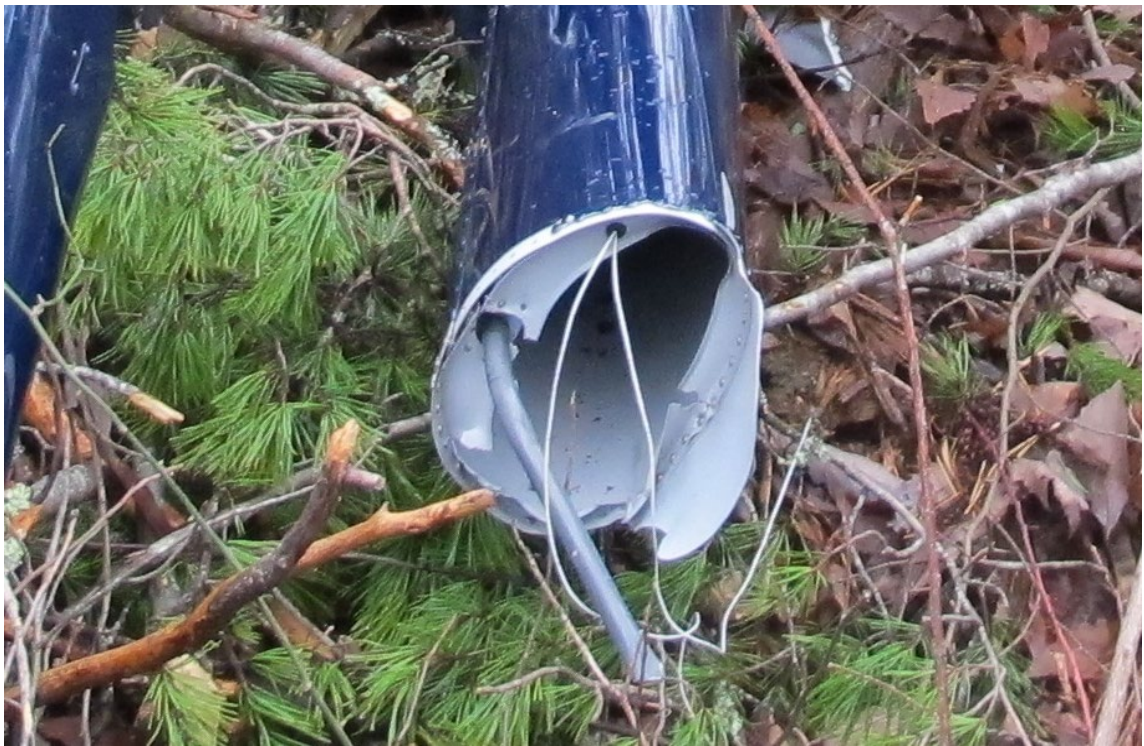
Separation between tailcone bays 5 and 6.

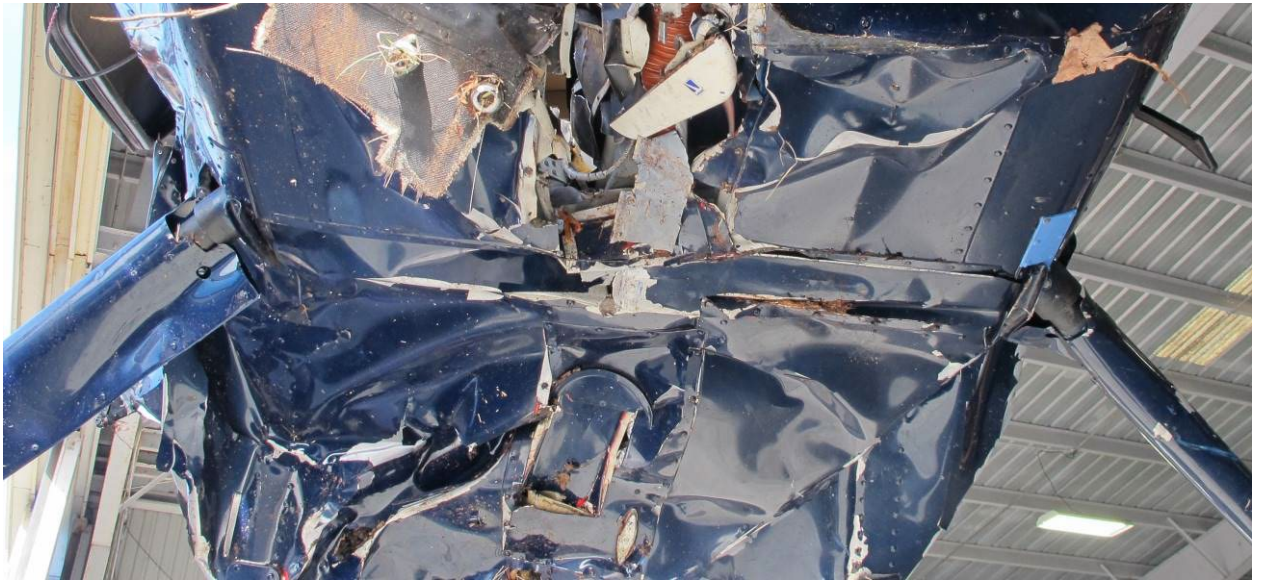
Front cross tube panel and elbows.

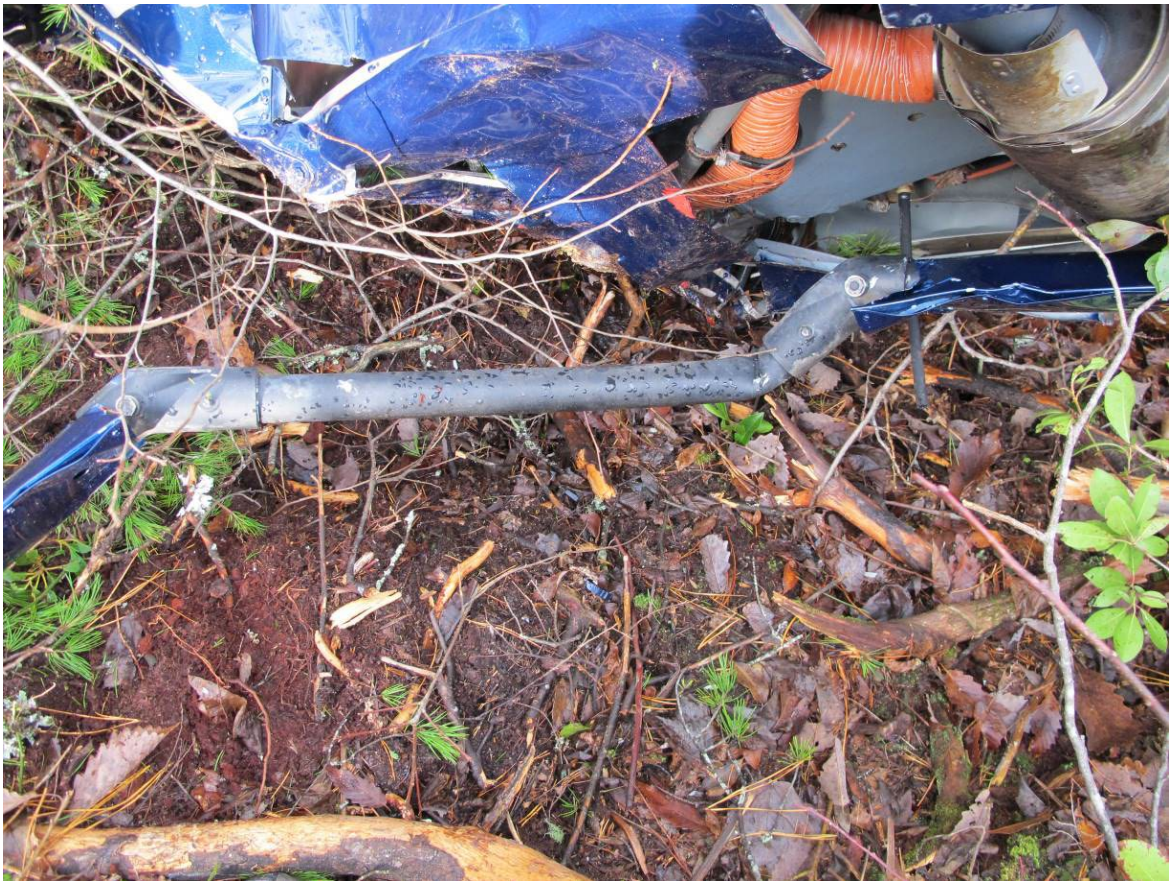
The aft cross tube was folded slightly aft and upward at the right elbow. Both elbows were separated from their mounts. Both elbows remained secure on the cross tube.

Aft cross tube.
