# Investigator notes

USA (Leipsic, OH) Air Tractor AT502B N5048S engine fire 04 August 2023. 1954 eastern daylight time, an Air Tractor AT-502B, N5048S, was substantially damaged when it was involved in an accident near Leipsic, Ohio. The pilot was not injured. The flight was operated as a Title 14 Code of Federal Regulations Part 137 aerial application flight. The pilot had been applying fungicide to several fields, during which he noted no engine performance anomalies. Shortly after starting the second spray run in a field, he heard a pop sound. He saw flames coming out of the engine exhaust stacks and the engine stopped producing power. He performed a forced landing to a neighboring field and the airplane ground-looped in the high crops. Examination of the wreckage by a Federal Aviation Administration inspector revealed that the airplane came to rest upright with substantial damage to the left wing. The NTSB is investigating.

WO 23-1215 reviewed

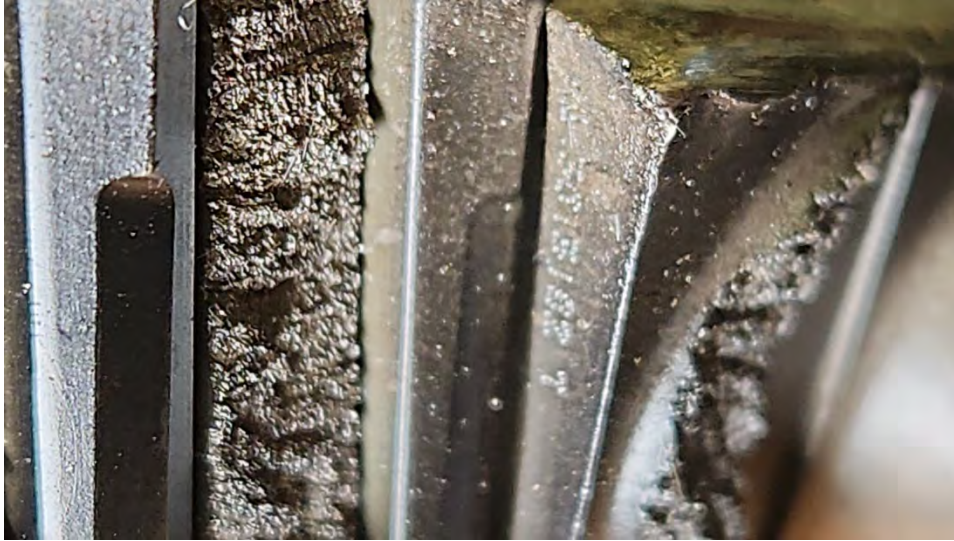
Blade part number AE 3013102T. All blades will need to be removed from disk, analyzed and PN verified

5 blades were removed to confirm part numbers. Blades were identified.

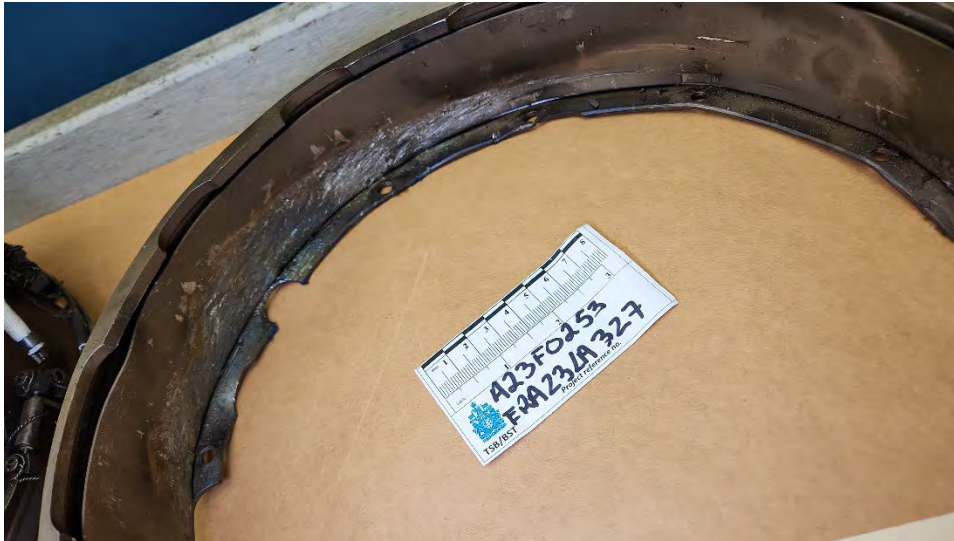
Departing blades impact marks

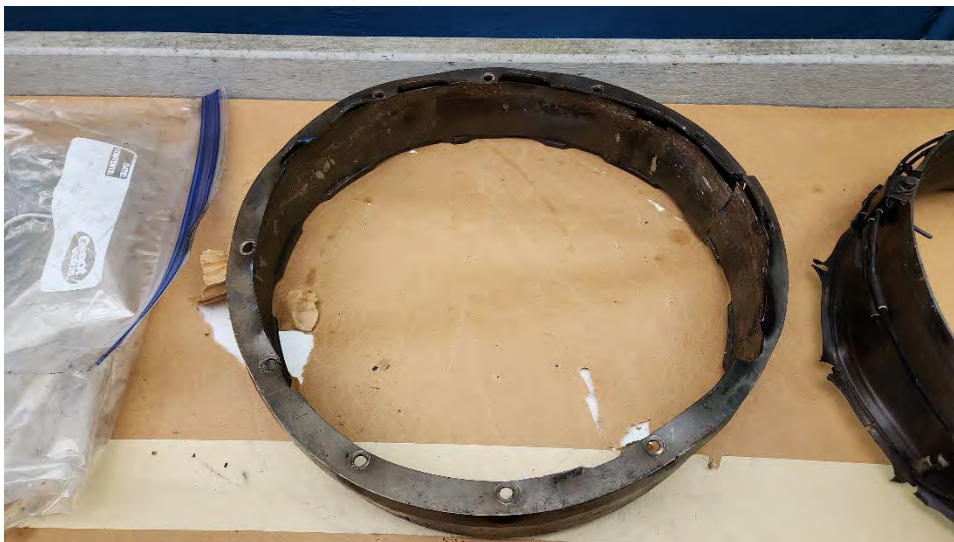
Ovalized shape of PT shroud

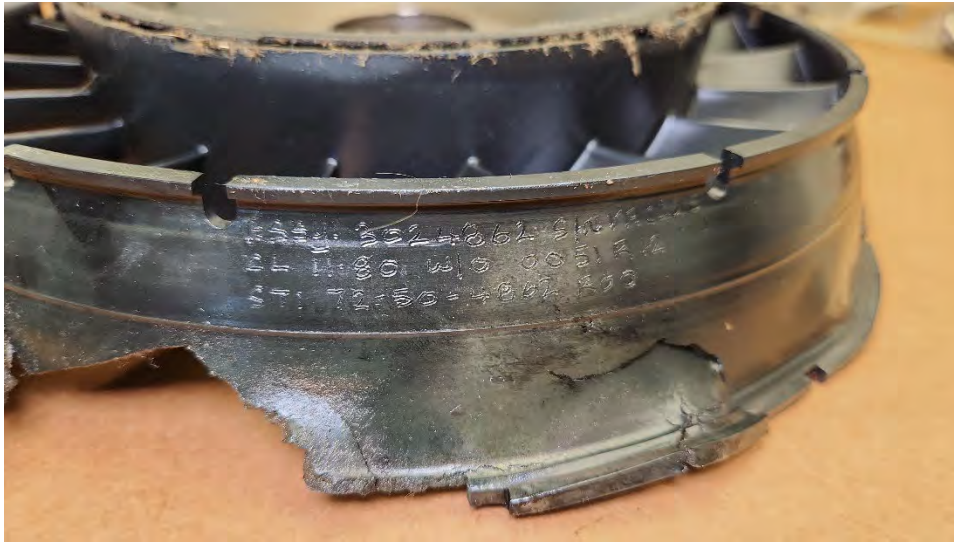
STI 72-50-4802 ROO part number therefore not PWC number

STI part number

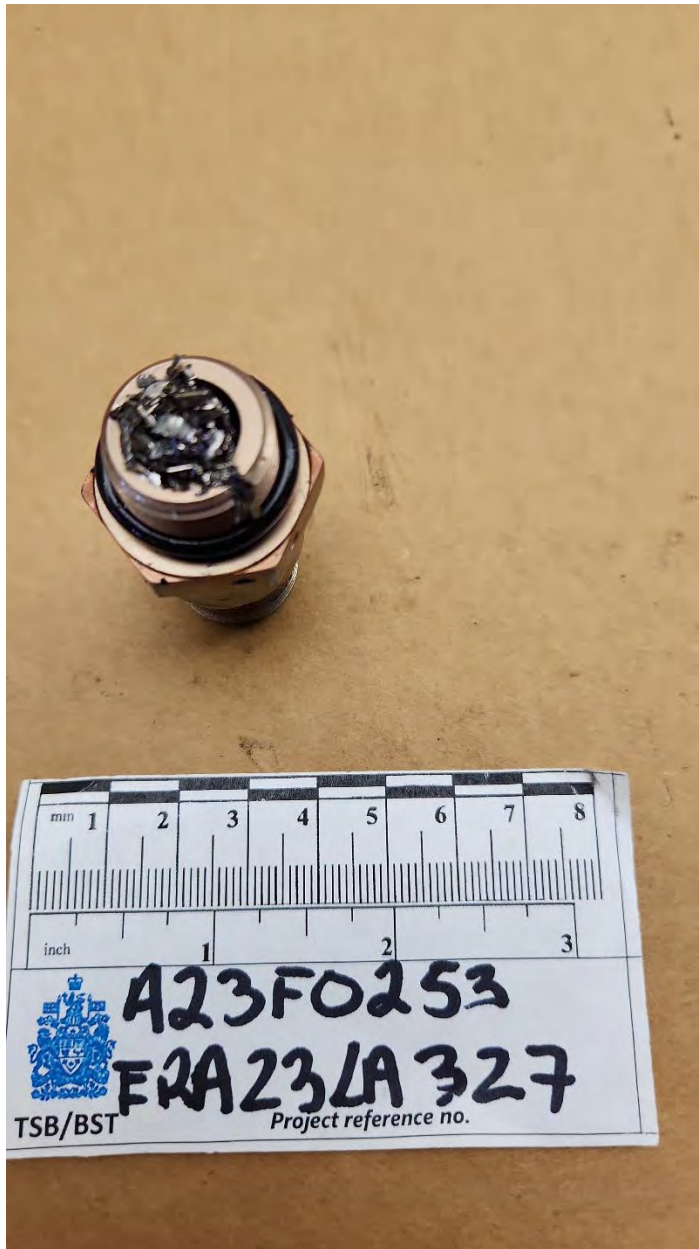
RGB chip plug with metal

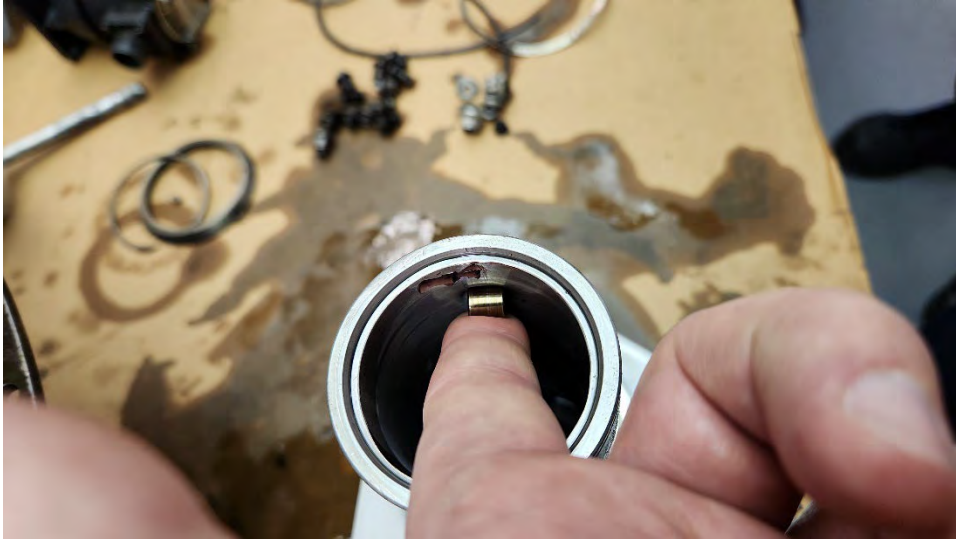
Imprint inside tube that enclose shaft forward to 3-4 showed an exact imprint of a roller bearing. Most likely one roller got stuck, rubbed and overheat. Shaft shows also sign of rubbing

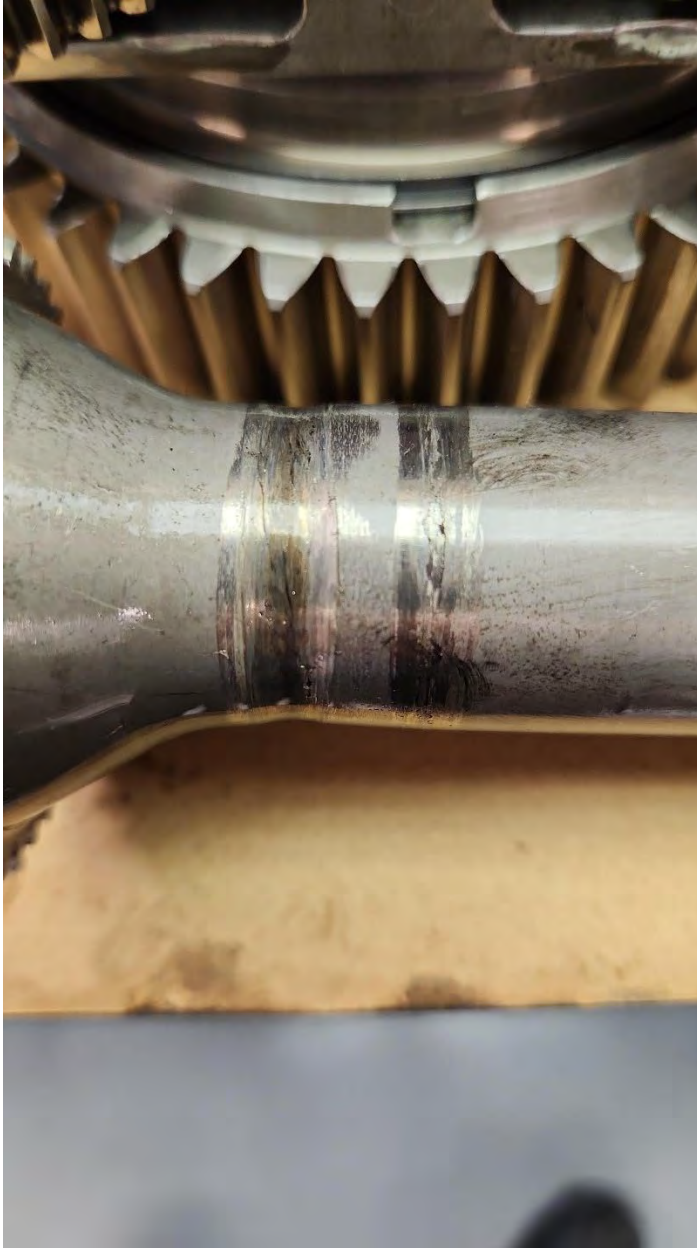
Scoring/rubbing on PT shaft

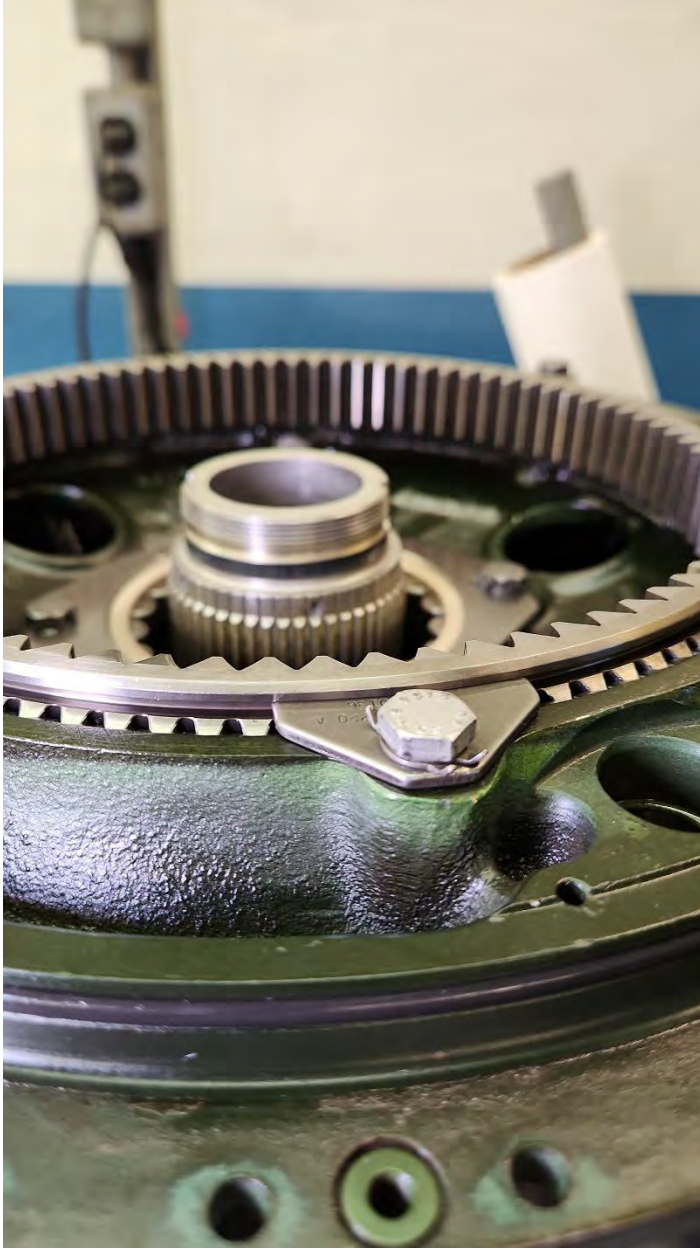
For demonstration ONLY. Ring gear correctly installed in groove to prevent axial play

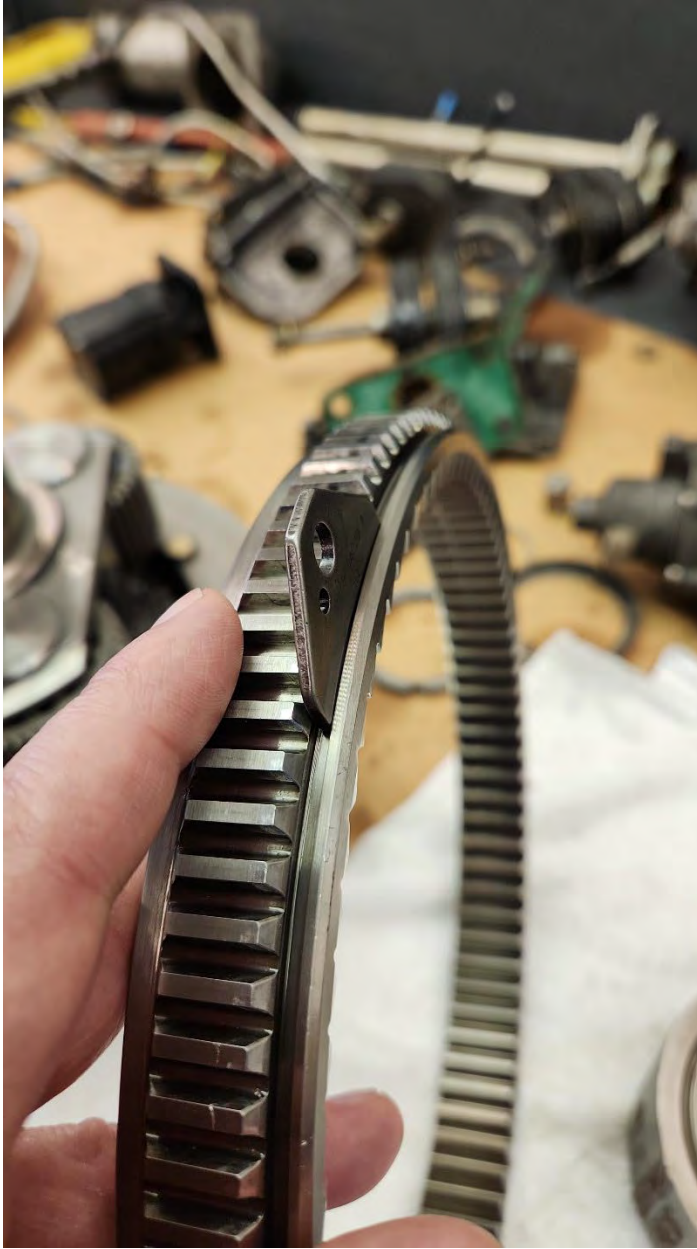
Demonstration ONLY tab in groove
