## **NATIONAL TRANSPORTATION SAFETY BOARD**

# **AIRFRAME AND ENGINE EXAMINATION**

**WPR16FA087**

Location: Astoria, Oregon  
Date: March 23, 2016  
Aircraft: North American AT-6A, N7055D  
NTSB IIC: Elliott Simpson

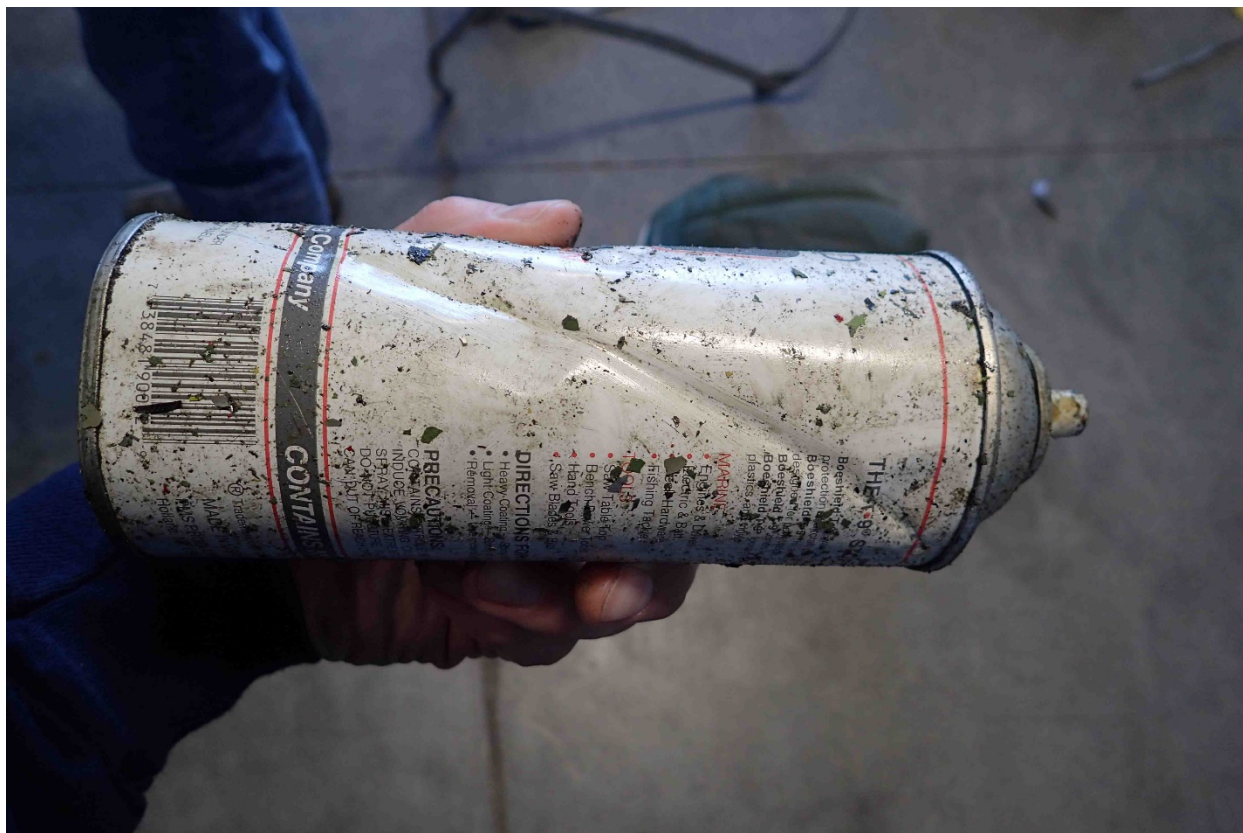
The vertical stabilizer remained partially attached at the root (Photo 2). A can of lubricant was found loose with the tail cone void, sitting against the aft cabin bulkhead (Photo 3, 4).

Photo 4 – Oil Can

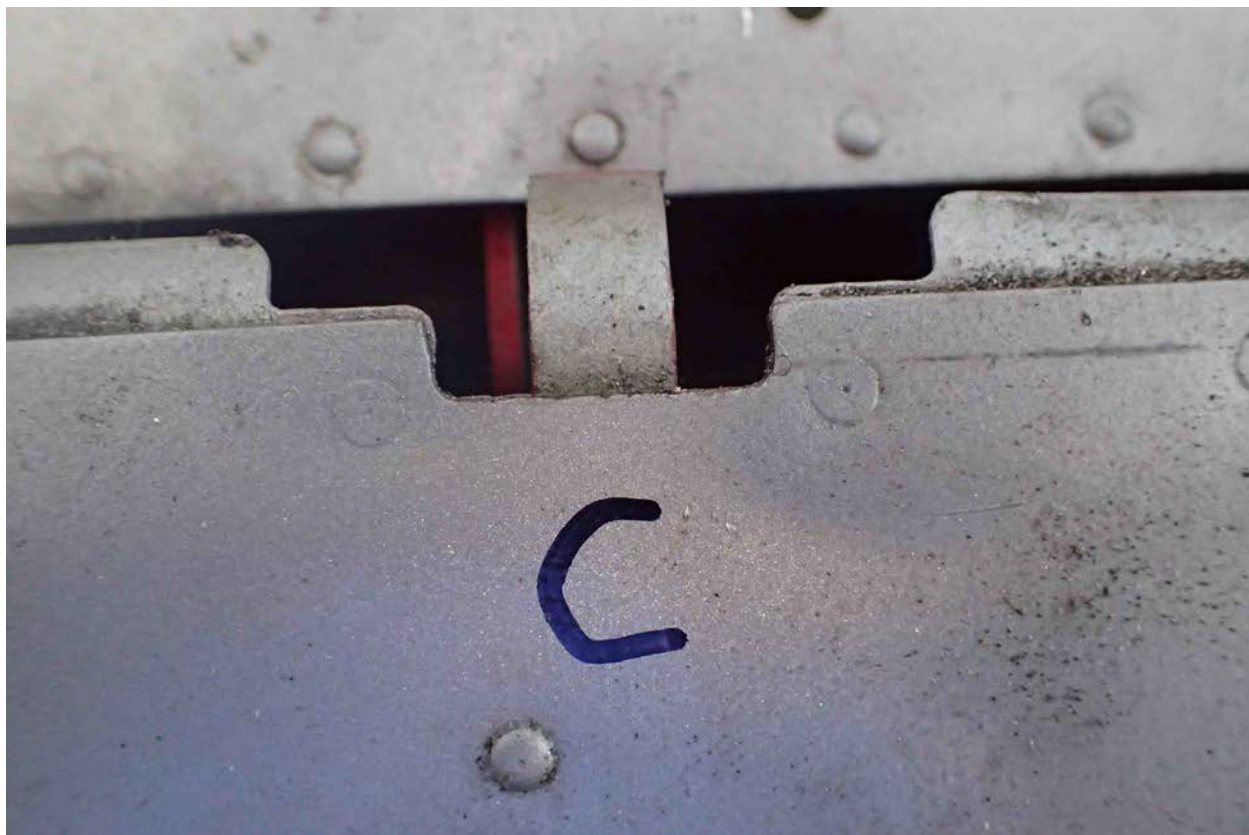
Photo 32 – Center Flap Hinge

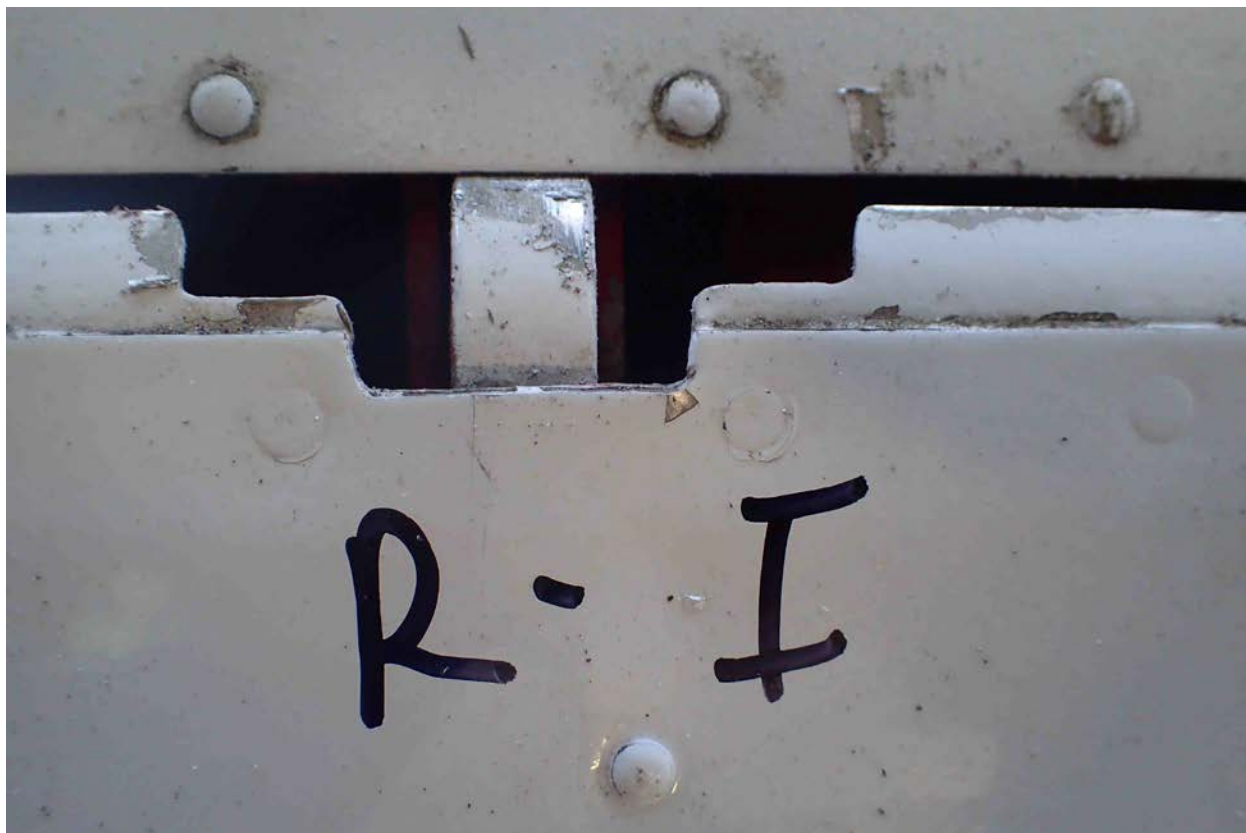
Photo 33 – Right Inboard Flap Hinge

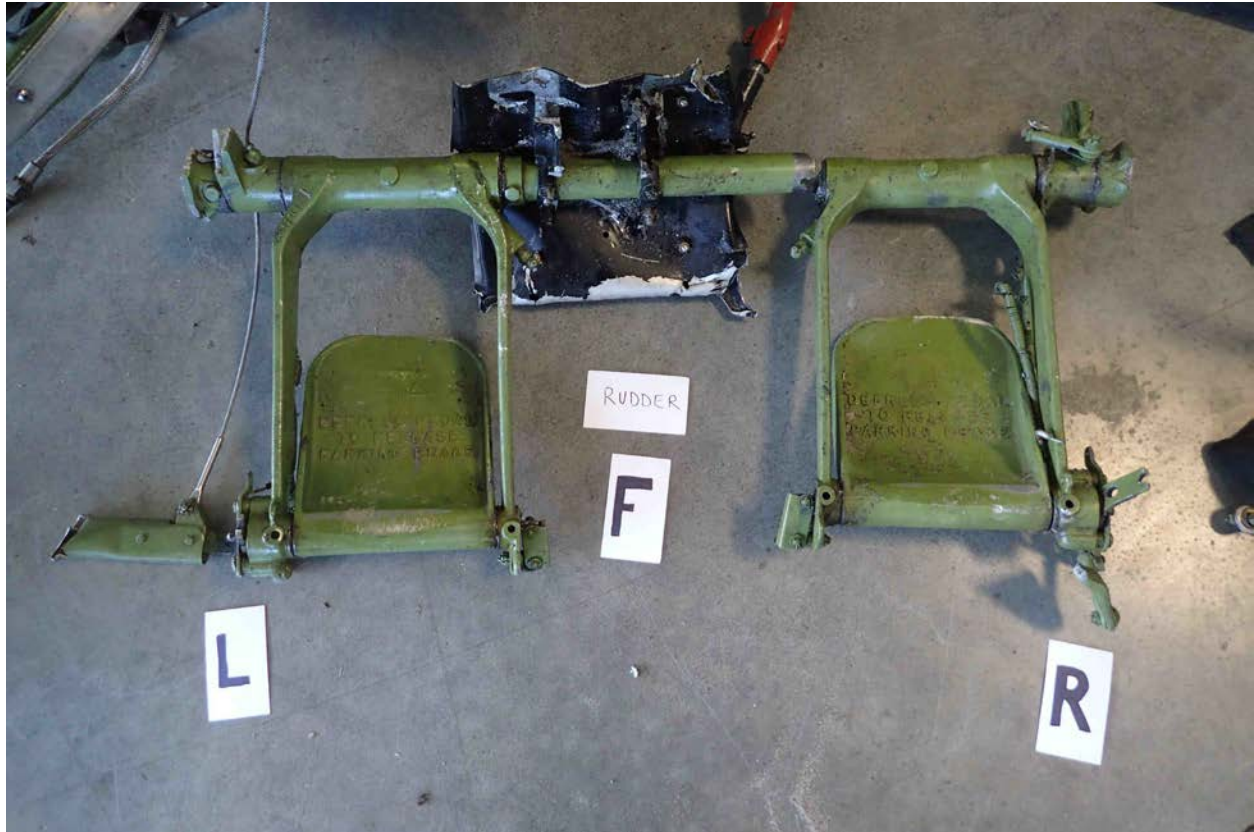
Photo 48 – Forward Rudder Pedal Assembly

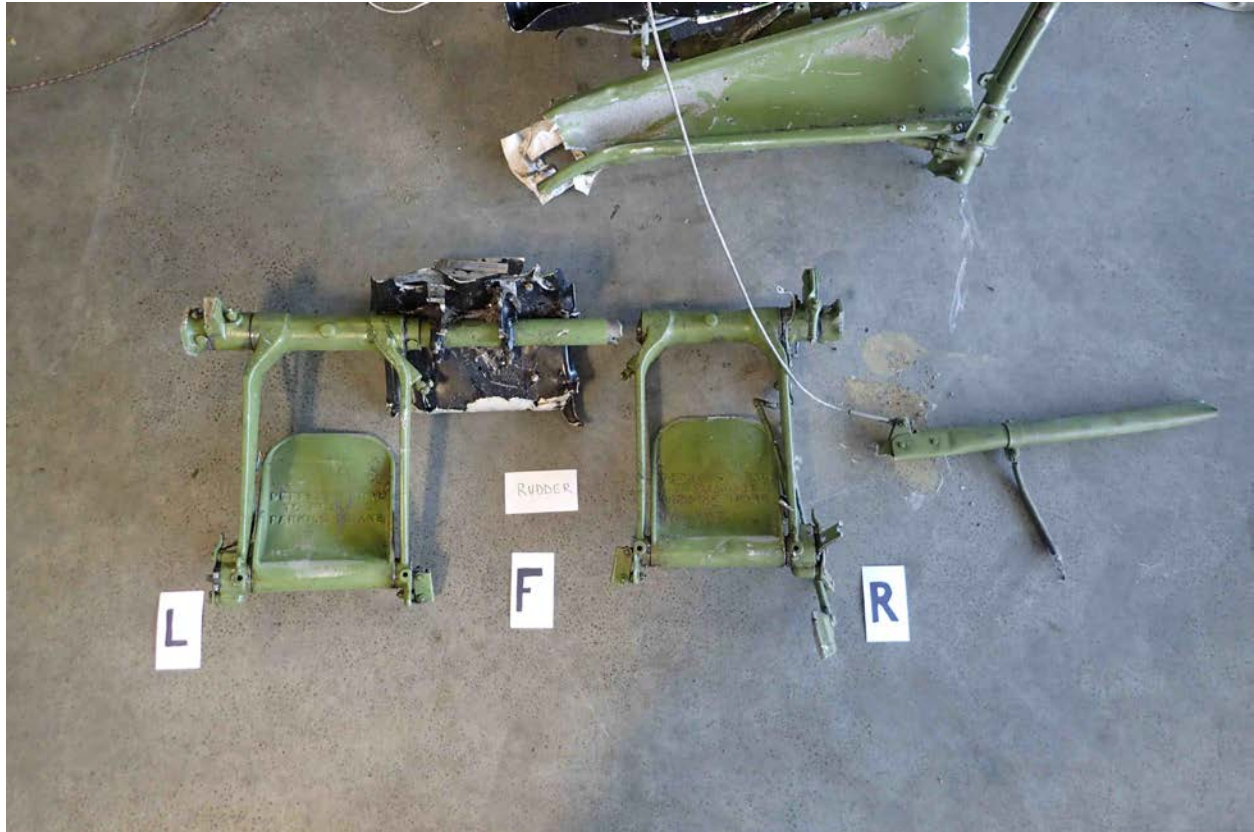
Photo 49 - Forward Rudder Pedal Assembly

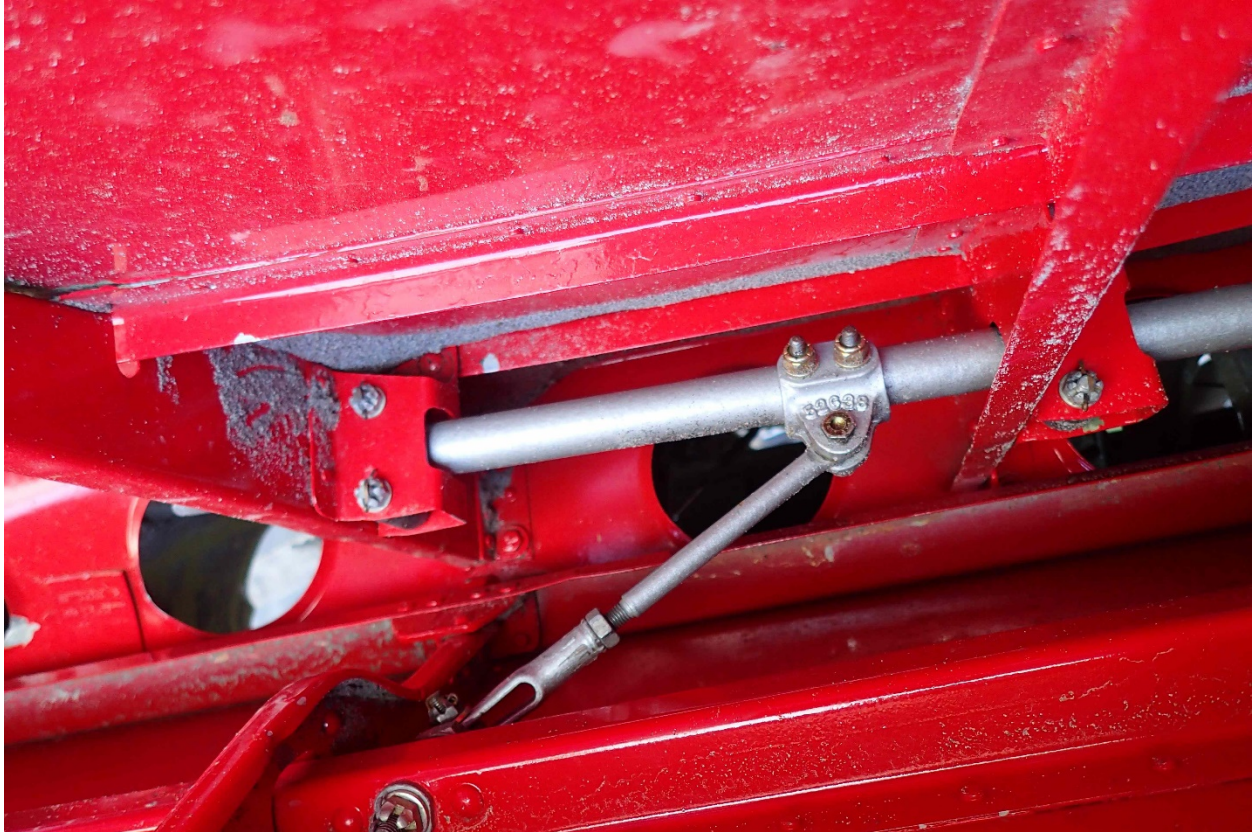
Photo 67 – Flap Extension Pushrod

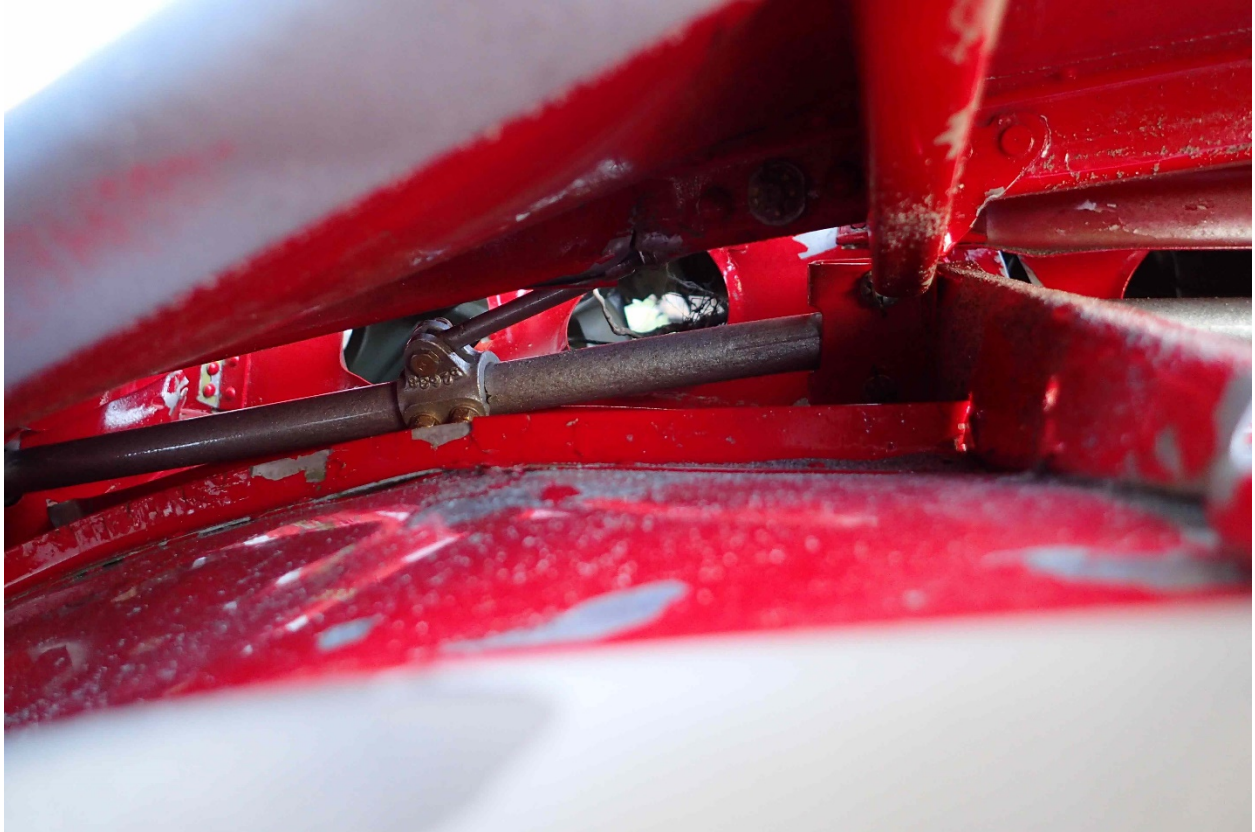
Photo 68 - Flap Extension Pushrod
