# Continental Motors

## ENGINE FIELD INSPECTION REPORT

| ENGINE MODEL | TSIO550C (9B) |
| FILE NUMBER | 17-083 |

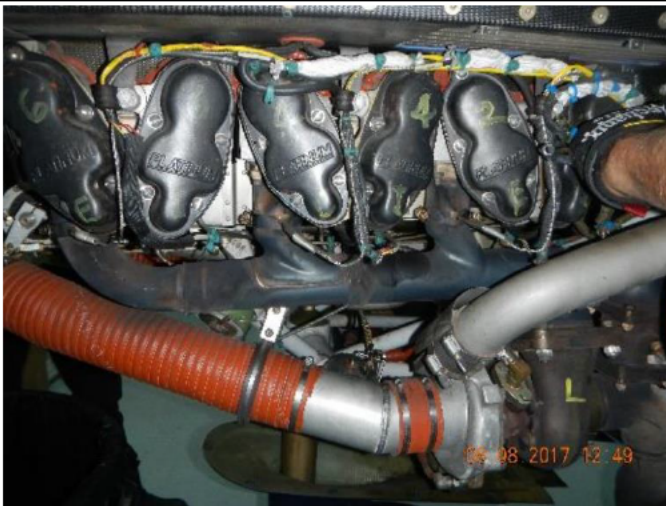
Condition: The exhaust components did not exhibit impact damage. The right exhaust pipe exiting the right turbocharger exhibited a small amount of oil inside. The rear mounted exhaust cross-over exhibited burned on oil deposits.

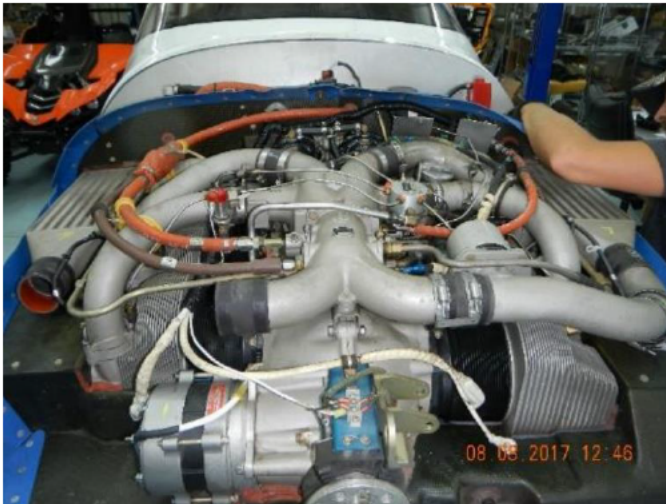
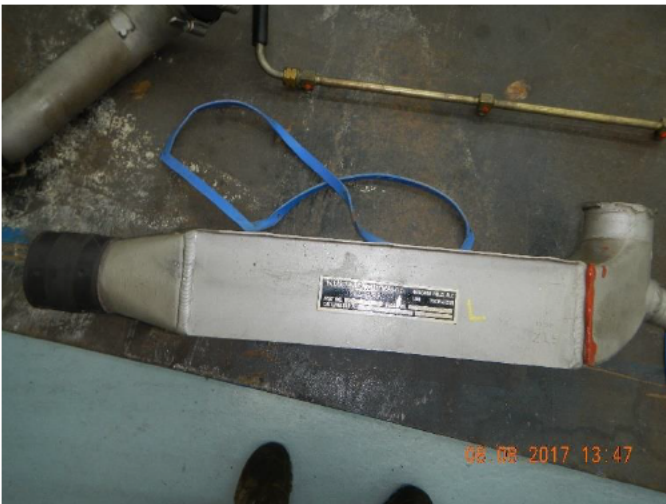
The induction system did not exhibit damage

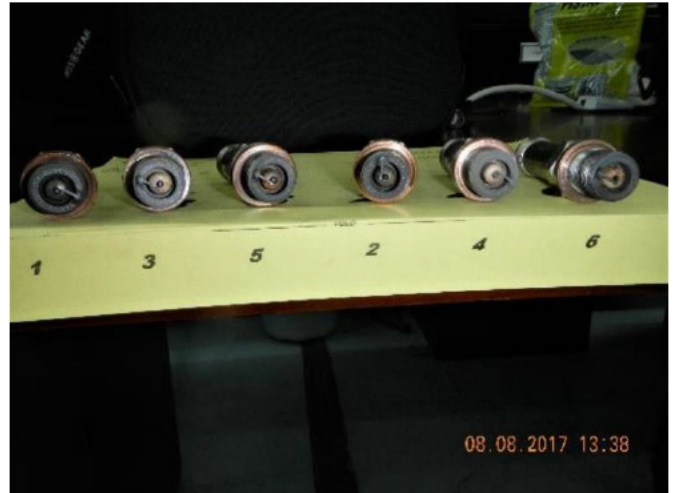
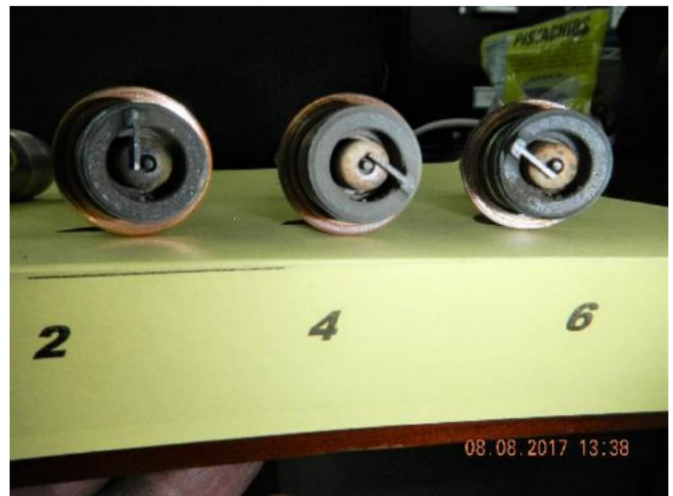
Condition: When compared to a Champion Check-A- Plug chart, the sparkplugs appear to be normal in wear. Number 1 sparkplug internal insulator was damaged. Sparkplugs one and two are slightly dark in color.

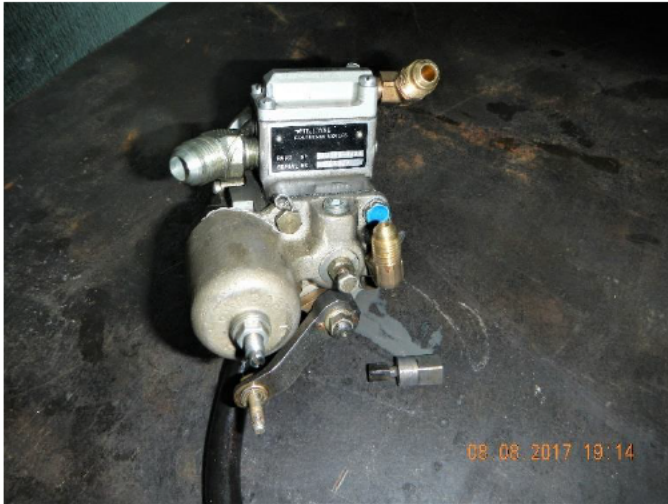
Condition: The engine driven fuel pump was intact and undamaged. The drive coupling was intact and the fuel discharged a small amount of fuel when the drive coupling was manually rotated.

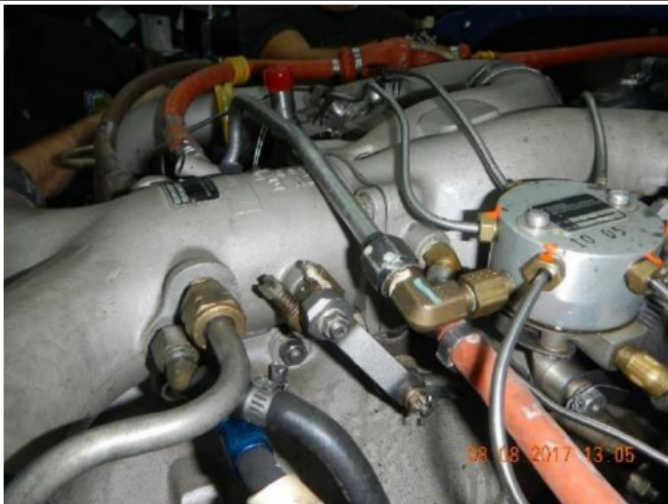
Condition: No damage was exhibited. The throttle arm was properly secured

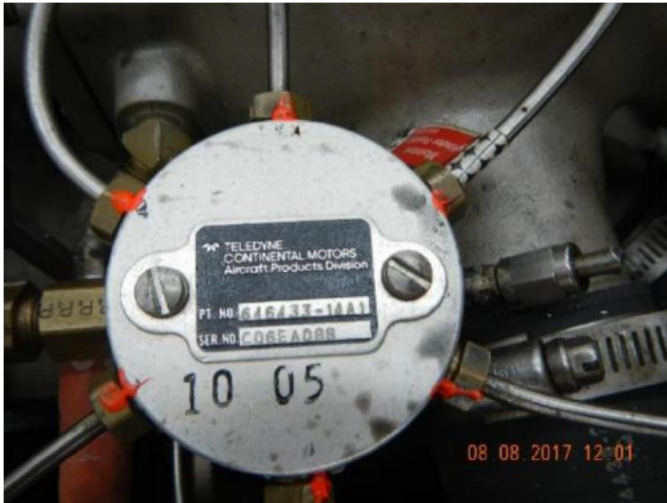
Condition: There was not visible damage to the fuel manifold

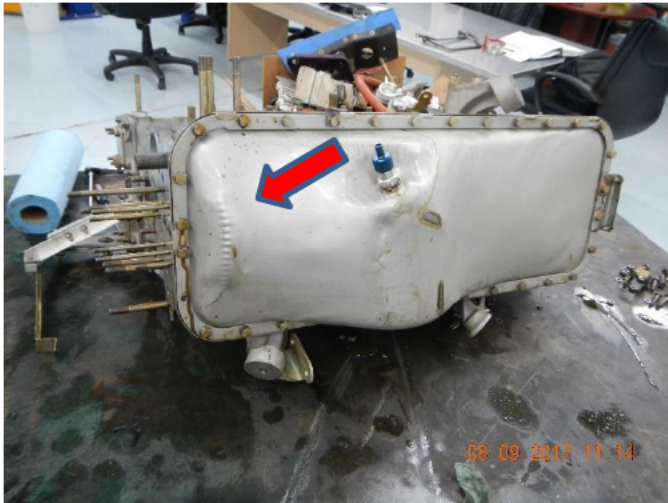
#### OIL SUMP

**Condition:** The oil sump received impact damage internally. The impression of gear teeth was visible on the lower rear. When the oil sump was removed, the camshaft gear was found adjacent to where the damage was exhibited. The oil sump contained damaged bearing material, broken rod bolts and nuts and other metal debris including the separated oil pump input shaft.

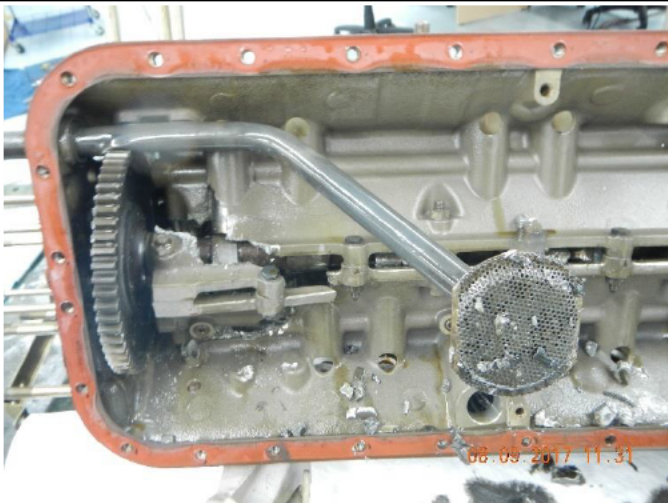
#### OIL PICK-UP TUBE & SCREEN

**Condition:** The oil pick-up tube was damaged where the camshaft gear became lodged after the camshaft separated. The screen exhibited metal material and contaminated oil.

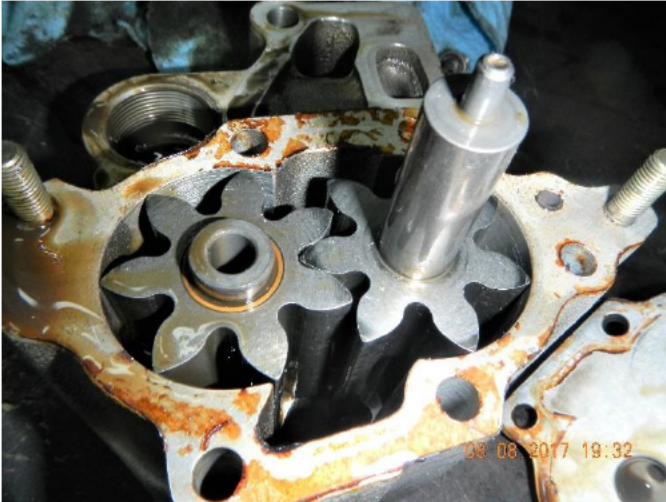
The oil pump input shaft separated but was recovered from the oil sump. The oil pump gears could not be removed from the oil pump cavity due to the burr on the spline shaft. The oil pump and gears will be sent to CMI for an analytical and metallurgical examination at the request of the NTSB IIC.

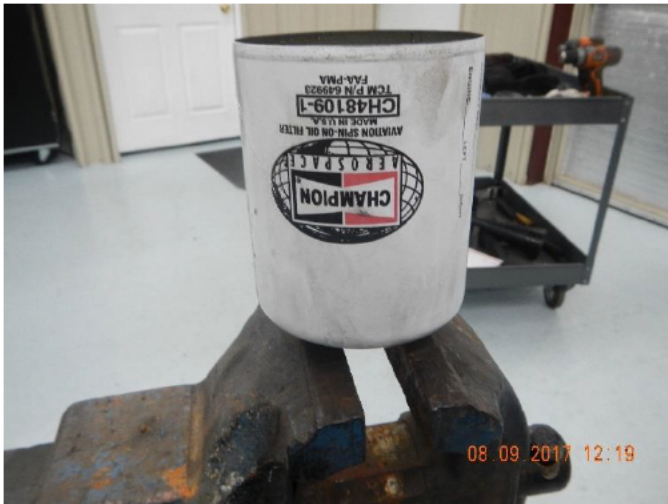
The oil filter was opened and examined. The filter paper media pleats contained metal particles.

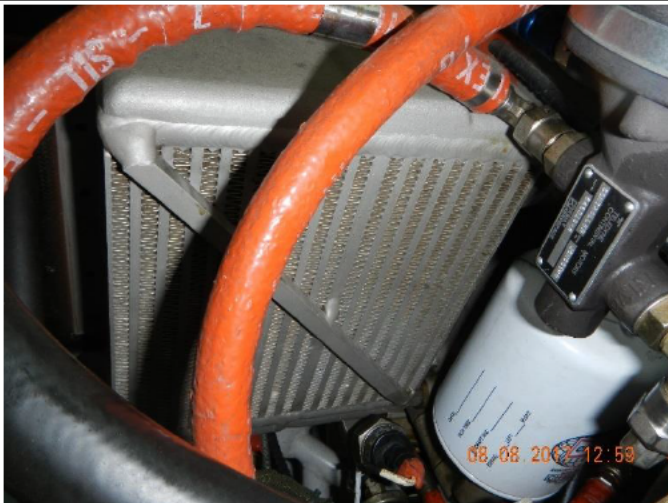
The oil cooler was not externally damaged

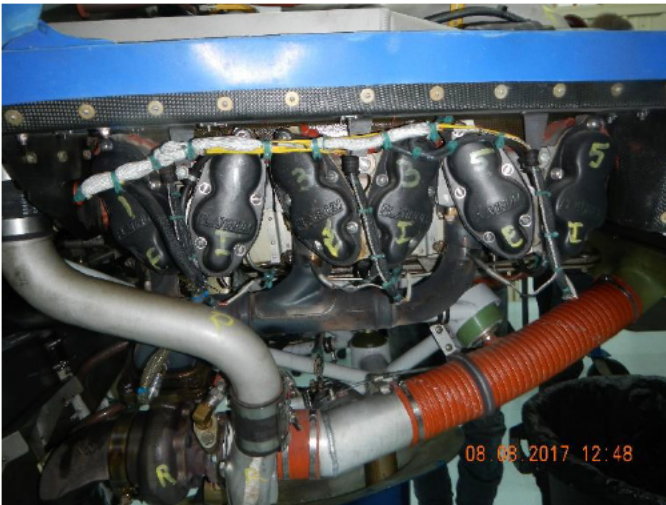
| Condition: | Externally, all cylinders appear to be normal | | |

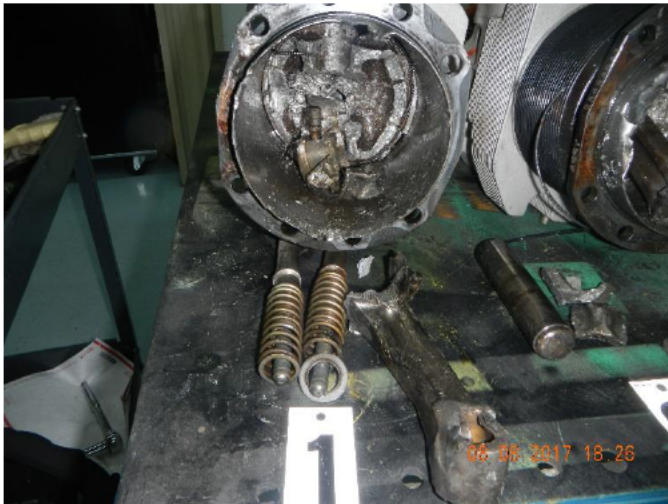
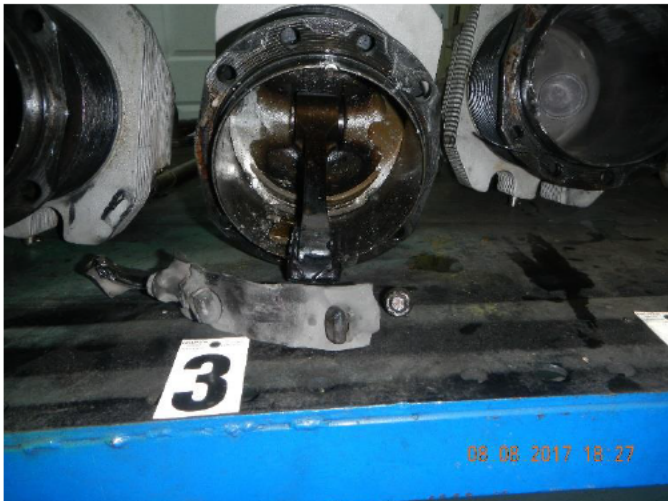
An electronic lighted borescope examination was performed. All intake and exhaust valves were intact and exhibited normal combustion signatures. When cylinders were removed, pistons for cylinders 1, 2, & 3 were stuck inside their respective cylinders and could not be removed. Cylinders 4, 5 & 6 were normal.

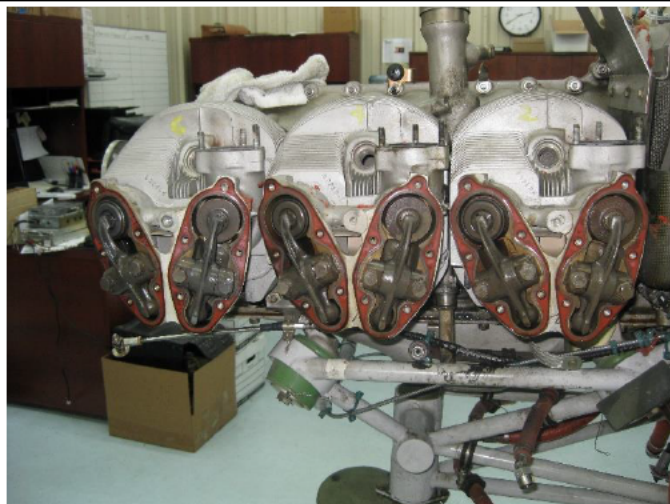
### ROCKER ARMS AND SHAFTS

All rocker arms and shafts were intact.

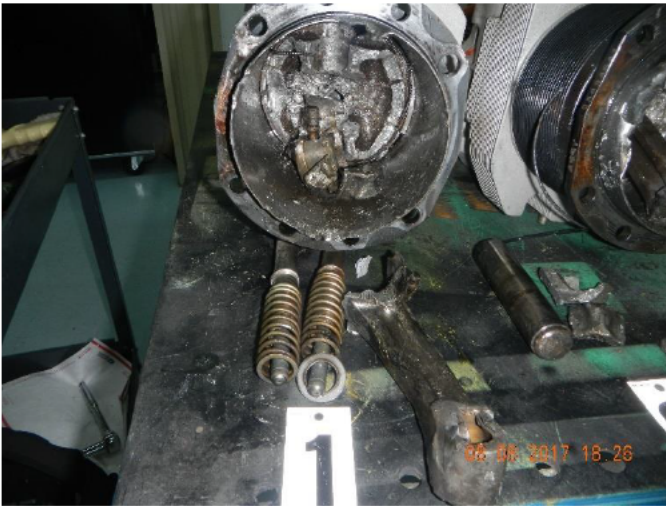
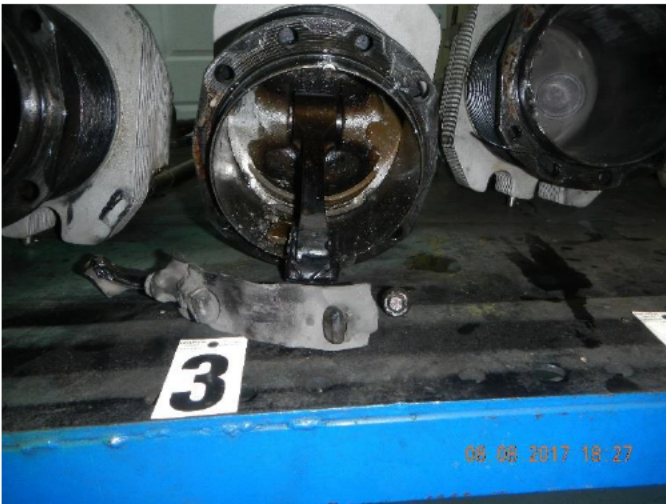
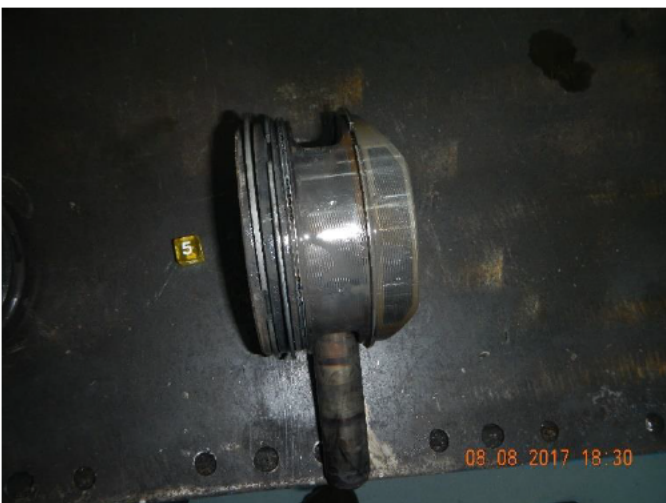
Pistons for cylinders 1, 2, & 3 were stuck inside their respective cylinders and could not be removed.

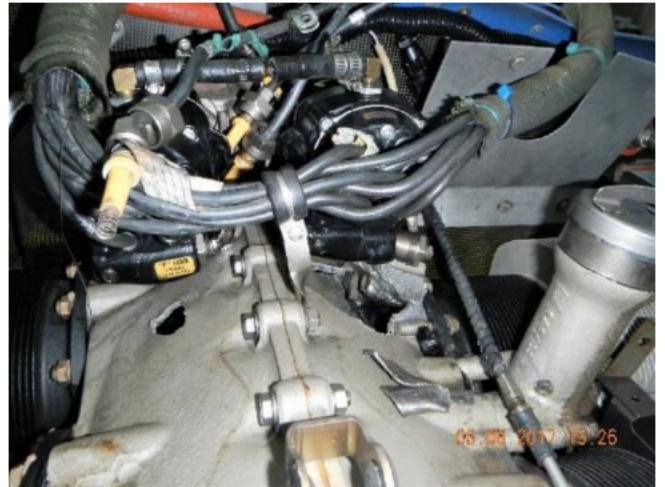
The left upper crankcase half was damaged above the cylinder # 2 mount.

The right upper crankcase half was damaged above the cylinder # 1 mount

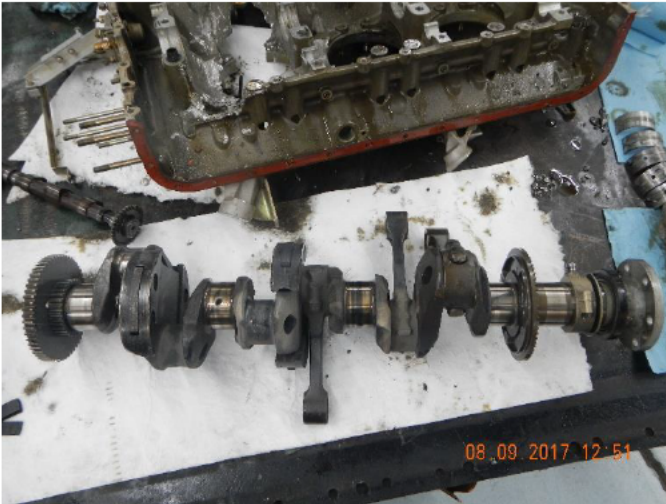
The # 3 main journal exhibited heat signatures. The corresponding main bearing did not.

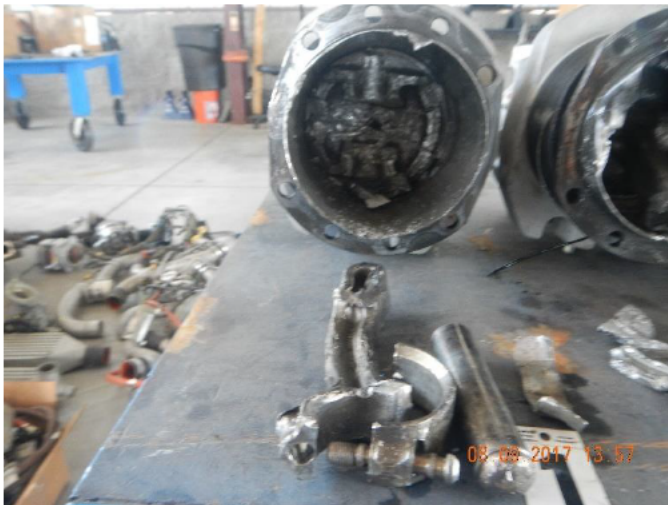
Condition: The rod separated at the connecting rod cap/bolts and piston pin boss

Condition: The rod bearing separated. Rod bearing material was located in the oil sump

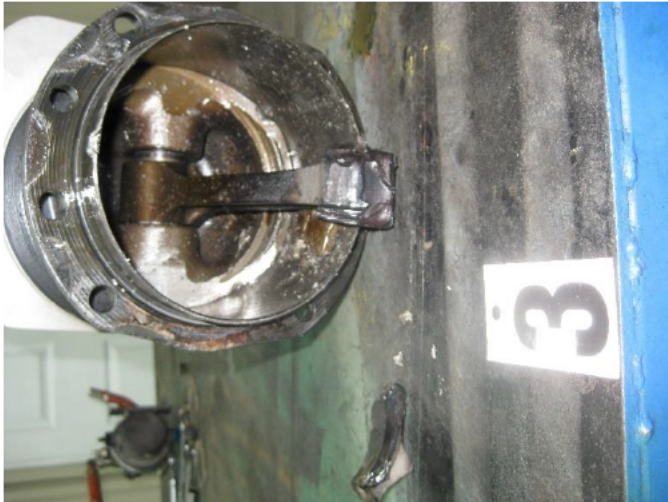
Condition: The rod separated above the connecting rod cap

Condition: Destroyed
