**FLUID SYSTEMS DIVISION  
PARKER HANNIFIN CORPORATION  
711 TAYLOR STREET  
ELYRIA, OHIO 44035**

**5 DECEMBER 2017**

**2C27-1 CENTRIFUGAL FUEL PUMP CARTRIDGE  
EXAMINATION**

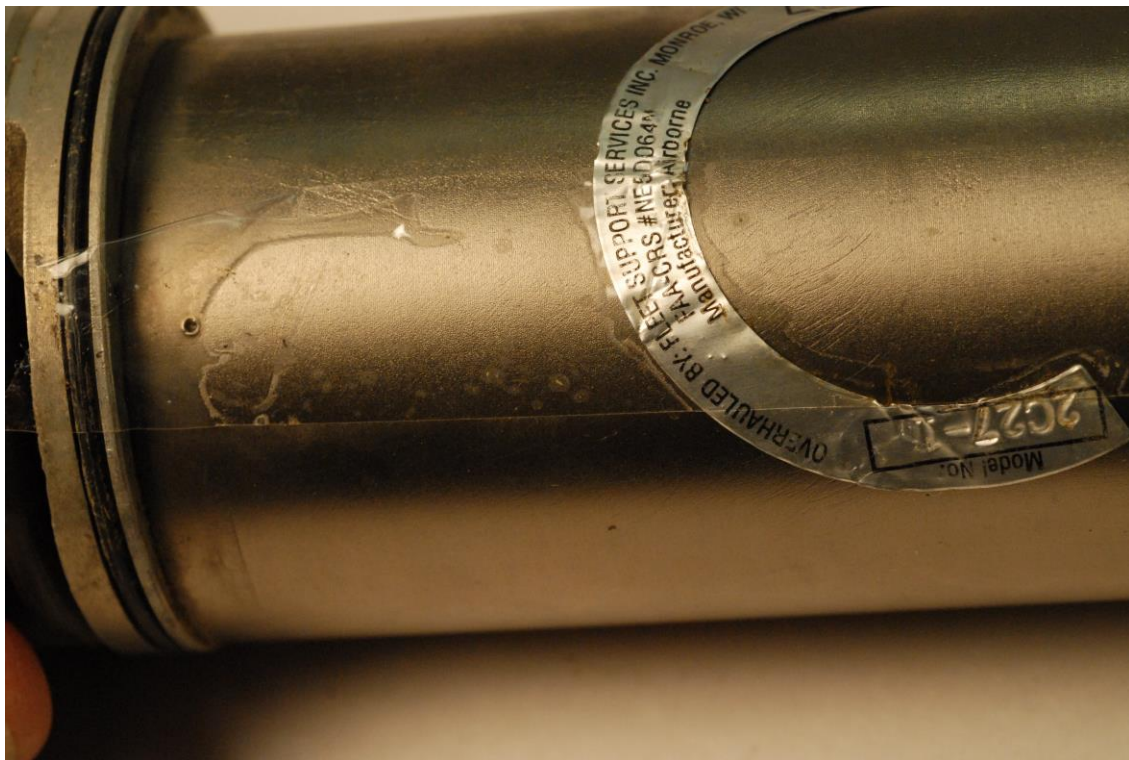
2C27-1 4H234 31Aug17\_017 – Name Plate

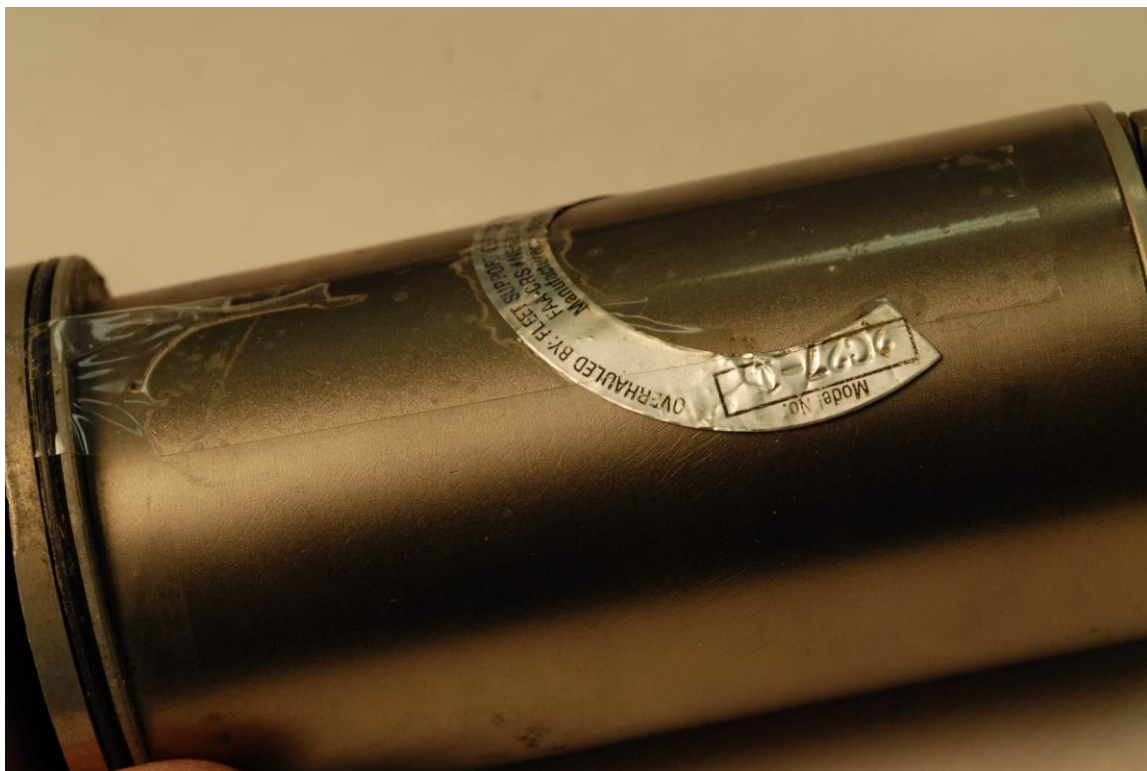
2C27-1 4H234 31Aug17\_018 – Name Plate

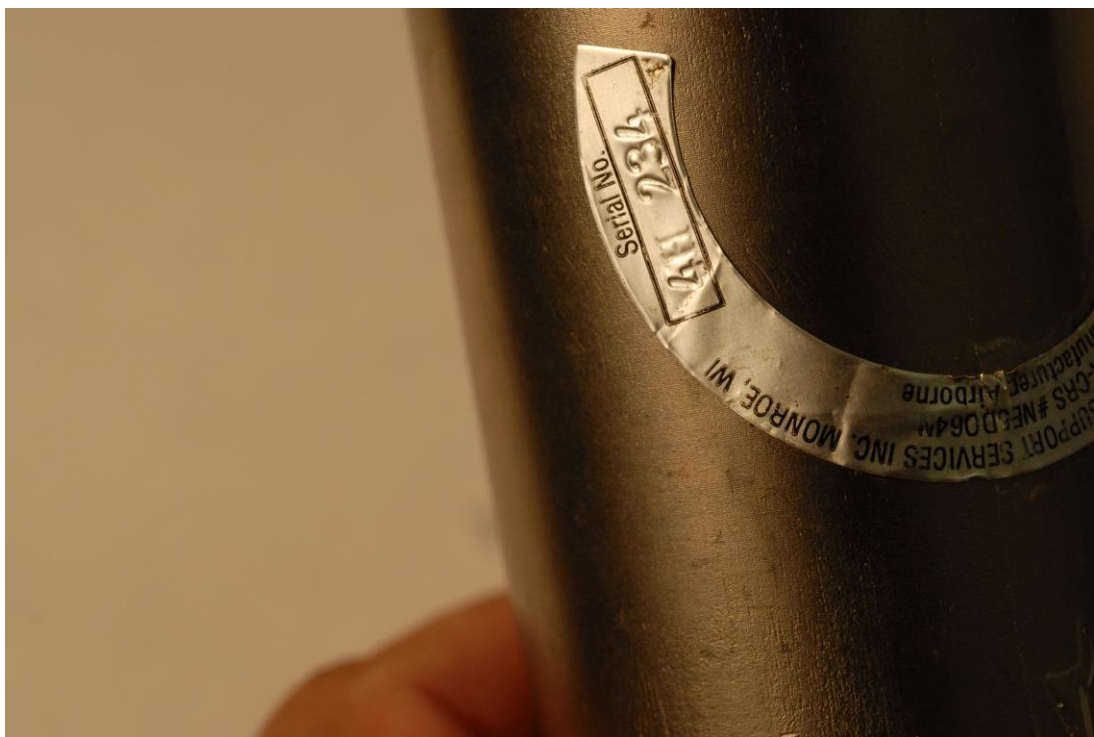
2C27-1 4H234 31Aug17\_019 – Name Plate

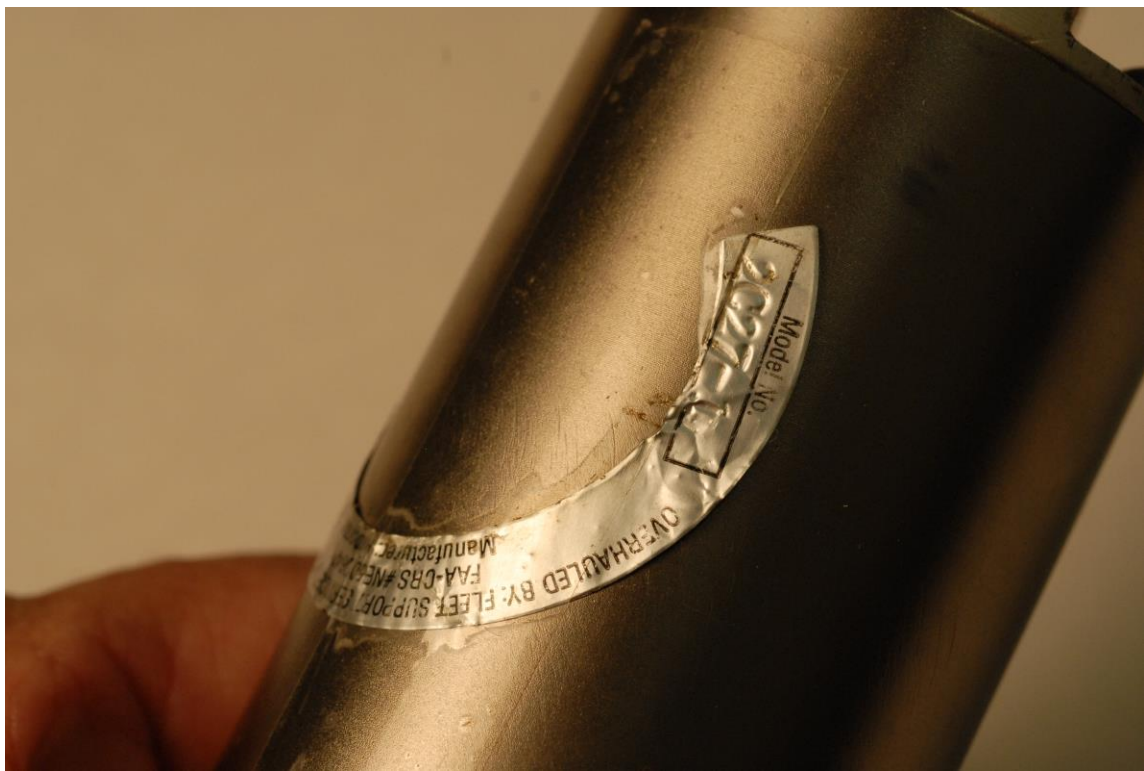
2C27-1 4H234 31Aug17\_020 – Name Plate

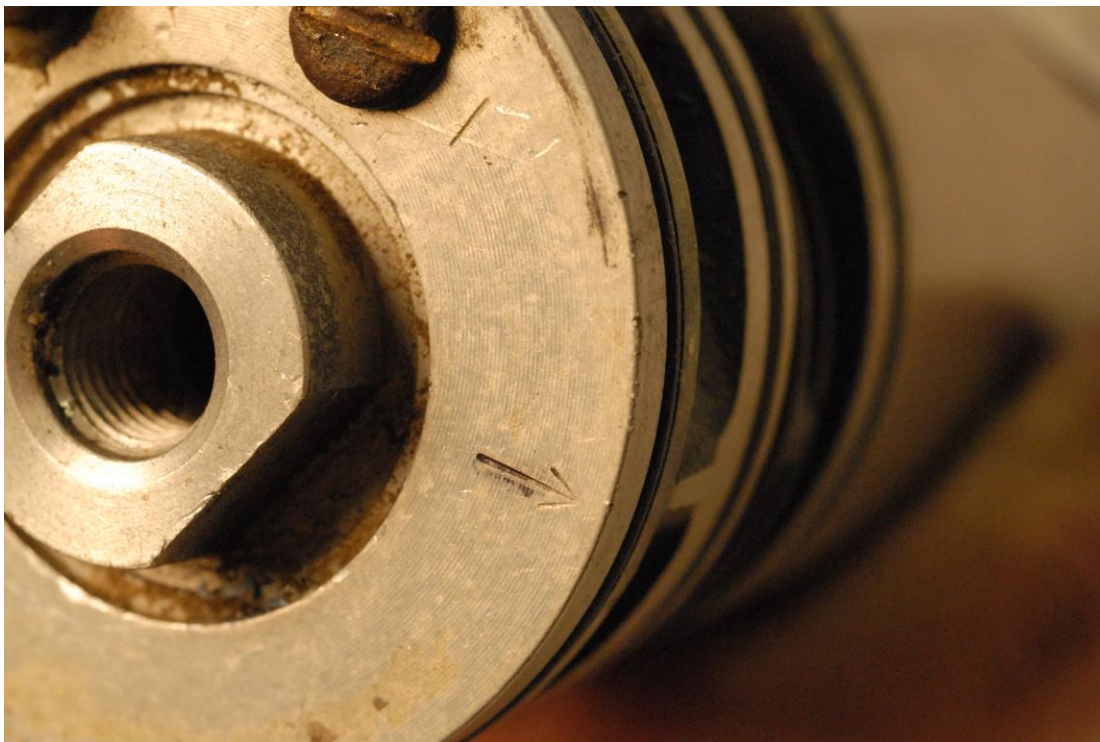
2C27-1 4H234 31Aug17\_021 - Cartridge Clocking Mark

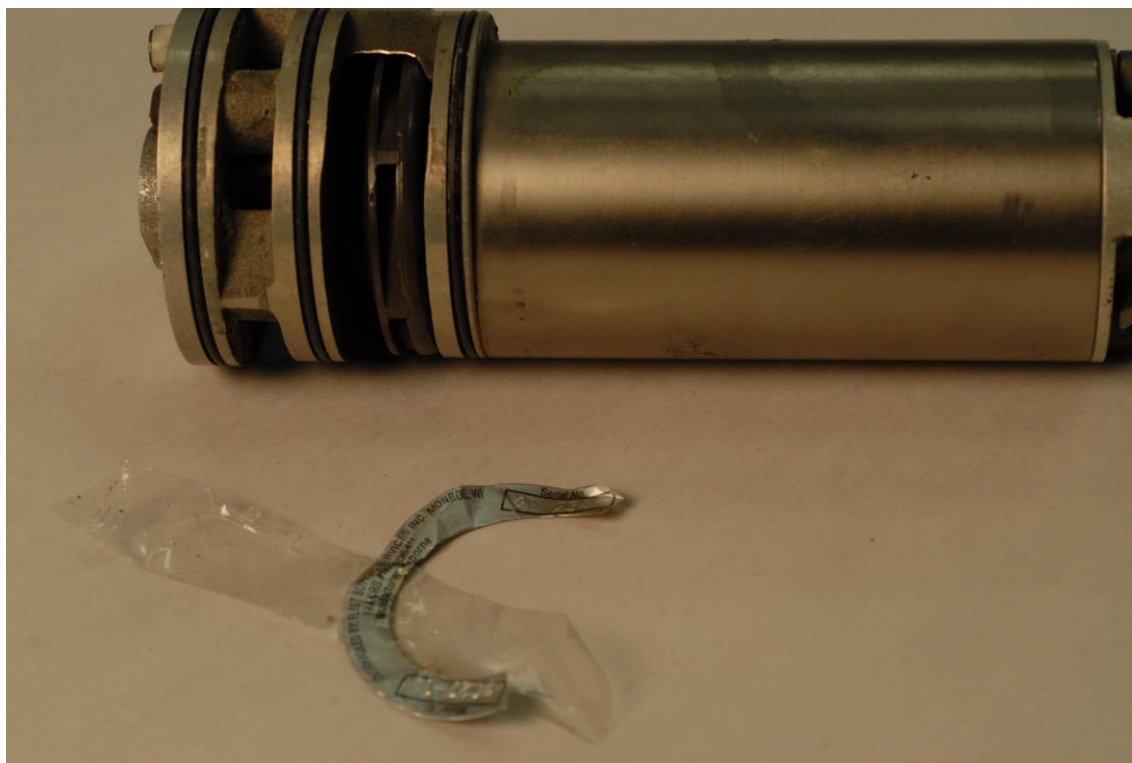
2C27-1 4H234 31Aug17\_022 – Name Plate removed

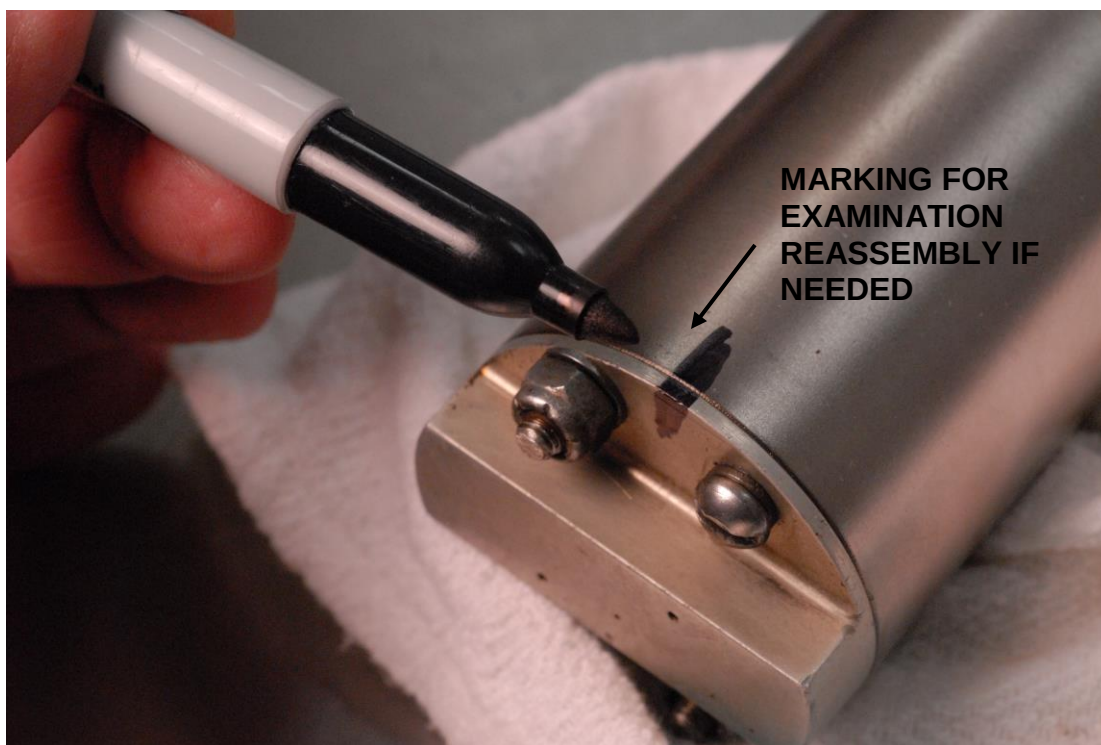
2C27-1 4H234 31Aug17\_023 – Marking for Reassembly if needed

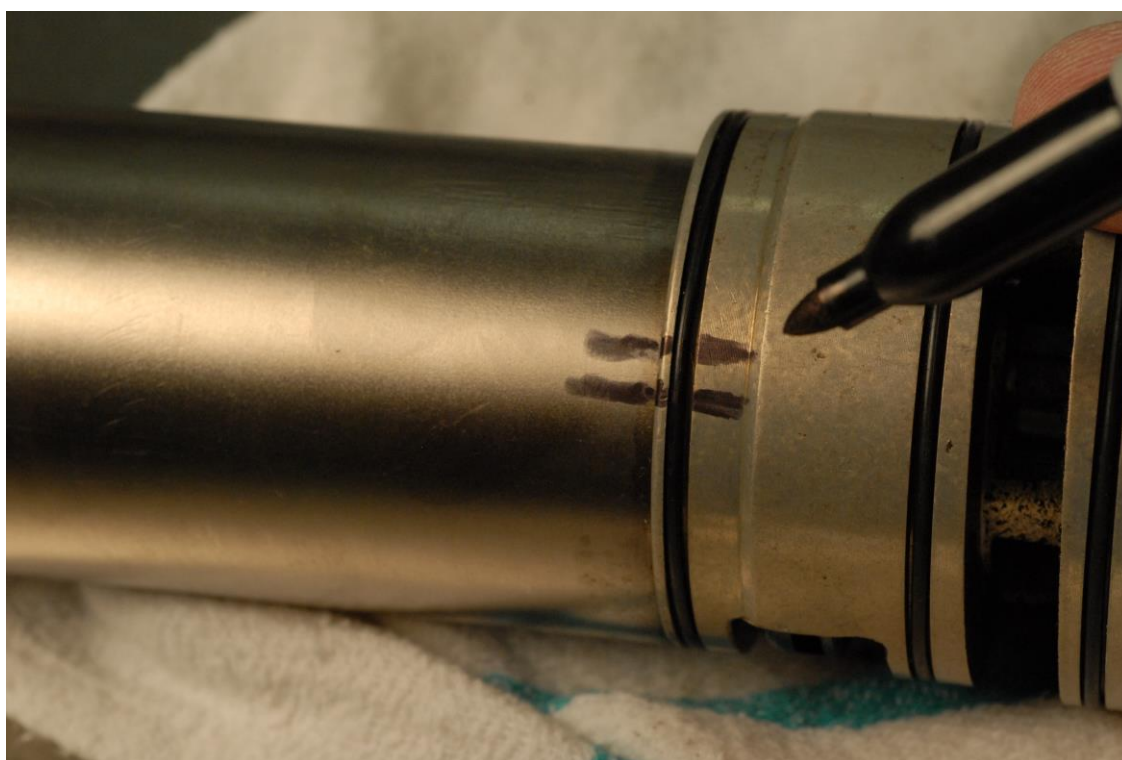
2C27-1 4H234 31Aug17\_024 – Marking for Reassembly if needed

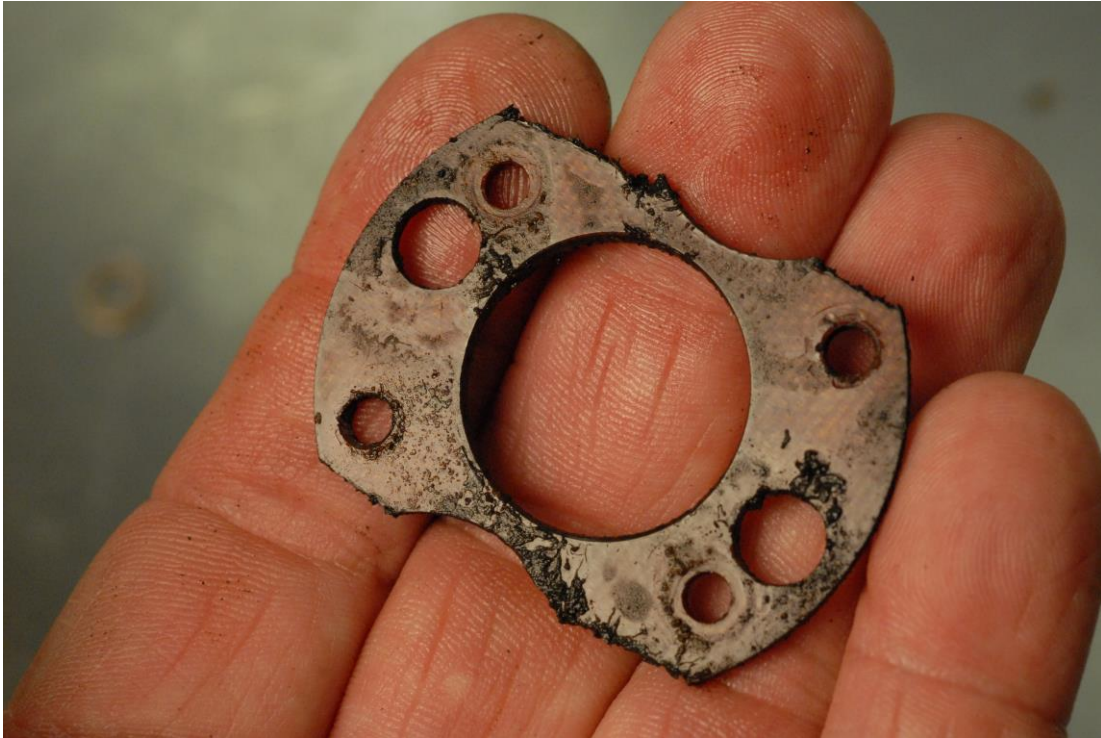
2C27-1 4H234 31Aug17\_031 – Brush Card Phenolic Insulator

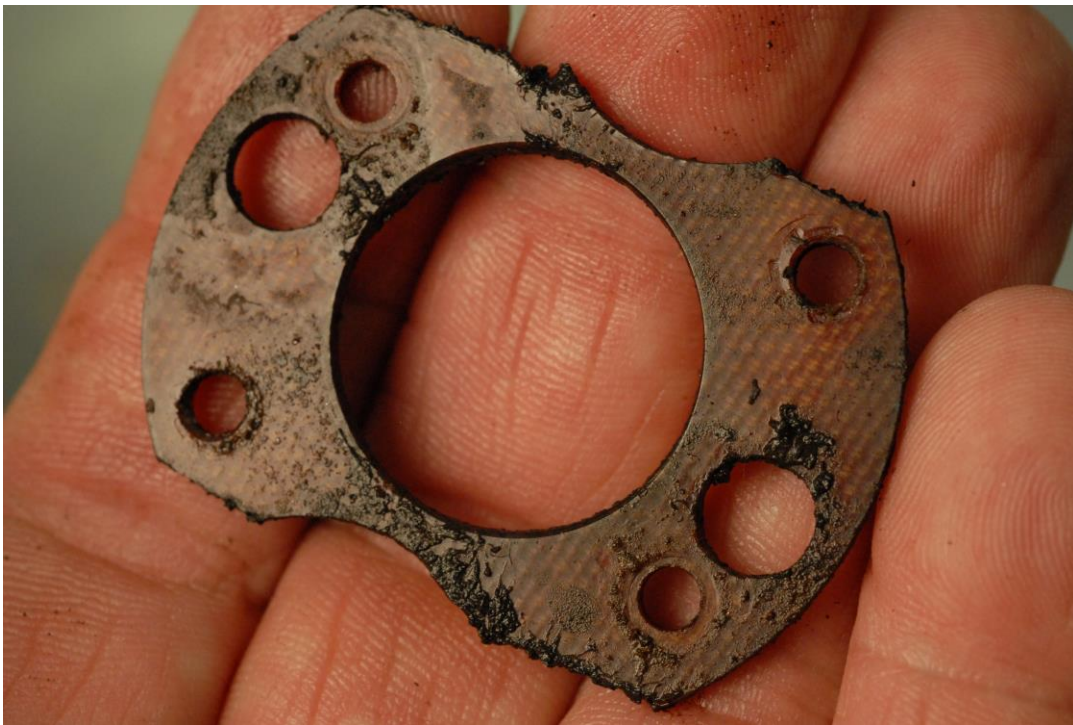
2C27-1 4H234 31Aug17\_032 - Brush Card Phenolic Insulator

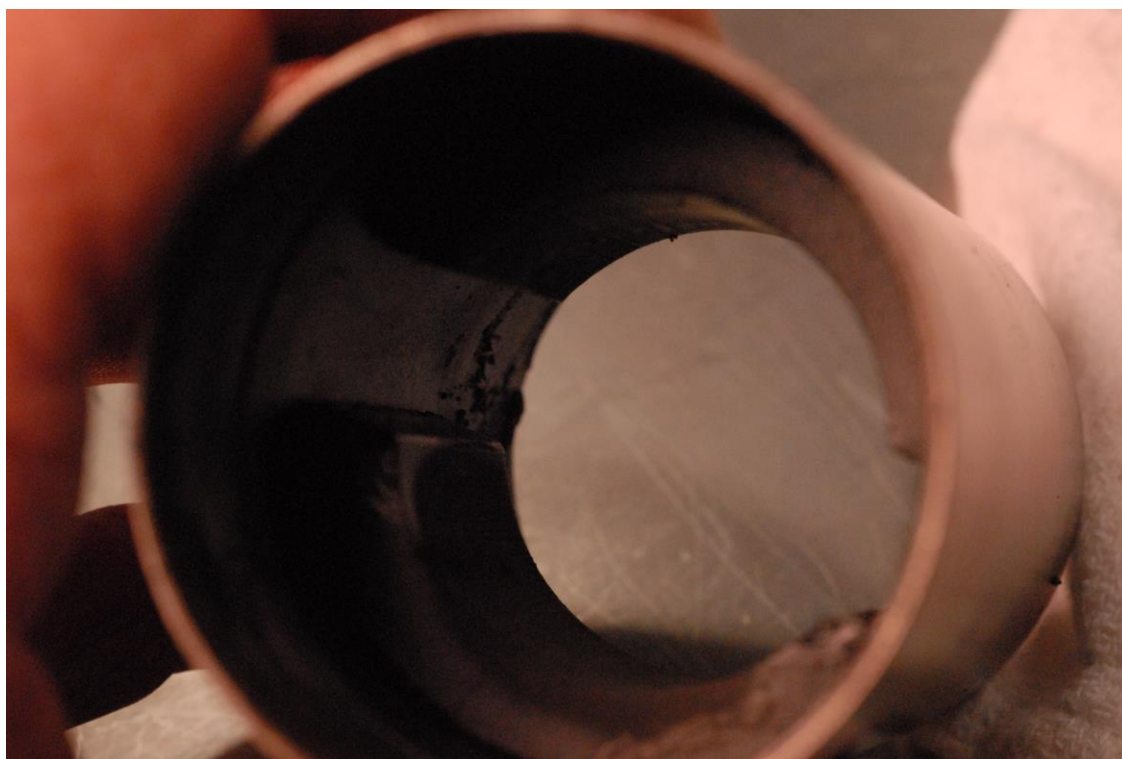
2C27-1 4H234 31Aug17\_046 – Field Tube

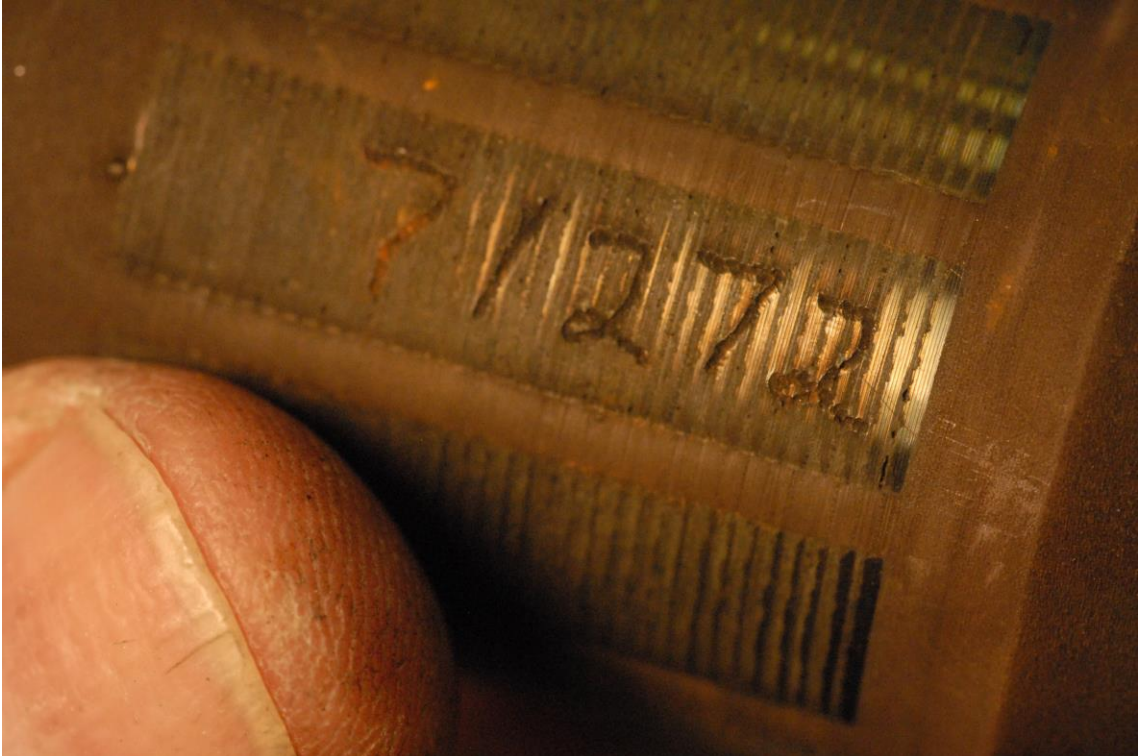
2C27-1 4H234 31Aug17\_064 – Non-Parker Marking
